Blued steel sheets : history, manufacturing and conservation.

The case of a Ganz & Co projection and enlargement lantern
conserved at the Collection Centre of the Swiss National Museum.

Master of Arts HES-SO in Conservation-restoration
Specialized in scientific, technical and horological objects

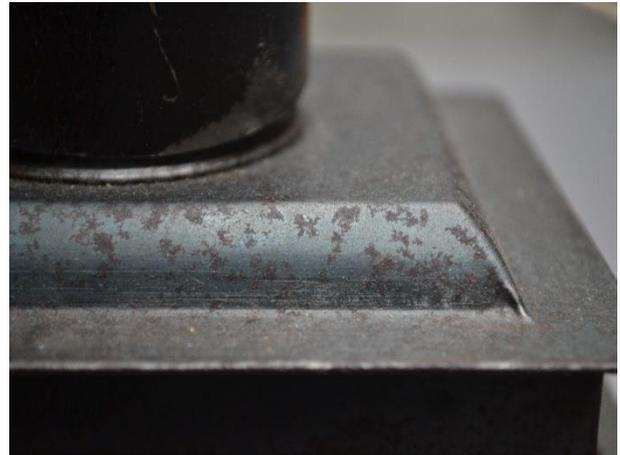
Picture 14 : Pitting and filiform corrosion on blued steel, Cinematograph 35mm conserved at the Cinematheque of Bern, inventory number GER 558, ©HE Arc CR, A.L

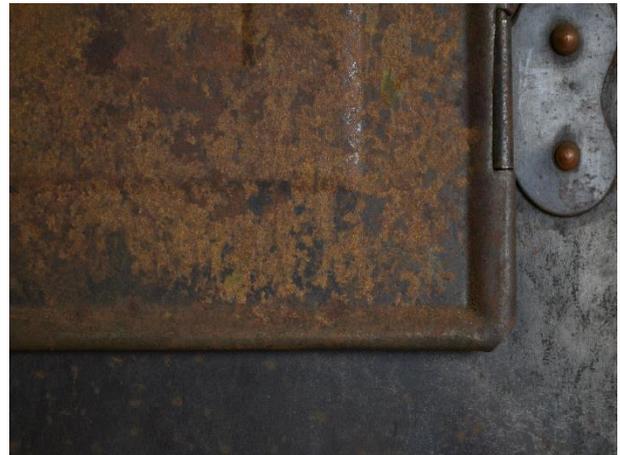
Picture 16 : Generalized corrosion, projection and enlargement lantern Meyer Ferd. Franz conserved at the Camera Museum, inventory number 2701 ©HE Arc CR, A.L

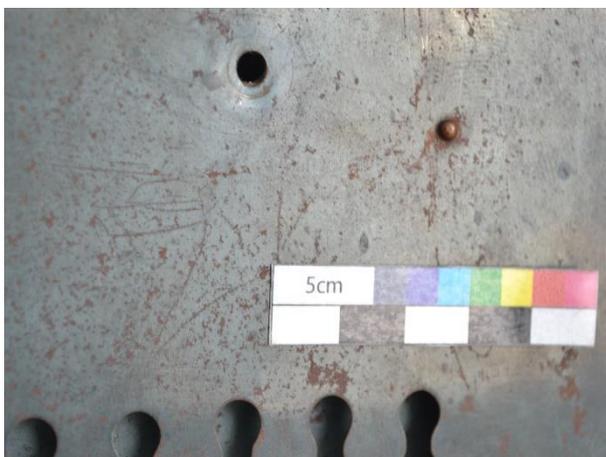
Picture 57 : Pitting corrosion on blued steel
©HE Arc CR, A.L

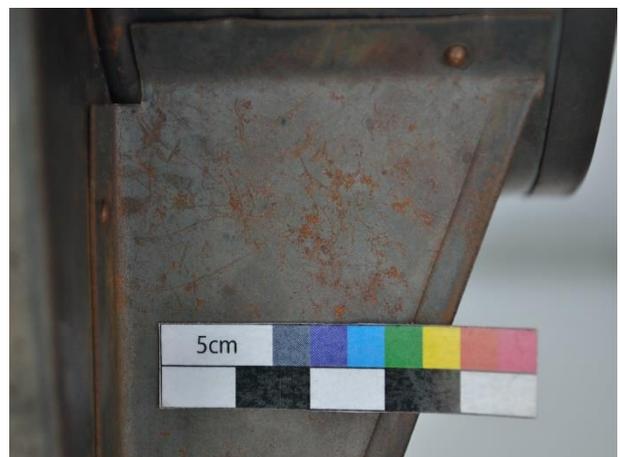
Picture 58 : Filiform corrosion on blued steel
©HE Arc Cr, A.L

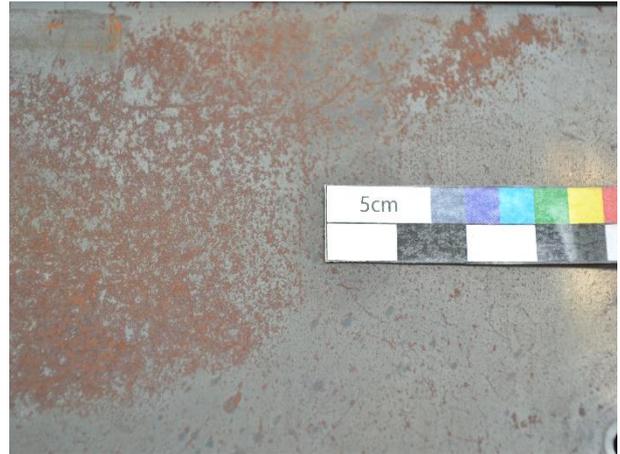
*Picture 60 : Generalized corrosion on blued steel ©HE
Arc CR, A.L*

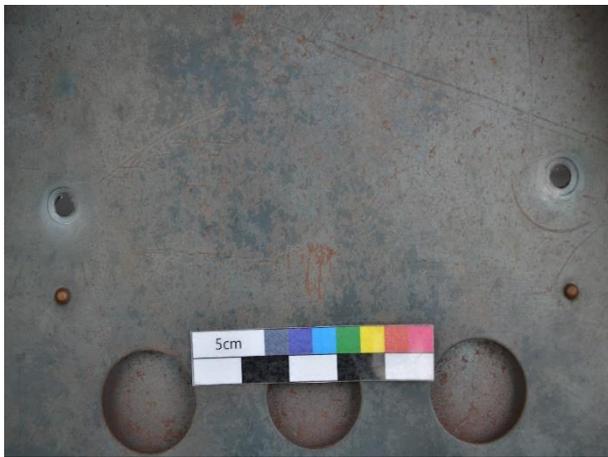
*Picture 61 : Losses of the blued layer
©HE Arc CR, A.L*

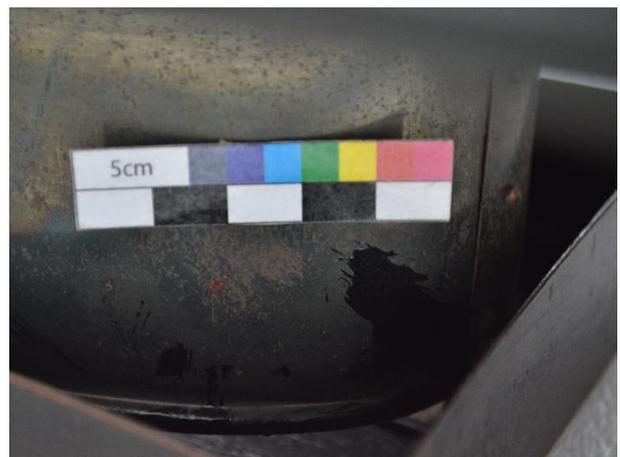
*Picture 64 : Sag of repaint on the bottom part of the
chimney ©HE Arc CR, A.L*

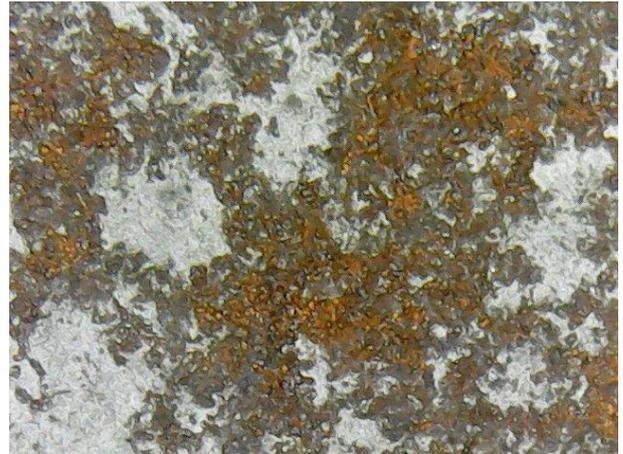
Picture 68 : Extensive filiform corrosion ©HE Arc CR, A.L

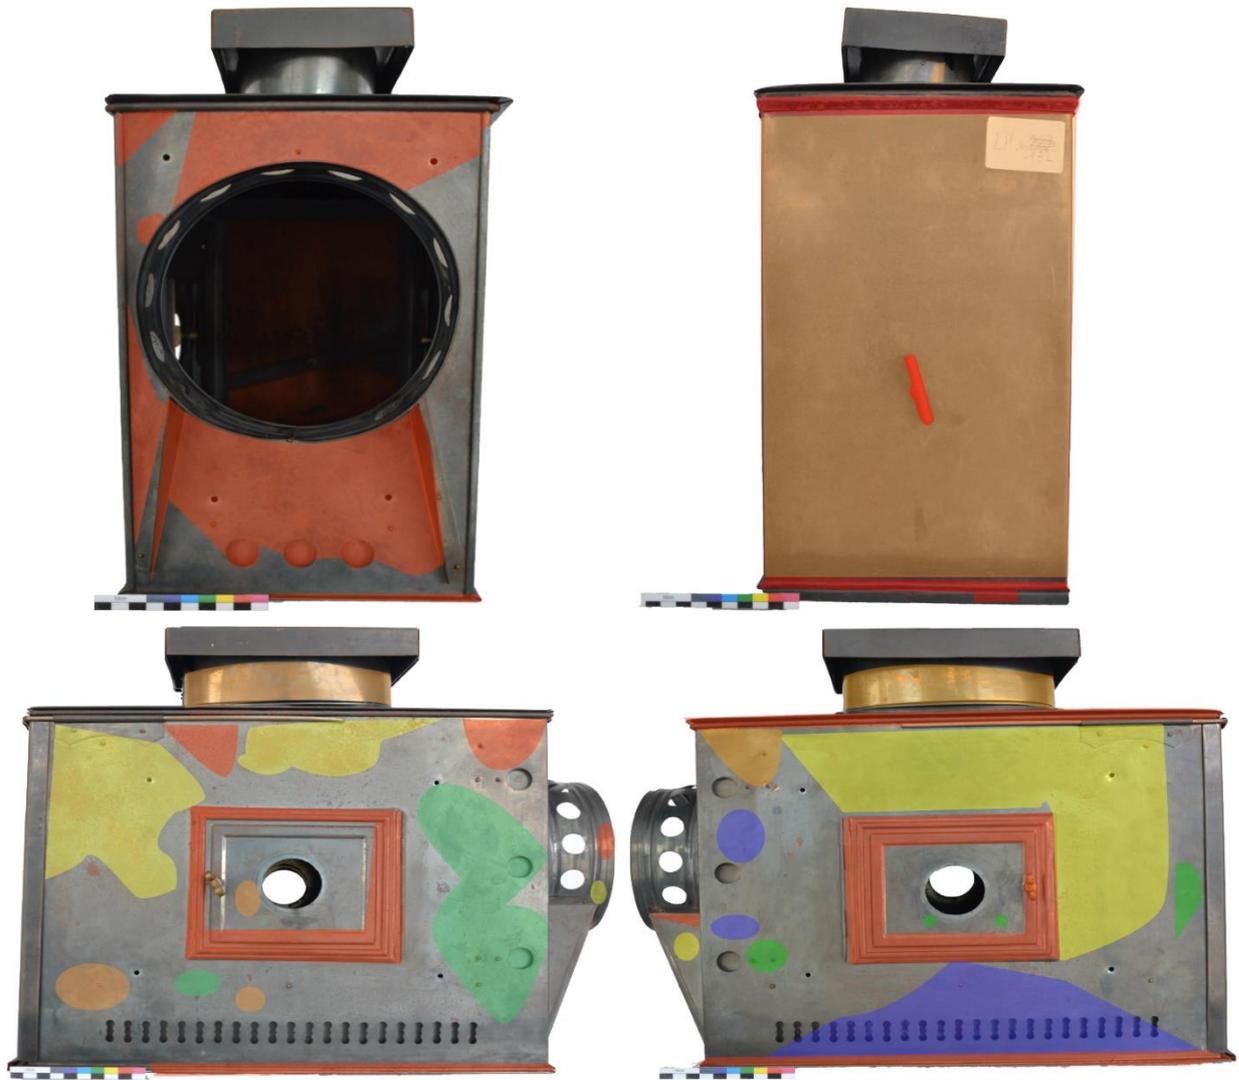
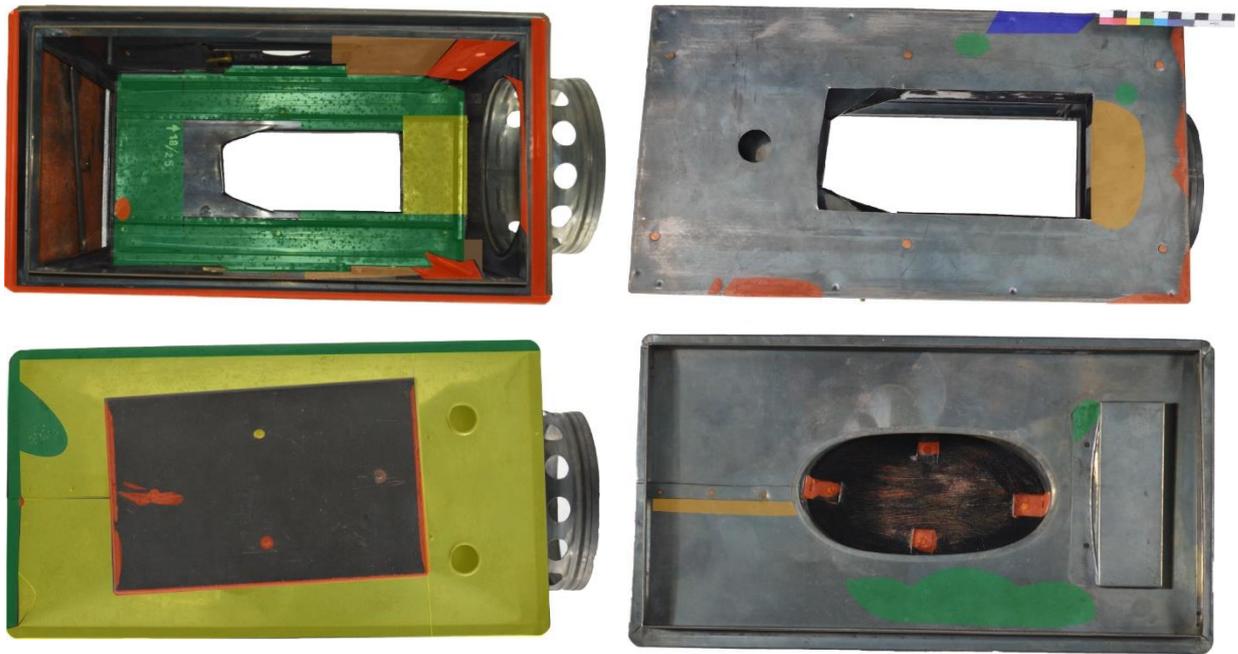
Picture 69 : Mapping of corrosion of the different sides of the object ©HE Arc CR, A.L

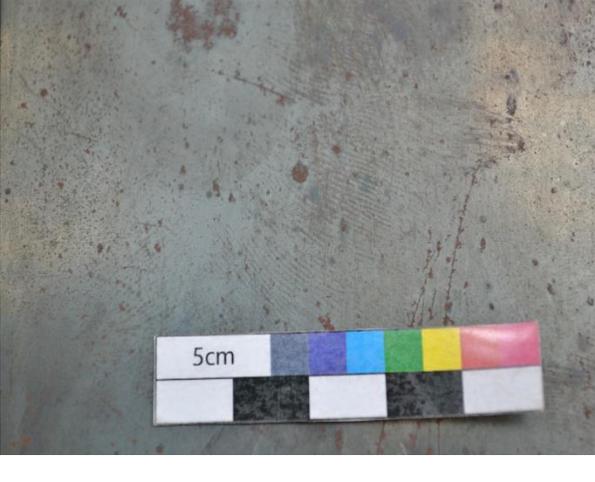
Lantern, walls and upper part	Ferrous alloy, blued steel	Fingerprints				Fingerprints are intrinsically related to the manipulation of the object, very probably before the blueing process, as this phenomenon has also been observed while preparing the blued steel coupons.

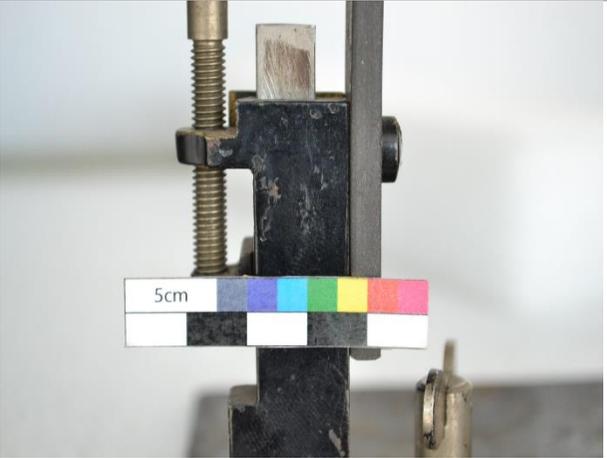
Localisation	Material	Surface alteration	Structural alteration	Functional alteration	Modifications, previous restorations	Diagnostic	Picture
Lantern, inside, base of the light source, black piece	Copper alloy, brass, paint		Losses of the paint layer			The manipulation and the settings of this part of the support of the light source may have cause losses of the paint layer.

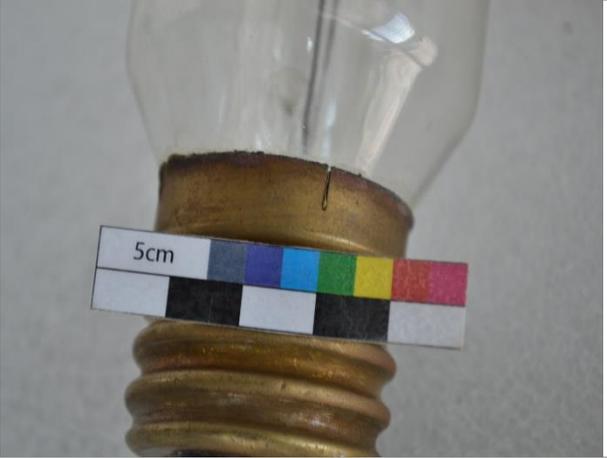
Lantern, inside, lamp cap	Copper alloy	Tarnishing				Copper alloys, when exposed to oxygen and humidity, develop tarnishing which is a discolouration of the surface of a metal when it is covered with a thin layer of corrosion products ¹³ .

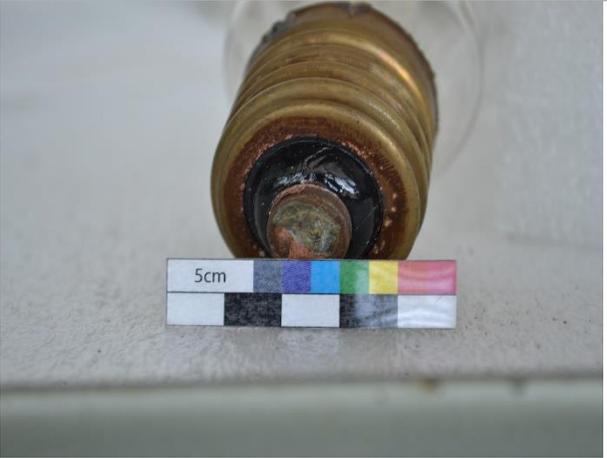
Localisation	Material	Surface alteration	Structural alteration	Functional alteration	Modifications, previous restorations	Diagnostic	Picture
Lantern, inside, lamp cap	Copper alloy	Copper alloy (brass?) deposit				The copper deposit seems to have been generated by the contact between the lamp cap and the copper of the socket.

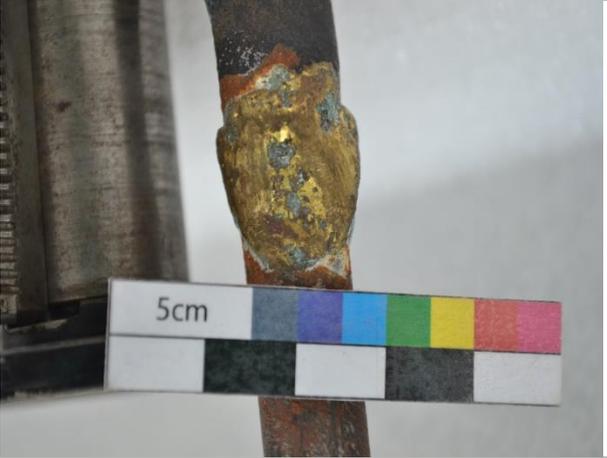
Lantern, inside, base of the light source	Copper alloy	Corrosion				An electrochemical reaction occurs between the metal and its atmosphere, causing its deterioration by reactions of oxidation and reduction ¹⁴ .

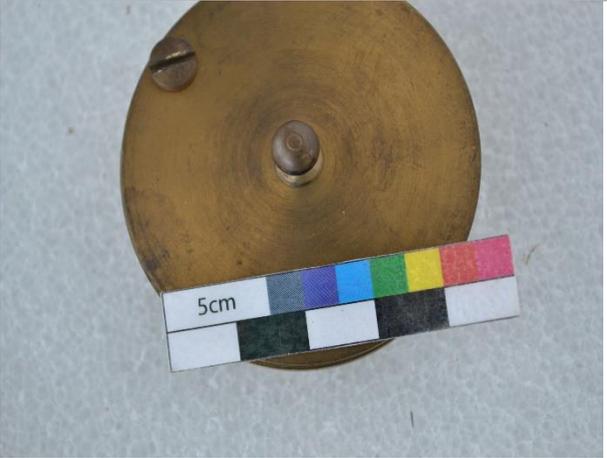
Localisation	Material	Surface alteration	Structural alteration	Functional alteration	Modifications, previous restorations	Diagnostic	Picture
Lantern, sides, peepholes	Copper alloy, brass	Tarnishing				Copper alloys, when exposed to oxygen and humidity, develop tarnishing which is a discolouration of the surface of a metal when it is covered with a thin layer of corrosion products ¹⁵ .

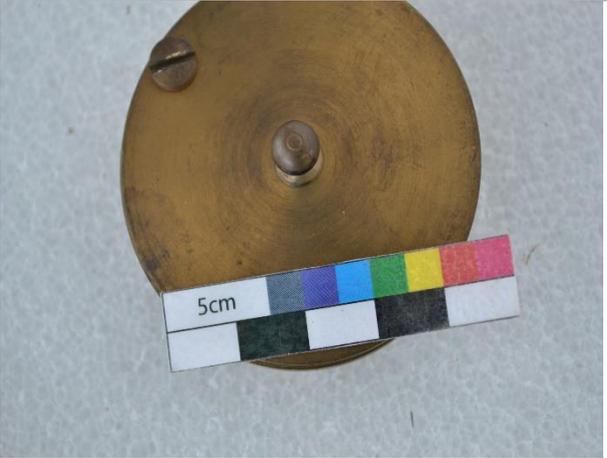
Localisation	Material	Surface alteration	Structural alteration	Functional alteration	Modifications, previous restorations	Diagnostic	Picture
Lantern, sides, peepholes	Copper alloy, brass	Halos				A lot of halos are visible on the object : it seems that it has been exposed to flows.

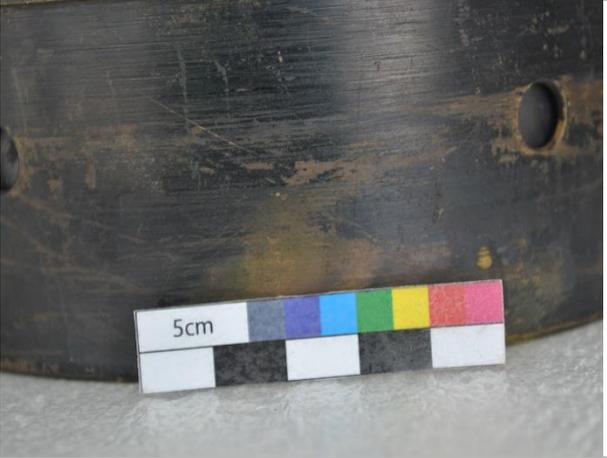
Lantern, inside, lens	Copper alloy, painted brass	Tarnishing				Copper alloys, when exposed to oxygen and humidity, develop tarnishing which is a discolouration of the surface of a metal when it is covered with a thin layer of corrosion products ¹⁶ .

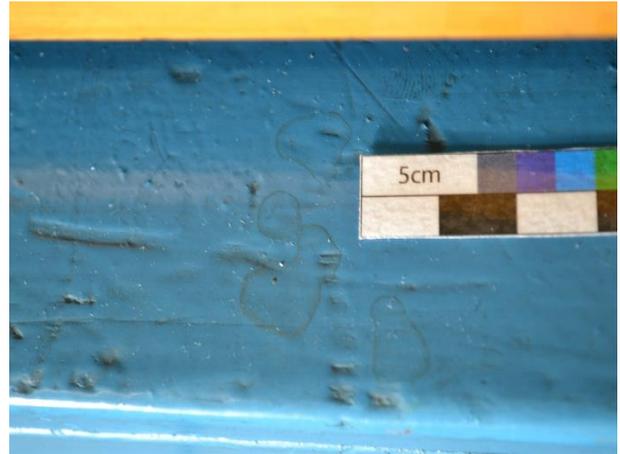
Picture 27 : Stain on the blue paint ©HE Arc CR A.L

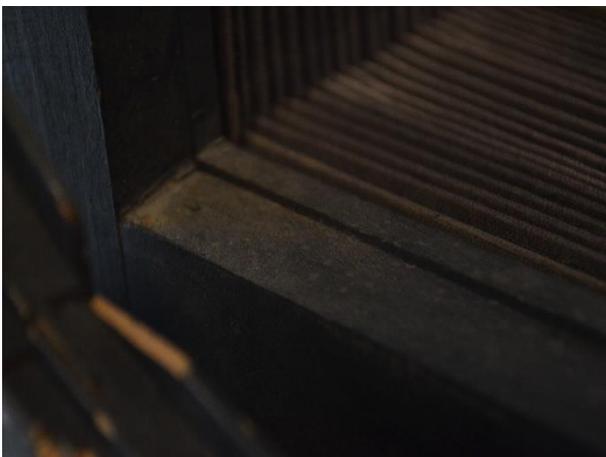
Picture 29 : Soiling of the black paint ©HE Arc CR A.L

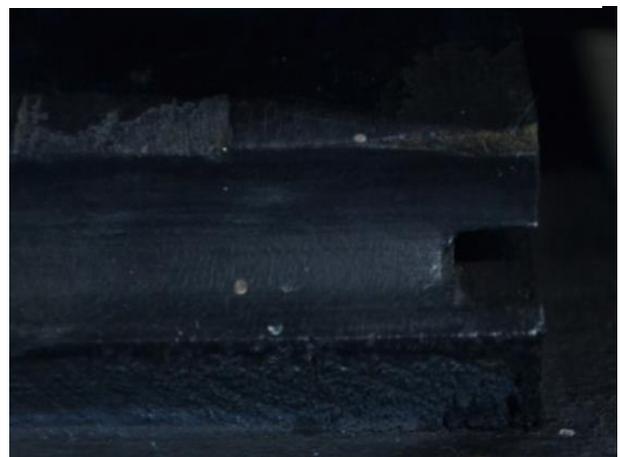
Picture 28 : Paint stain on the black paint ©HE Arc CR, A.L

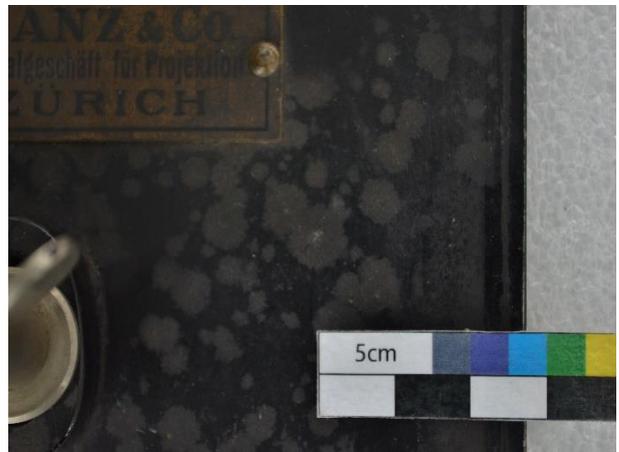
Picture 35 : Halos caused by flows ©HE Arc CR, A.L
