Blued steel sheets : history, manufacturing and conservation.

The case of a Ganz & Co projection and enlargement lantern
conserved at the Collection Centre of the Swiss National Museum.

Master of Arts HES-SO in Conservation-restoration
Specialized in scientific, technical and horological objects

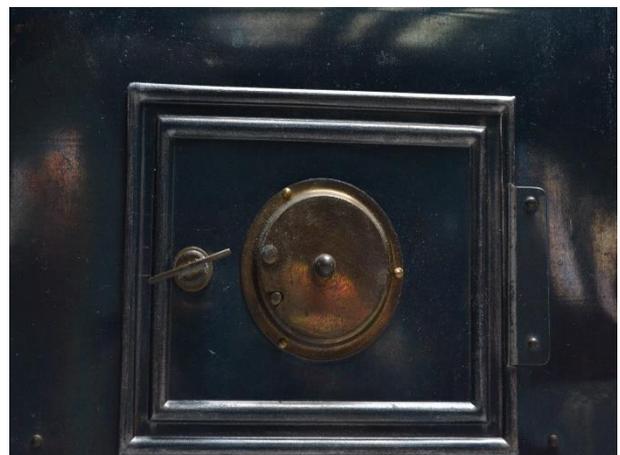
Picture 12 : Pristine blued steel surface, ICA Trilby projector conserved at the Cinematheque of Bern, around 1915, inventory number 182027 ©HE Arc CR, A.L

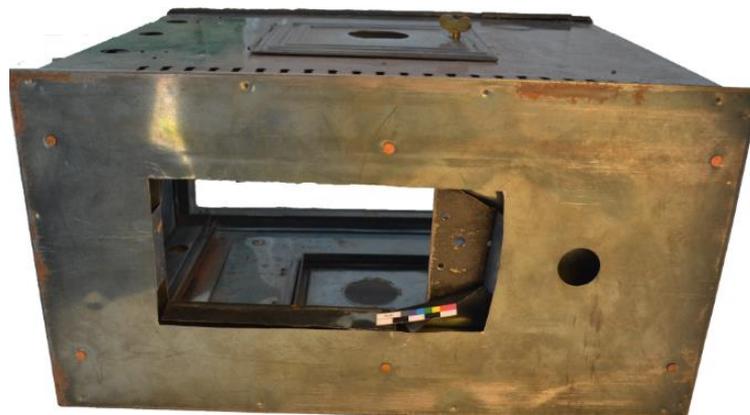
Literature evokes both puddle iron and steel as base materials used to manufacture blued sheets. To determine the nature of the metal, for documentation purposes as well as for allowing the right choice of metallic coupons to test the treatments of conservation, a sample (*Picture 25*) has been collected on the object to be observed and analysed as a cross-section under inverted microscope and scanning electron microscopy. The sample (*Picture 28*) has been obtained by cutting the metallic sheet with a wire cutter, as the use of a chainsaw⁸⁵ was not possible on this object for access and construction reasons (*Picture 26, Picture 27*).

Picture 25 : Localisation of the sample at the bottom of the lantern ©HE Arc CR, A.L

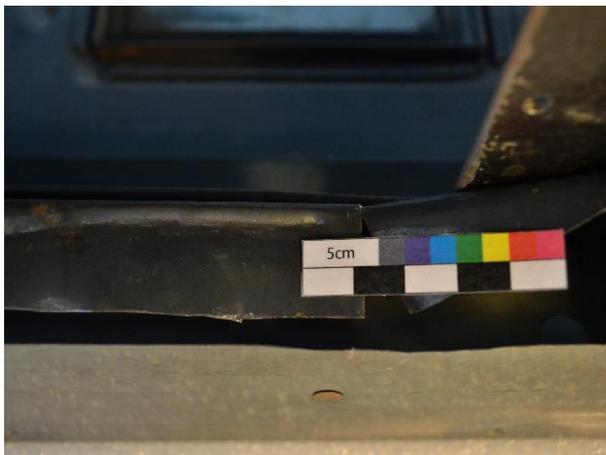
Picture 26 : Area of the object before collecting the sample ©HE Arc CR, A.L

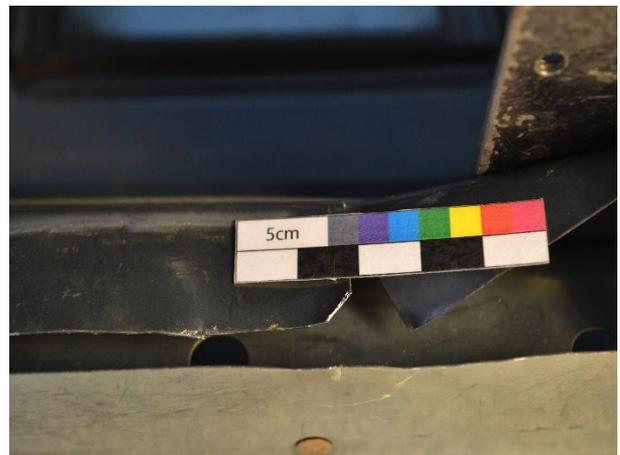
Picture 27 : Area of the object after collecting the sample ©HE Arc CR, A.L

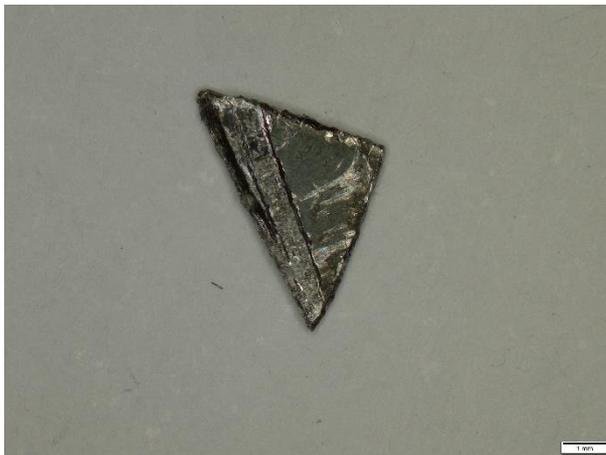
The observations under inverted microscope demonstrated a microstructure with a low quantity of impurities (*Picture 29*). A puddled iron would contain way more constitutive elements and inclusions as phosphor⁸⁶, aluminium, copper or molybdenum (*Picture 31*). Also, the composition of two areas of the sample have been analysed with scanning electron microscopy (*Picture 30, Picture 32, Picture 33*). Iron (Fe), manganese (Mn), silica (Si), sulphur (S) characterize a steel alloy as well as the microstructure⁸⁷.

Picture 28 : View of the sample under binocular magnifier ©HE Arc CR, A.L

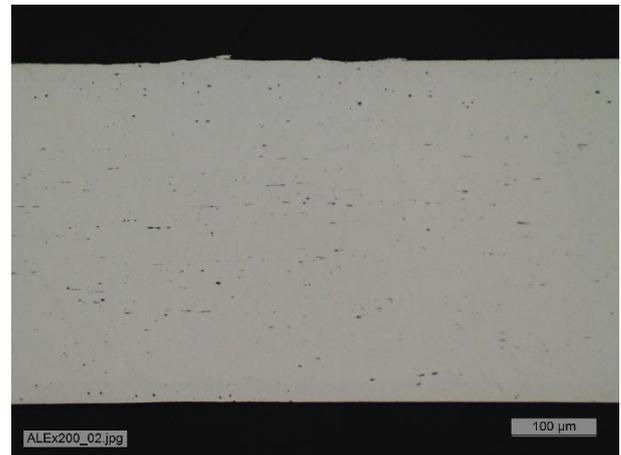
Picture 29 : Microstructure of the sample ©HE Arc CR, A.L

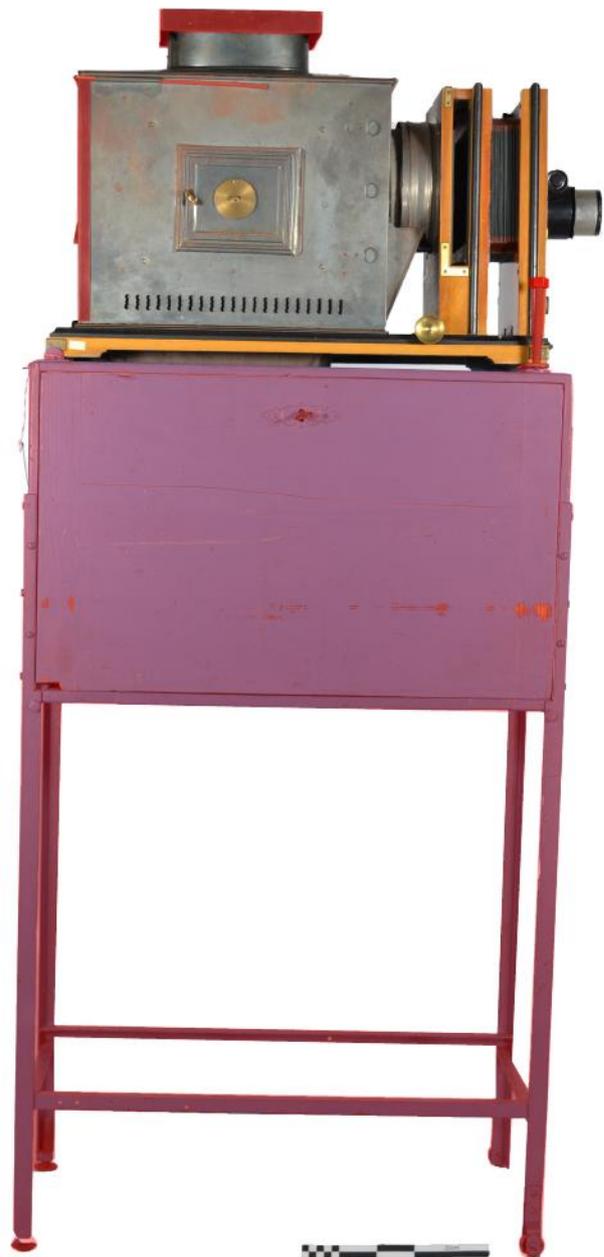
The study of the object conducted to the conclusion that it has been considerably modified from its original condition (*Picture 44*). The original object is the lantern and its wooden base. A comparison with a Ganz & Co lantern commercialized around 1914 could be done (*Picture 21*), as the dimensions and the configuration of the lantern, the length of the bellow (45cm), the size of the glass plates and the base of the light source of the object. The fact that asbestos plates are equipping the inside of the lantern was also questioned, as there is no need of them as heat protection for an incandescent bulb. The lantern was initially commercialized with a radial arc lamp (*Picture 45*), which explains the necessity of asbestos plates to control the released heat¹⁰². The evolution of the light sources and the depletion of charcoals needed to supply the arc lamp may be the reasons which pushed the owner of the object to operate a change of the light source¹⁰³. It can be observed that the constitutive elements of the former arc lamp have been used to build the actual light source : the metallic base, the control knobs and the metallic body (*Picture 46*). To fit the new light system, holes have been bored at the bottom of the lantern and at the top of the wooden

Picture 44 : Added parts on the object, in red
©HE Arc CR, A.L

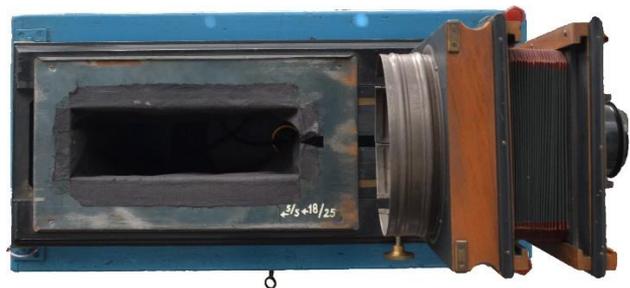
Picture 47 : Bored bottom of the lantern
©HE Arc CR, A.L

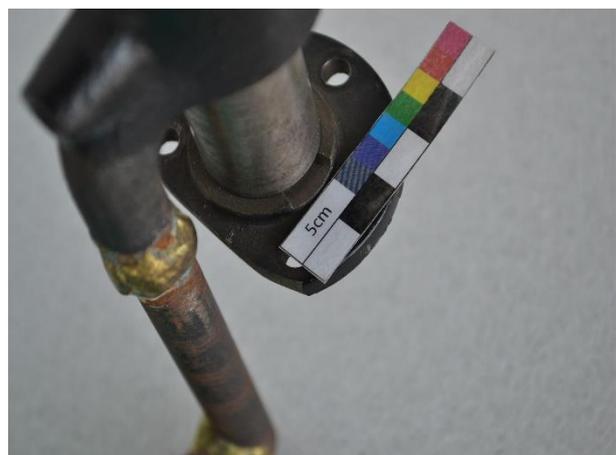
box (Picture 47). The bulb equipping the light source has been produced between 1926 and the 1994, if we refer to the Philips logo and a technical brochure introducing the device (Picture 48, Picture 49). A lot of elements show that these modifications have been made by an amateur. The finishing touches of the metal work as well as the soldering work on the light source and the lens are generally rough (Picture 50), and a light bulb which is not suitable for projection has been chosen. The Philips type 62 bulb with a power of 1000W was supposed to be used to enlighten theatres¹⁰⁴. However, the lamp allowed the use of plastic diapositives, which would have been impossible with an arc lamp¹⁰⁵.

Picture 50 : Rough modifications of the light source : soldering and cutting ©HE Arc CR, A.L

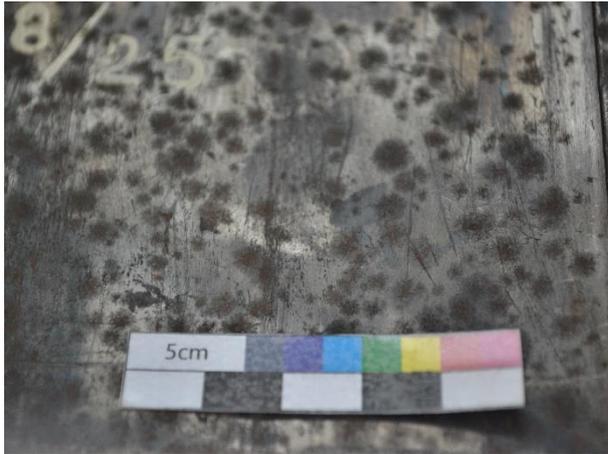
All the constitutive parts of the lantern show general surface dust and soiling. Its blued steel sheets principally show red corrosion products of different thicknesses. Pitting (*Picture 57*), filiform (*Picture 58*) and generalized corrosion (*Picture 60*) have been identified. The inside of the lantern is covered with localised areas of filiform corrosion, except where the base of the light source is placed (*Picture 59*). Occasional black corrosion products are visible on the upper part of the lantern. Losses of the grey protective layer (*Picture 61*) are also noticeable, mainly on the outside sides of the sheets. Mechanical alterations as scratches (*Picture 63*), as well as structural alterations, as deformation and dents are also perceptible. Chemical alterations as fingerprints and localized whitish surface dirt are also visible, as well as sheen of the blueing layer. A lot of halos (*Picture 62*) are also perceptible on the blued steel, as well as sag of repaint (*Picture 64*).

*Picture 59 : Localised filiform corrosion on blued steel
©HE Arc CR, A.L*

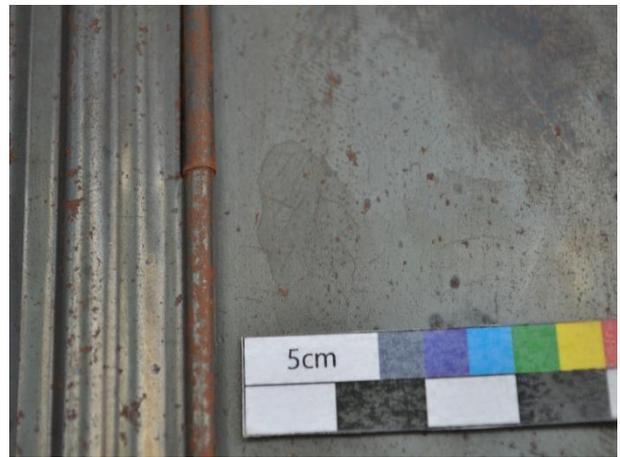
*Picture 62 : Halo on the blued layer
©HE Arc CR, A.L*

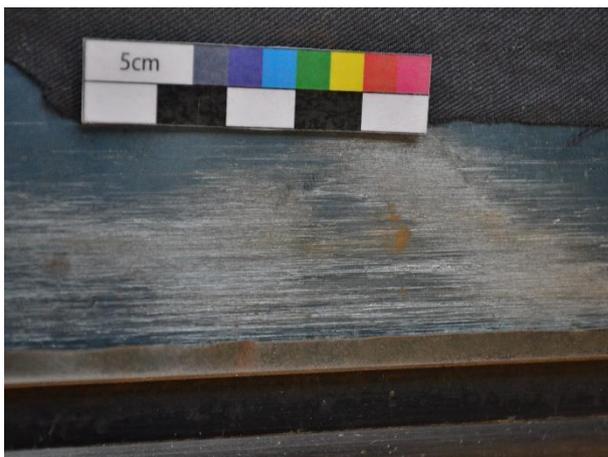
*Picture 63 : Scratches on the surface of the sliding
plate of the lantern ©HE Arc CR, A.L*

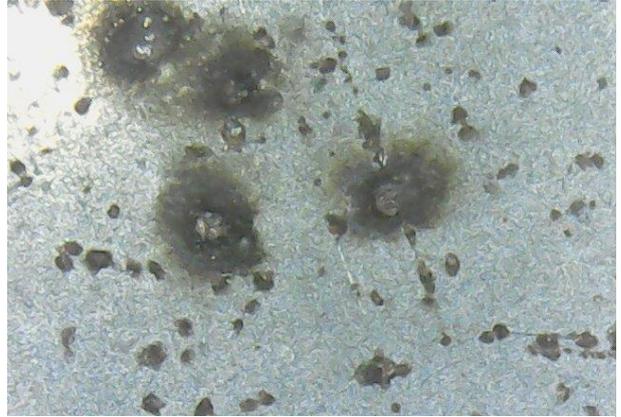
Pitting corrosion (*Picture 65*) forms cavities at the surface of the metal and initiates with the presence of chloride ions¹¹². It sparked everywhere on the blued steel sheets, except on areas covered with another piece of metal or asbestos plates. Few pristine blued areas are found on the outside walls of the lantern.

Picture 65 : Pitting corrosion on blued steel ©HE Arc CR, A.L

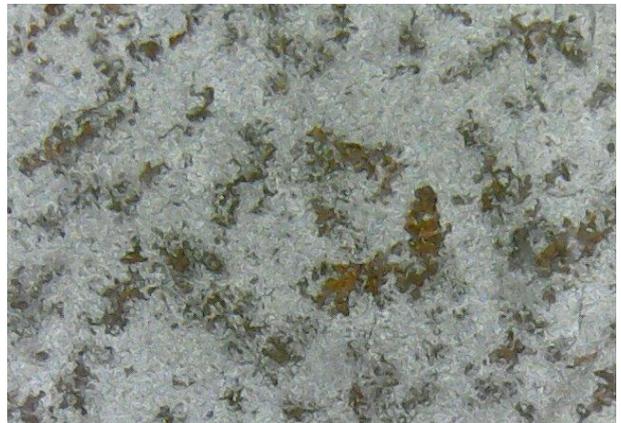
Filiform corrosion (*Picture 66*) develops under the blued coating as the form of filaments¹¹³. It is punctually developed on the outside walls of the lantern, but hundreds of small, localised areas of filiform corrosion are punctuating the bottom of the inside of the lantern, as well as the borders of the side doors.

Picture 66 : Filiform corrosion on blued steel ©HE Arc CR, A.L

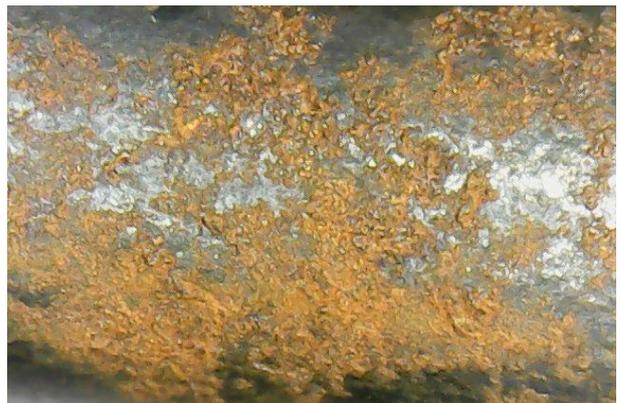
Extensive filiform corrosion (*Picture 67*) is a developed form of filiform corrosion. It is characterised by an underlayer of black filaments covered with a thick and layer of red corrosion products. It is generally developed on the upper parts of the sides of the lantern, and completely generalised at the front. Also, the areas of bending and stamping of the sheets are very much impacted by generalised corrosion.

Picture 67 : Extensive filiform corrosion on blued steel ©HE Arc CR, A.L

The bending of the sheets has very probably caused the development of thicker corrosion products, as the microstructure of the metal has been modified by the manufacturing.

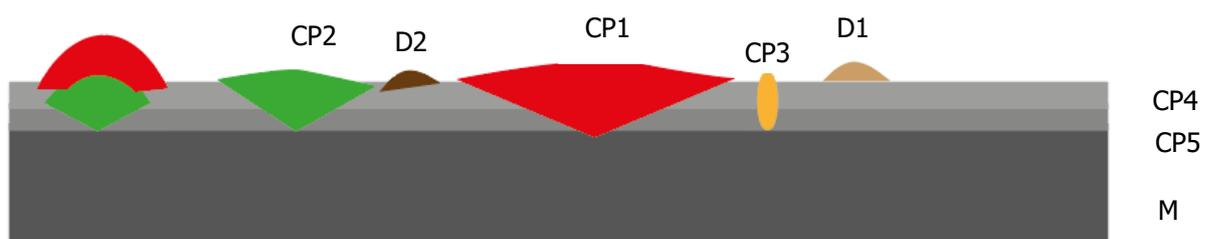
Extensive filiform corrosion is characterised by three textures of corrosion products : a very powdery overlayer, a moderately adherent layer in between and an adherent underlayer. All of them are characterized by a red-orange colour.

Pitting corrosion is composed of a single moderately adherent layer, of a red-orange or black colour. Filiform corrosion is composed of a single very adherent layer, of a black colour. Some pristine areas of the blued metal sheet are also preserved (*Diagram 6*).

Diagram 6 : Stratigraphy of the blued steel sheet of the object ©HE Arc CR, A.L

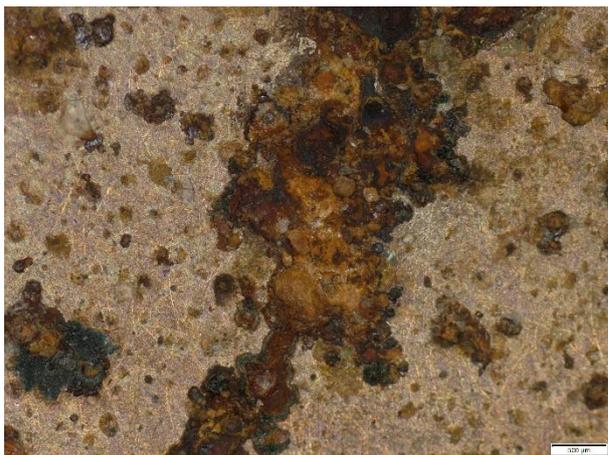
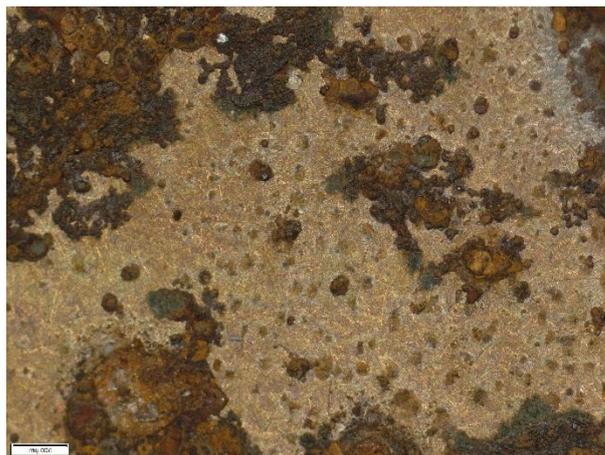
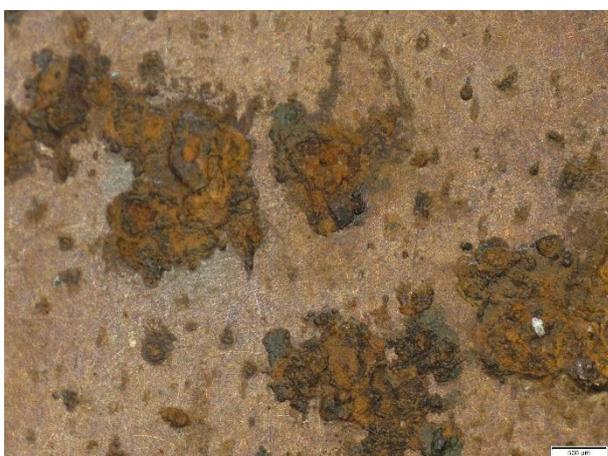
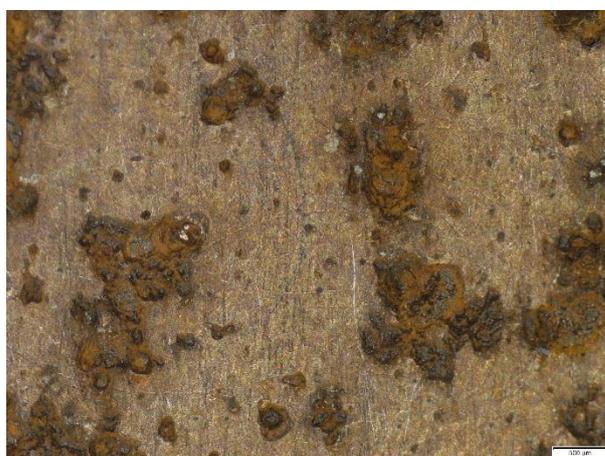
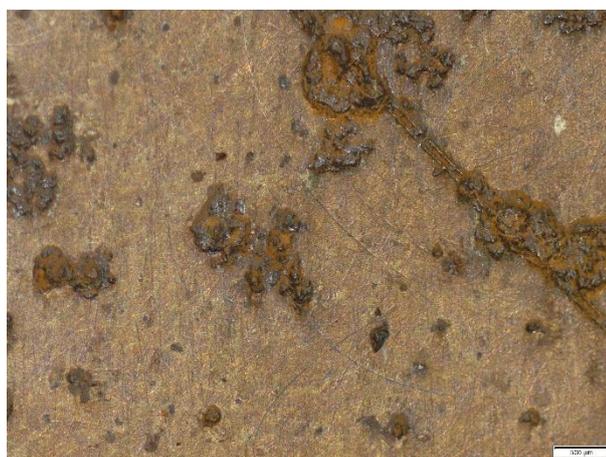
Both very flexible and flexible nylon brushes allowed the removal of the very low adherent powdered corrosion products, while the rigid nylon brush spread all the powdered corrosion products, inducing minor scratches on the blued surface. Both medium and rigid steel brush swatted and spread the corrosion products and induced scratches from their first application on the surface (*Picture 72*).

Picture 72 : Cleaning tests by brushing on the blued corroded coupons ©HE Arc CR, A.L

The use of a flexible nylon brush could be considered as a complementary technique for the removal of the very low adherent powdered corrosion products.

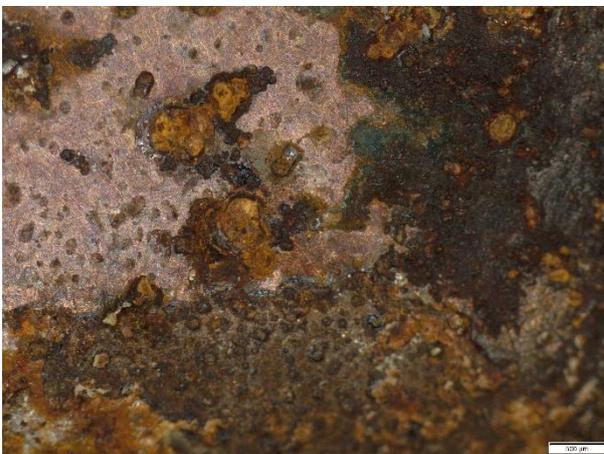
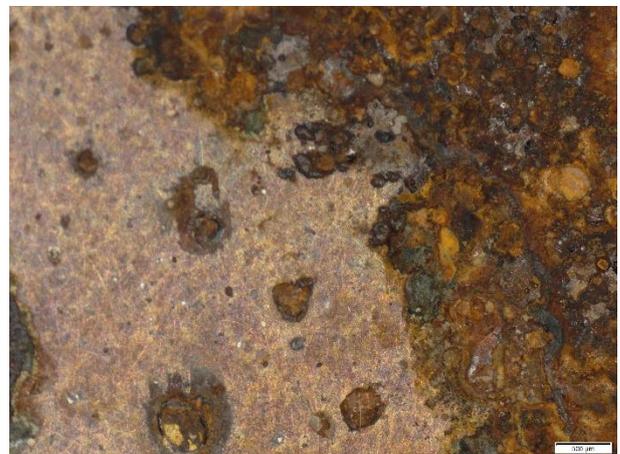
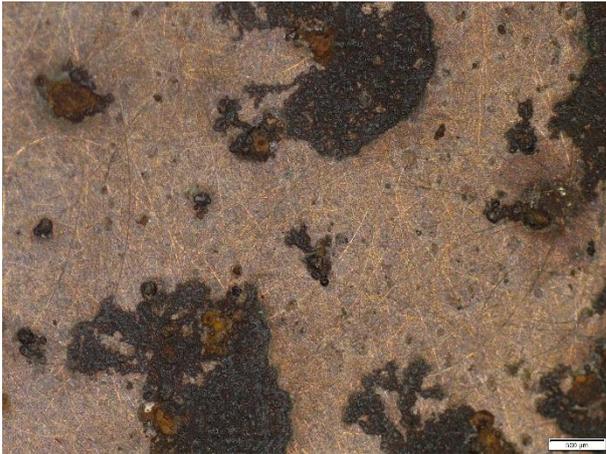
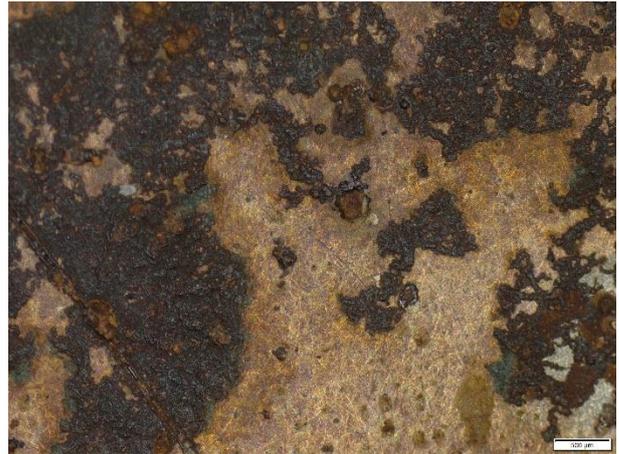
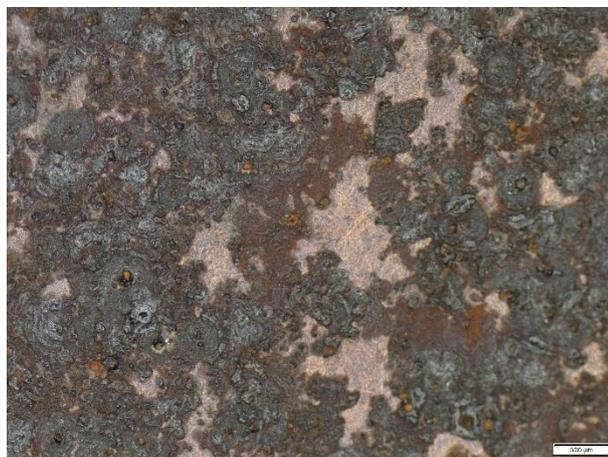
Picture 75 : Cleaning tests by erasing on the blued corroded coupons ©HE Arc CR, A.L

What is interesting with this method is that the corrosion products associate with the eraser peels. All the erasers except the most flexible allowed the removal of the powdery corrosion products. However, Läuffer Plast-0140 and Staedler Mars plastic erasers let some shiny marks on the surface. The flexible eraser Caran d'Ache Genève 0149.310 has an interesting shape which could be helpful to access stamped surfaces as well as flat ones (Picture 75).

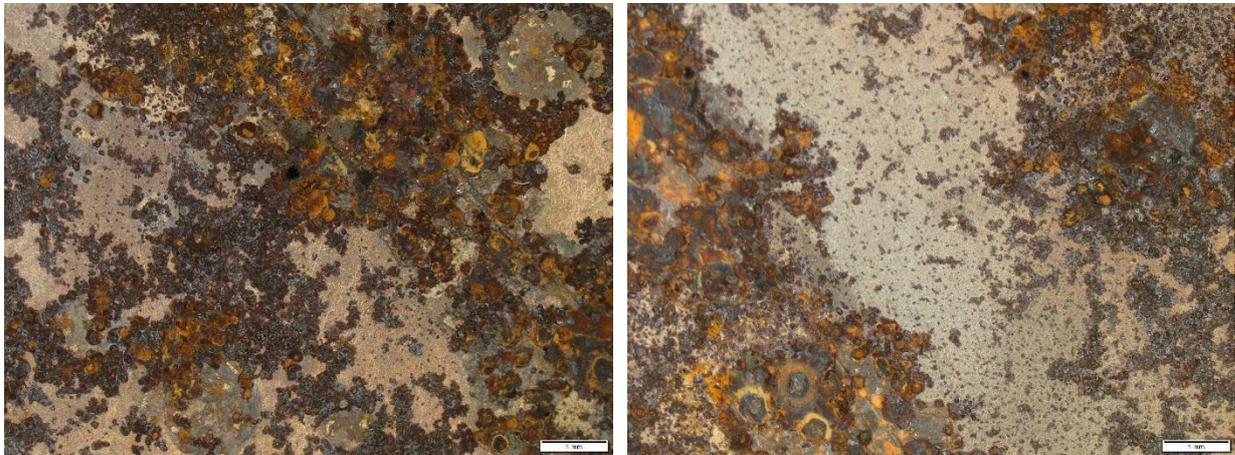
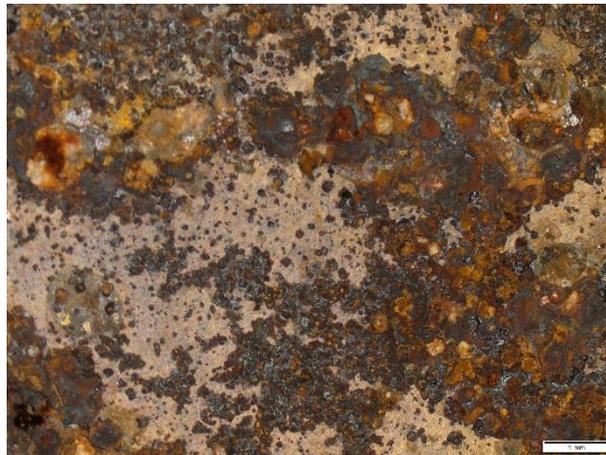
Picture 76 : Cleaning tests by sandblasting on blued corroded coupons ©HE Arc CR, A.L

Glass beads and biloxit damaged the blued layer, while Emsodur allowed a very slow removal of the soft and semi-rigid corrosion products. This method is not suitable for the removal of the corrosion products on blued steel (*Picture 76*).

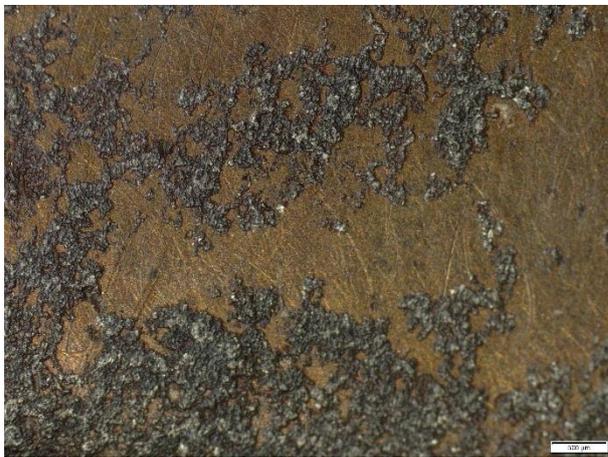
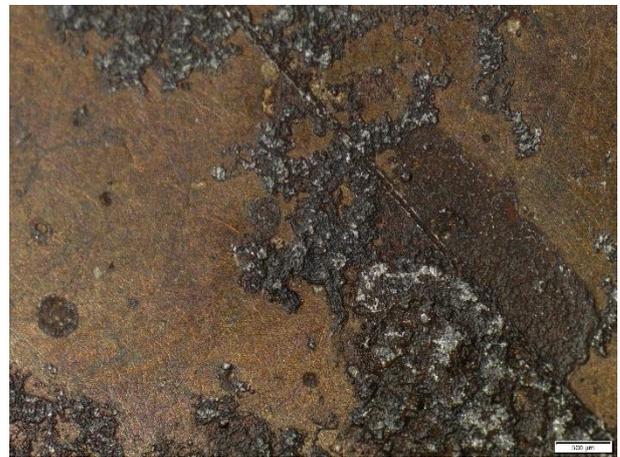
Picture 78 : Cleaning with aluminium foil and paraffin oil on blued corroded coupons ©HE Arc CR, A.L

This method allows the removal of the powdery and moderately adherent corrosion products. Also, it slightly mats the blued surface. The cleaning is fast but incomplete and the buffer should be changed quickly as aluminium pieces come off. However, the buffer adapts to angular and rounded areas.

Oil does not improve the removal of the adherent corrosion products. It compacts them on the surface of the metal. The aluminium foil removes partially the corrosion products, but the process is not convenient (*Picture 78*).

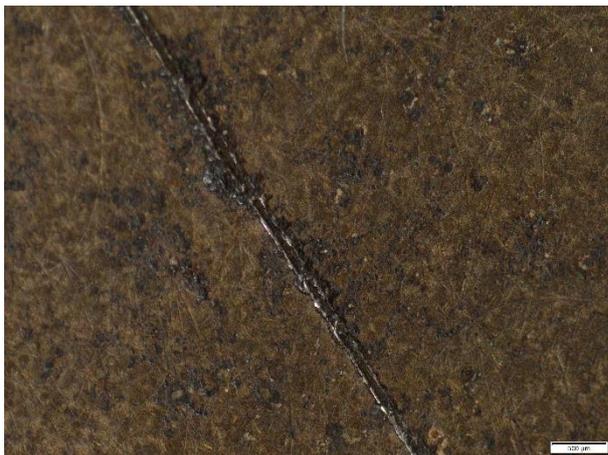
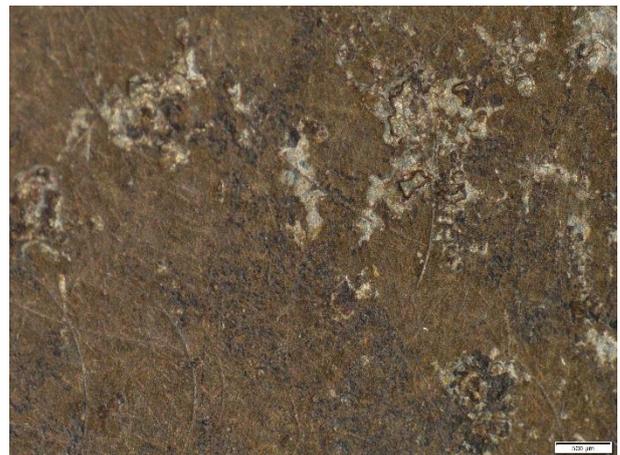
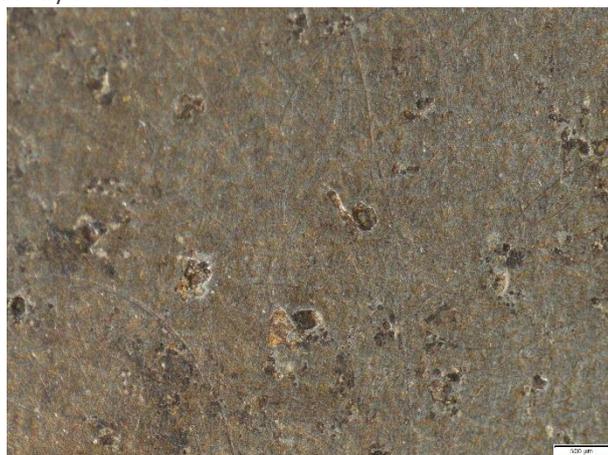
Picture 80 : Cleaning tests with a rotative steel brush Bijoutil 53526 and paraffin oil ©HE Arc CR, A.L

Despite of the small quantity of oil, this method generates important projections of oil on the periphery of the object and on the collaborator. The removal of the corrosion products is nearly total, but a brightness is brought on the blued layer, which seemed polished. Here again, it is difficult to control the cleaning with the presence of oil (*Picture 80*).

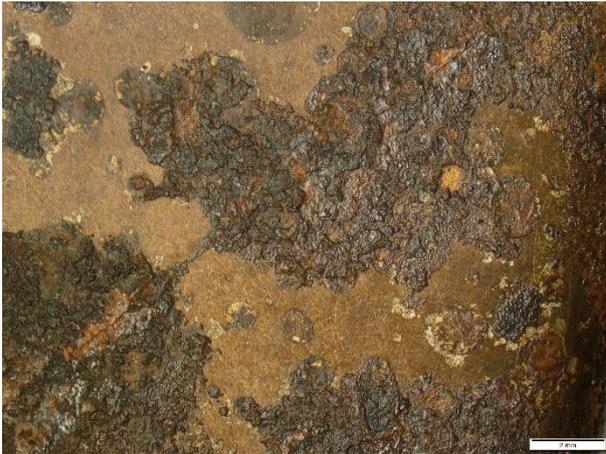
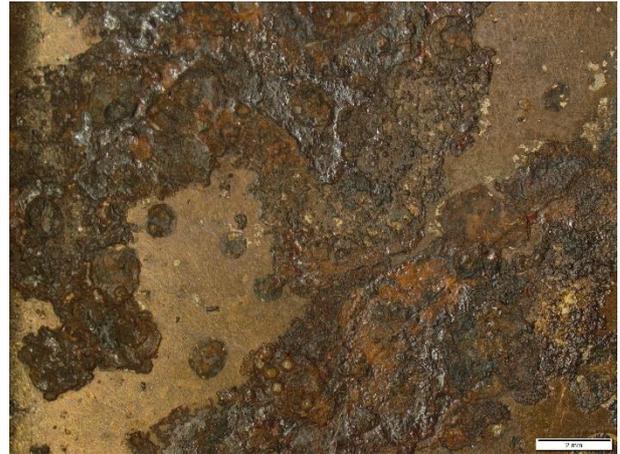
Picture 82 : Cleaning with the flat steel tool of the blued corroded coupons ©HE Arc CR, A.L

Associated with a drop of paraffin, the tool allows the corrosion products to be suspended in the liquid. When applied several times locally, it allows the push the adherent corrosion products. However, the oil agglomerates the corrosion products and does not allow a complete removal. A dry application should be preferred (*Picture 82*).

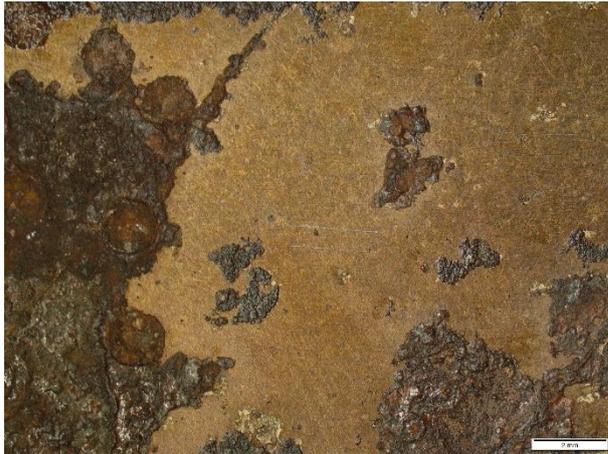
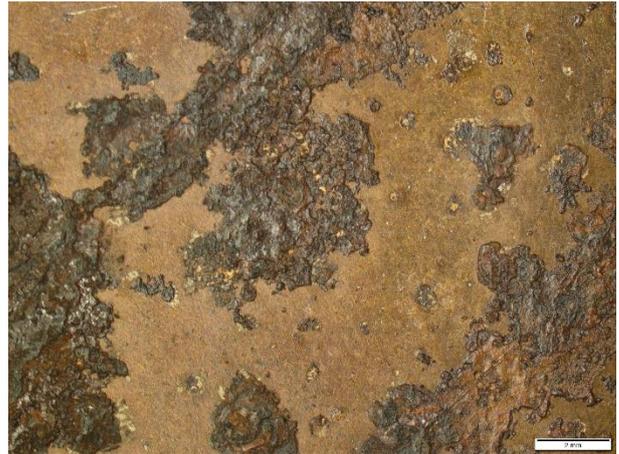
Picture 84 : Cleaning with razor blade with clipper of the blued corroded coupons ©HE Arc CR, A.L

This method has generated scratches, as the blade push on the very adherent corrosion products. The quantity of oil is also not the easiest to clean (*Picture 84*).

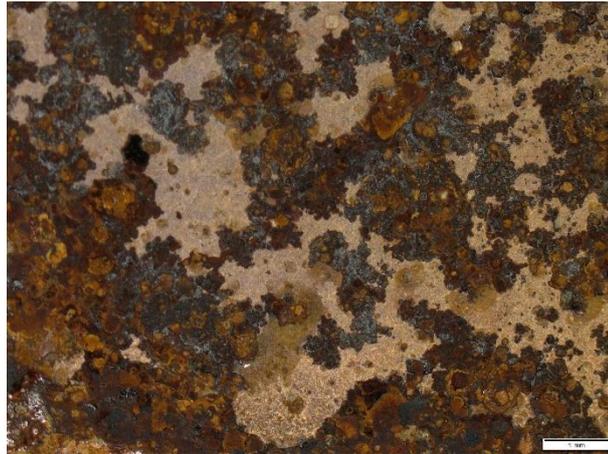
Picture 86 : Cleaning with ultrasonic and a wood tool of the blued corroded coupons ©HE Arc CR, A.L

The method allowed the removal of powdery and semi-adherent corrosion products. Adherent corrosion products could not be removed. The blued layer has not been damaged. However, it is not a method adapted to the cleaning of large surfaces, as it is quite slow. The treatment is moderately rapid, and several nozzles should be prepared as they warm a bit the cyanoacrylate (*Picture 86*).

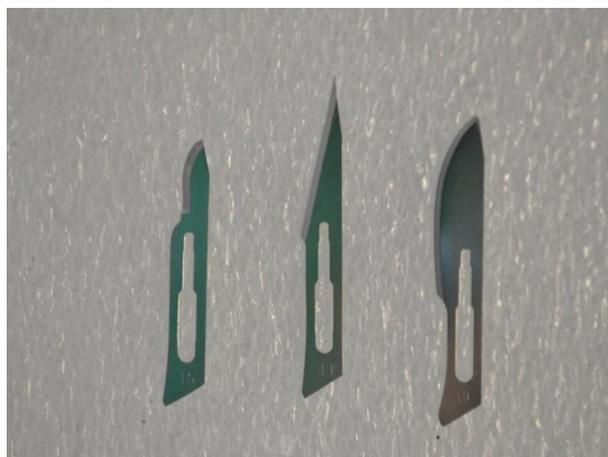
Picture 87 : Scalpel blades 15, 11 and 10 tested on the coupons ©HE Arc CR, A.L

Every blade induced scratch on the surface of the blued coupons. Blade 15 allowed an efficient removal of the porous corrosion products, but it was difficult to put pressure on the other blades on the irregular corroded surface.

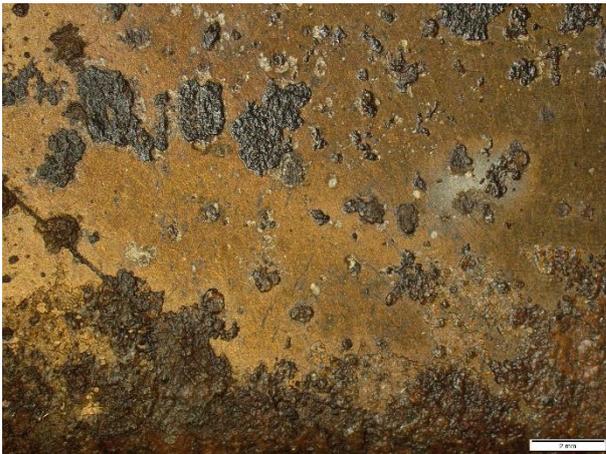
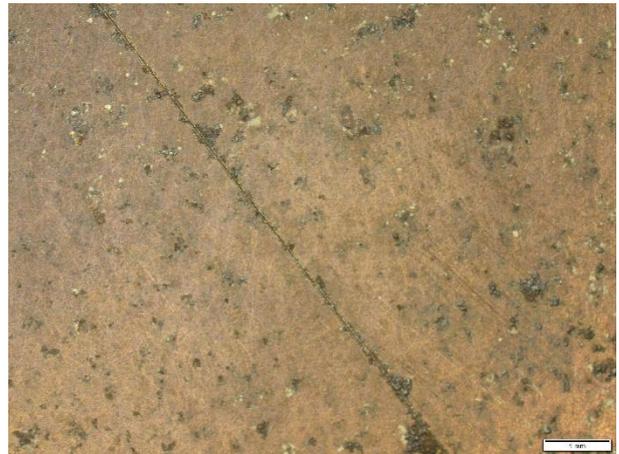
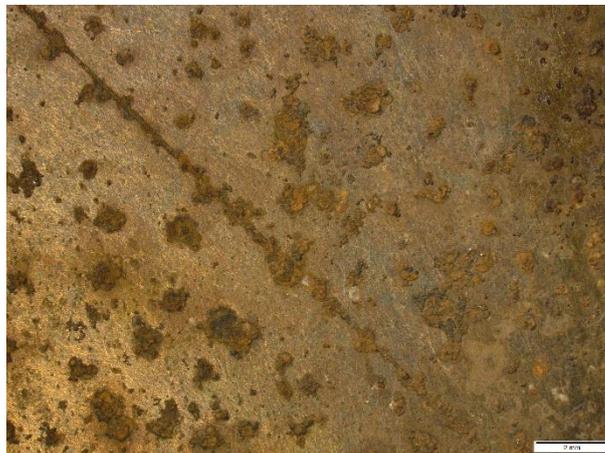
Picture 88 : Cleaning with steel wool 000 of the blued corroded coupons ©HE Arc CR, A.L

The use of dry 000 steel wool was conclusive. No damage was made on the blued layer and the corrosion products are removed until the original surface of the material. However, it leaves powdery deposits on the surface. This method could be the main technique to decrease the corrosion until the

limitos, without oil. (*Picture 88*).

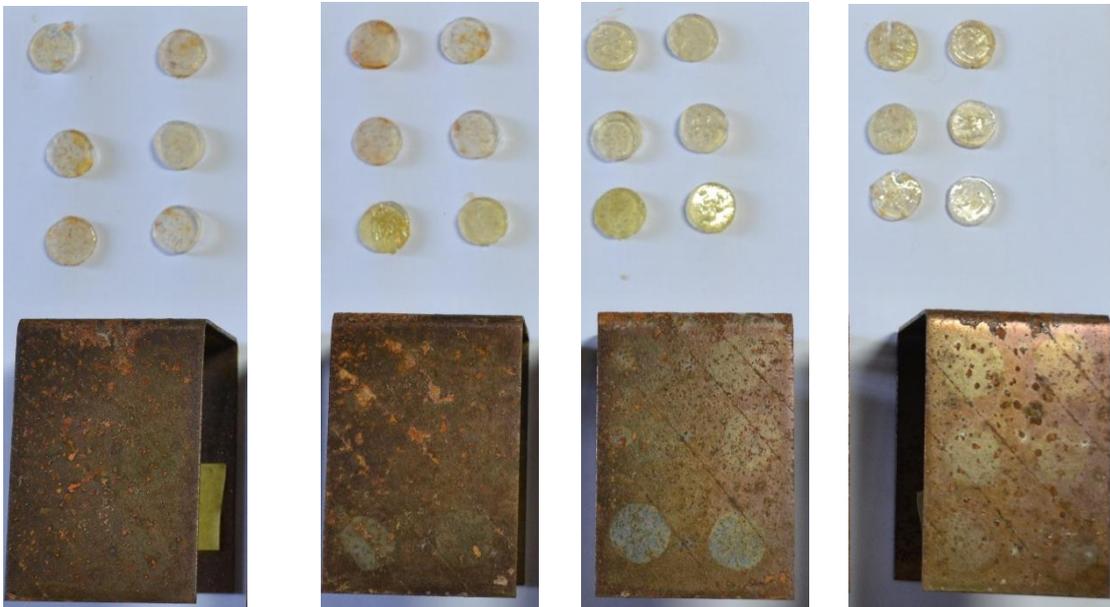
Picture 89 : Chelating agents on corroded coupons ©HE Arc CR, A.L

Citric acid and TAC gels at a pH of 7.5 and 8.5 leaved an undamaged blued layer and slightly tackled the corrosion layer. However, TAC and EDTA gels attacked the blued layer : the gels became green, and the blued layer has been reduced.

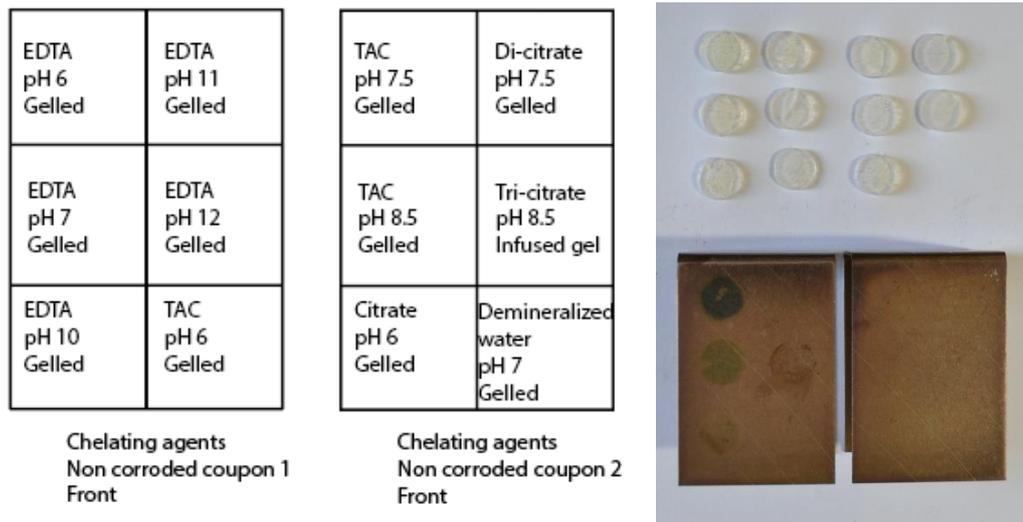
Picture 90 : Chelating agents on blued coupons ©HE Arc CR, A.L

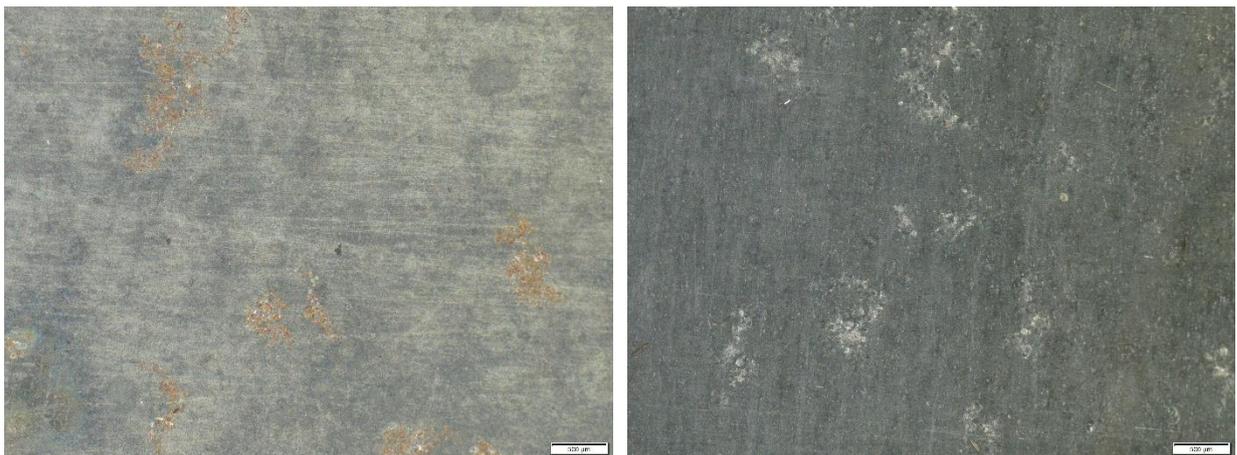
Figure 91 : Blue steel layer before and after treatment ©HE Arc CR, A.L

- 1. Wool steel 000 is gently rubbed on the corroded surface, allowing the removal of low from adherent corrosion products ;
- 2. A flexible nylon brush is used to remove the corrosion deposits generated by the wool steel 000 ;
- 3. The flexible eraser Caran d'Ache Genève 0149.310 is rubbed on the same surface to agglomerate the remaining detached corrosion products ;
- 4. The flat steel tool is used on the very adherent corrosion products to push them from the surface ;
- 5. The wood steel 000 and the eraser can be used again, as the very adherent corrosion products have been reached.

This protocol can be repeated until a smooth surface is perceived with the fingertips. It is also recommended to check the advancement of the treatment with magnifying glasses.

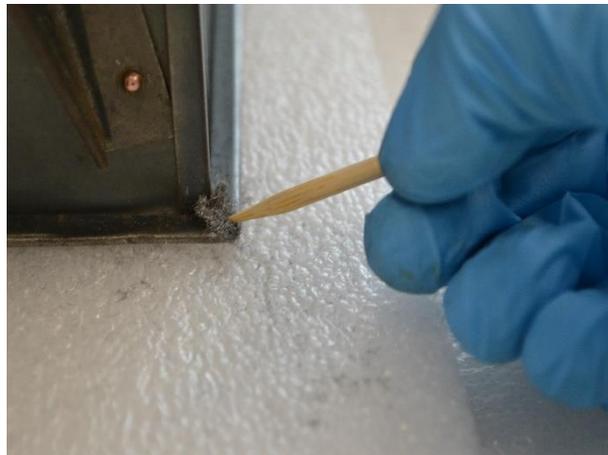
Picture 92 : Corrosion removal in a narrow area with wool steel 000 and a stick ©HE Arc CR, A.L

This method allowed the removal of the different types of corrosion products found on the object. The retouching of the losses, which has been considered at the beginning of the thesis, has not been fully explored as the condition of the surface was very satisfying after cleaning. However, the method of re-heating the object is completely excluded, as it could influence the microstructure of the object.

The protocol of treatment enunciated in chapter 9.5 has been applied to the outside and inside surfaces of the blued lantern. Some areas which were not easily accessible with a piece of wool steel have been treated with a wool steel swab or with a small wool piece directed with a wood stick.
