Blued steel sheets : history, manufacturing and conservation.

The case of a Ganz & Co projection and enlargement lantern
conserved at the Collection Centre of the Swiss National Museum.

Master of Arts HES-SO in Conservation-restoration
Specialized in scientific, technical and horological objects

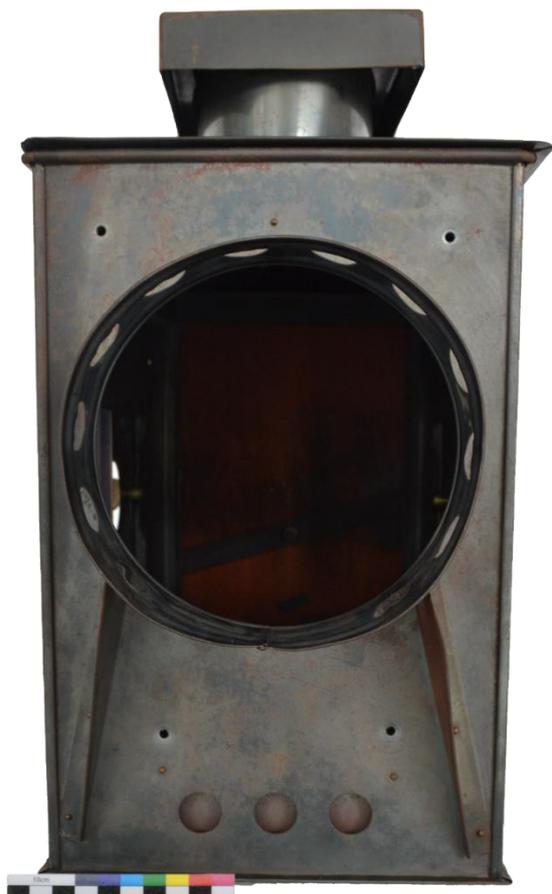
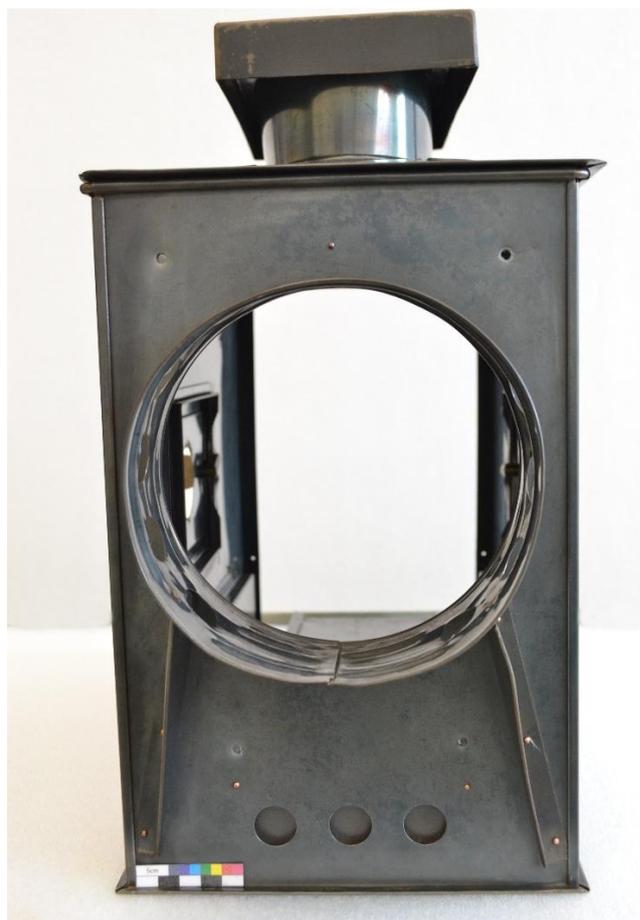
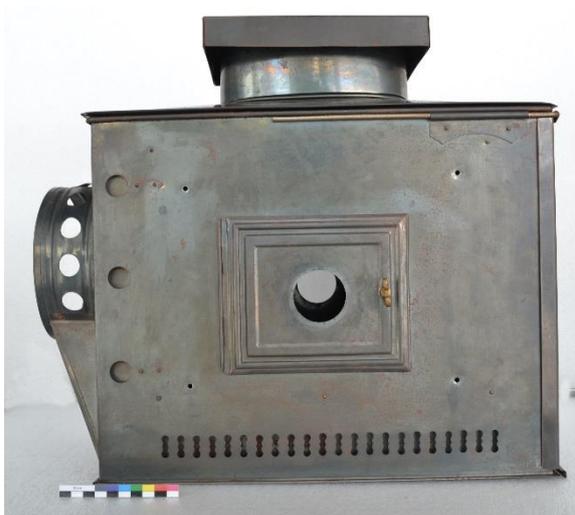
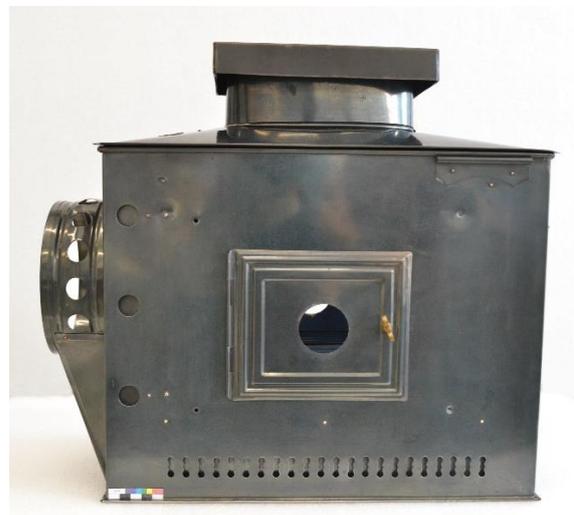
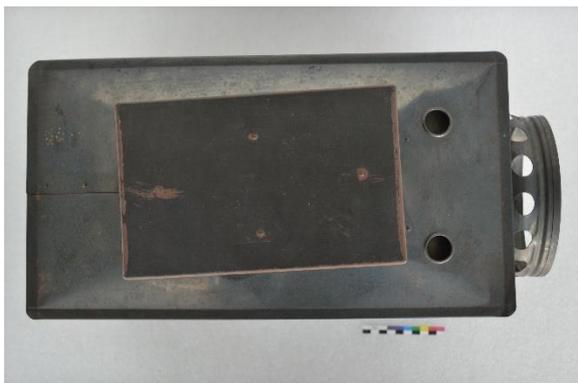
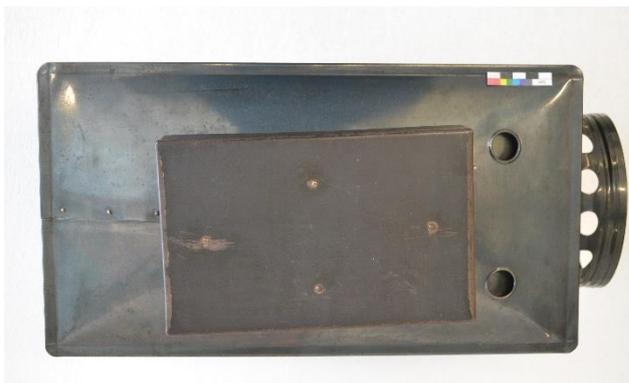
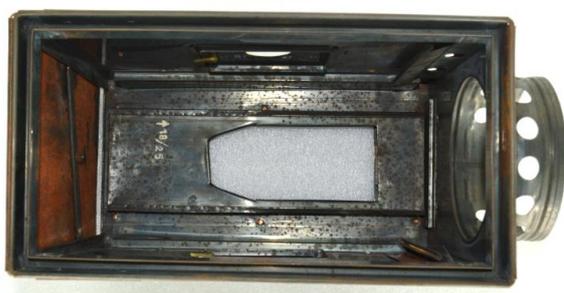
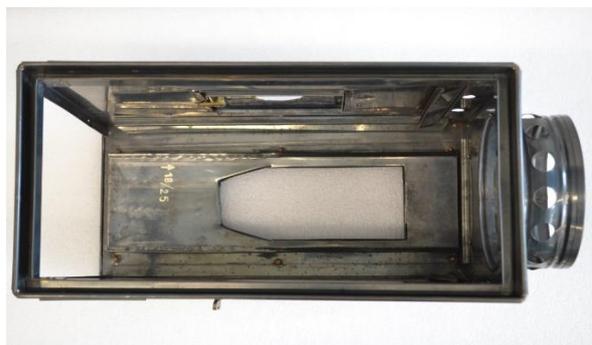
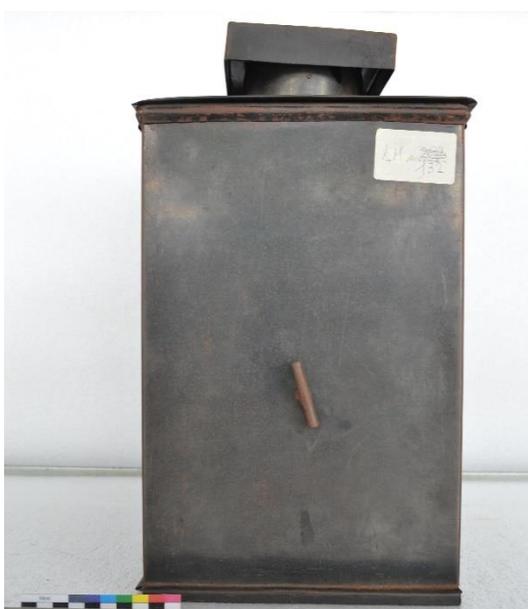
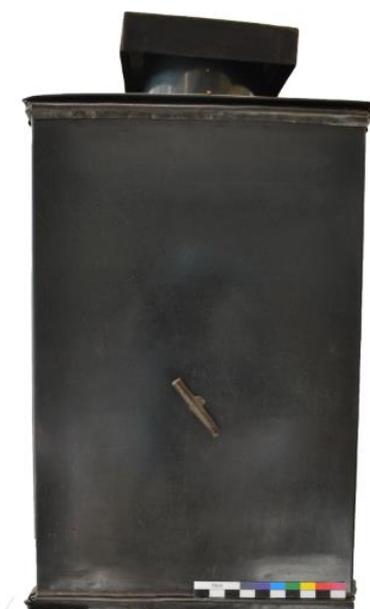
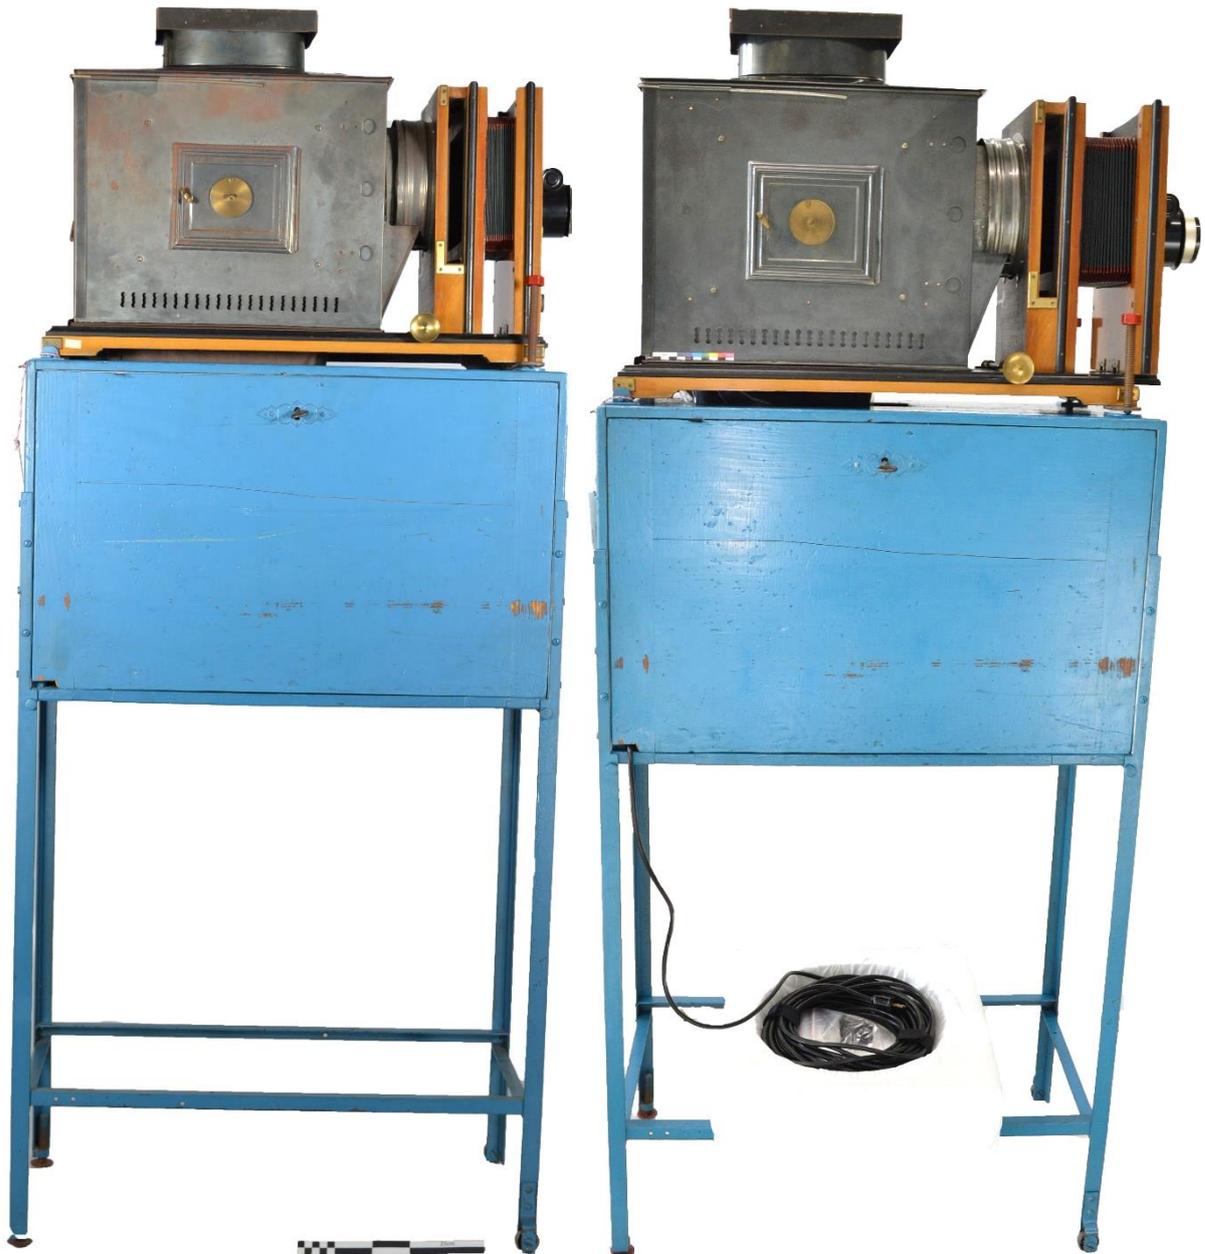
Picture 93 : Pictures before (left) and after (right) restoration of the object ©HE Arc CR, A.L

This method allowed the removal of the different types of corrosion products found on the object. The retouching of the losses, which has been considered at the beginning of the thesis, has not been fully explored as the condition of the surface was very satisfying after cleaning. However, the method of re-heating the object is completely excluded, as it could influence the microstructure of the object.

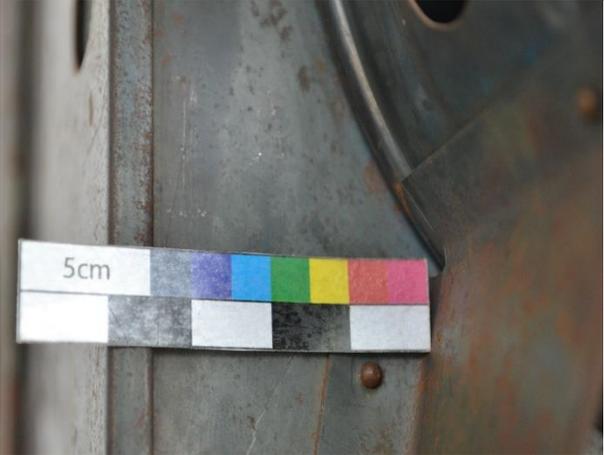
Localisation	Material	Surface alteration	Structural alteration	Functional alteration	Modifications, previous restorations	Diagnostic	Picture
Lantern, walls and upper part	Ferrous alloy, blued steel	Soiling				<p>As it is a technical object, soiling can be related to the manipulation of the device.</p> <p>Also, the conditions of conservation before joining heritage collections can be a cause.</p>

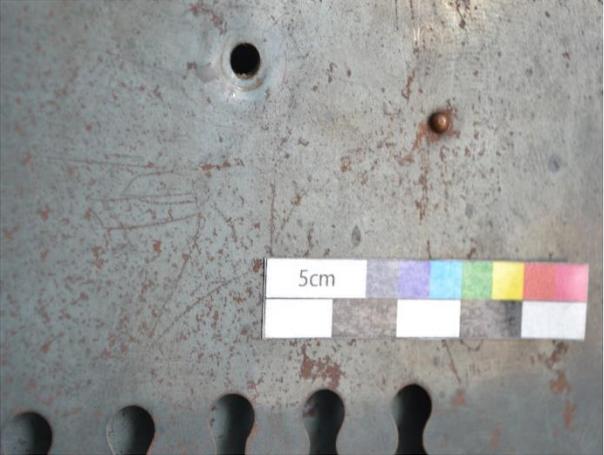
Localisation	Material	Surface alteration	Structural alteration	Functional alteration	Modifications, previous restorations	Diagnostic	Picture
Lantern, walls and upper part	Ferrous alloy, blued steel	Pitting corrosion				The porous nature of the blued layer and the manipulation of the object, causing scratches and weaknesses in the protective layer helped the development of pitting corrosion, which forms cavities at the surface of the metal, initiated by chloride ions.

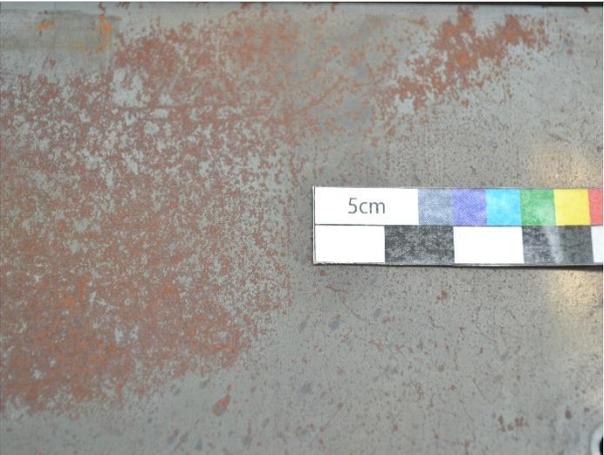
Lantern, walls and upper part	Ferrous alloy, blued steel	Generalised corrosion				The porous nature of the blued layer and the manipulation of the object, causing scratches and weaknesses in the protective layer helps the development of generalised corrosion. A general and even tapering of the metal occurs as it reacts with the atmosphere ¹ .

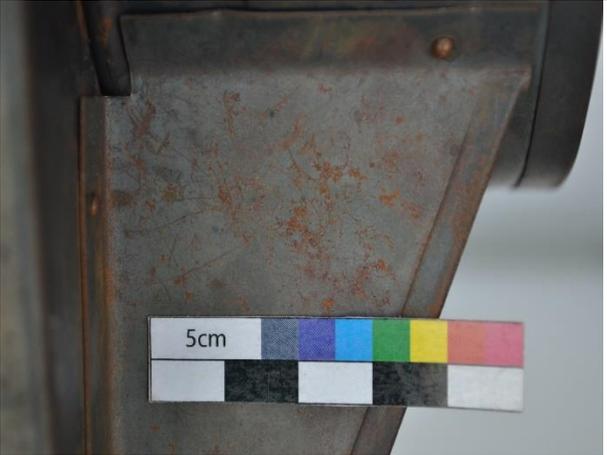
Localisation	Material	Surface alteration	Structural alteration	Functional alteration	Modifications, previous restorations	Diagnostic	Picture
Lantern, walls and upper part	Ferrous alloy, blued steel	Filiform corrosion				The porous nature of the blued layer and the manipulation of the object, causing scratches and weaknesses in the protective layer helps the development of filiform corrosion which develops under the blued coating as the form of filaments ² .

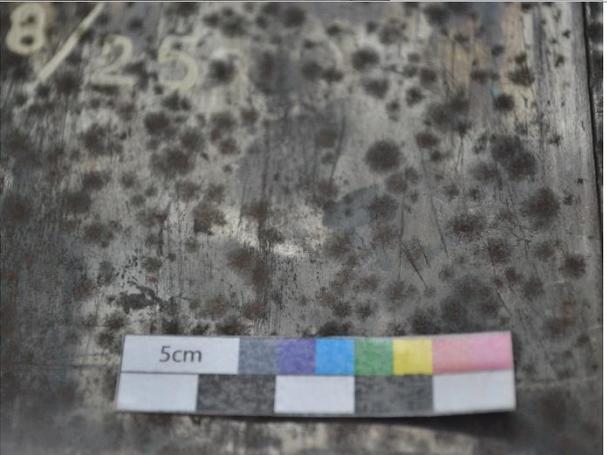
Lantern: bottom part, inside and borders of the side doors	Ferrous alloy, blued steel	Localised filiform corrosion				It seems that the object has been exposed to flows. Drops of water stood on the surface. It allowed an electrochemical reaction between the metal and the atmosphere ³ , reuniting the conditions for the development of filiform corrosion.

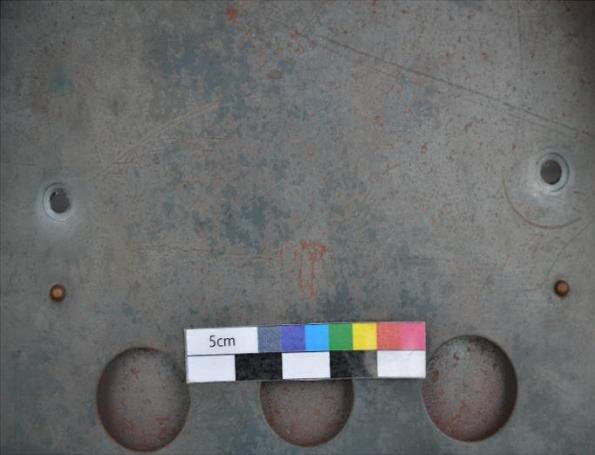
Localisation	Material	Surface alteration	Structural alteration	Functional alteration	Modifications, previous restorations	Diagnostic	Picture
Lantern, walls and upper part	Ferrous alloy, blued steel		Losses of the blued layer			Losses of the blued layer occur when corrosion weakened and raised the layer. Some ancient traces of filiform corrosion are visible where the losses are.

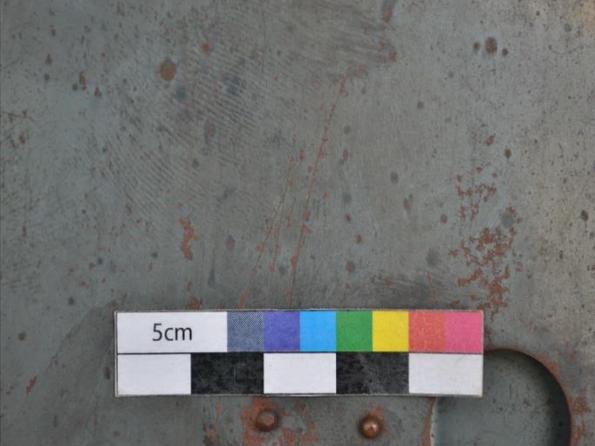
Localisation	Material	Surface alteration	Structural alteration	Functional alteration	Modifications, previous restorations	Diagnostic	Picture
Lantern, walls and upper part	Ferrous alloy, blued steel	Scratches				As it is a technical object, scratches can be related to the manipulation of the device. Scratched surfaces corroded preferentially.

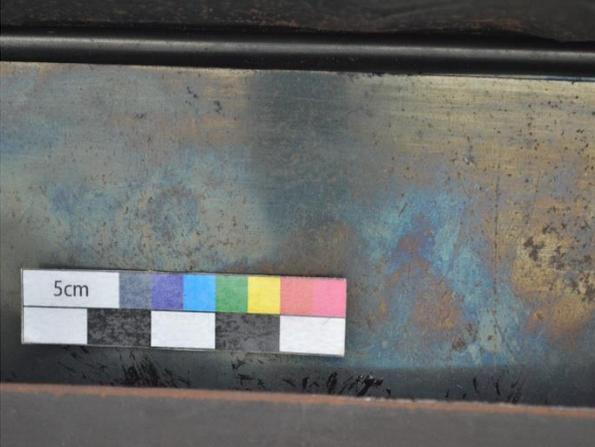
Lantern, walls and upper part	Ferrous alloy, blued steel	Sheen				Sheen is related to the lack of homogeneity of the blueing technique used on the sheets. A lighter colour of blueing (here, blue) is visible.

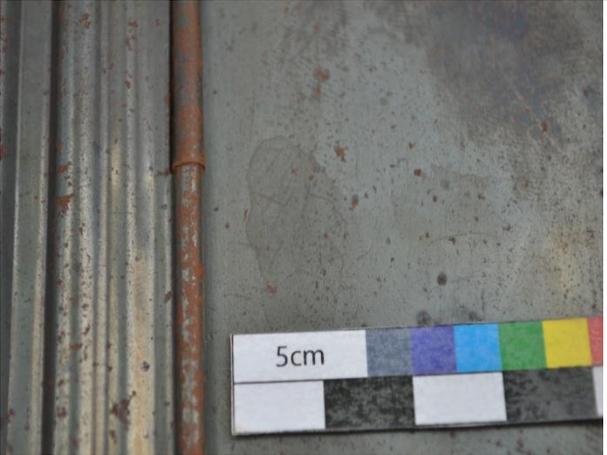
Localisation	Material	Surface alteration	Structural alteration	Functional alteration	Modifications, previous restorations	Diagnostic	Picture
Lantern, walls and upper part	Ferrous alloy, blued steel	Halos				A lot of halos are visible on the object : it seems that it has been exposed to flows.

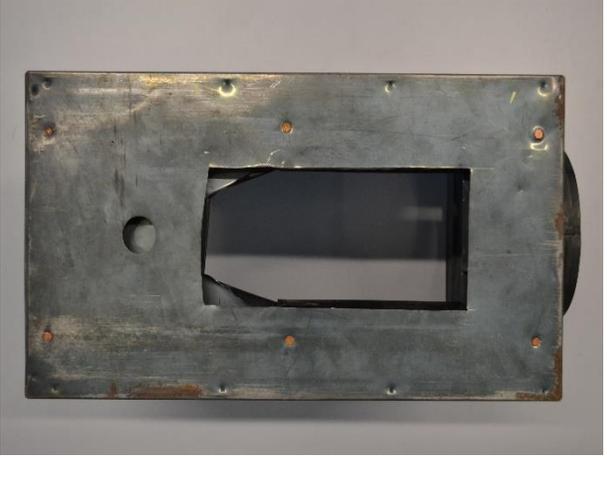
Lantern, inside, bottom part	Ferrous alloy, blued steel				Cutting	The bottom of the lantern has been intentionally cut to obtain space for the bulb and its support. It is part of the whole modification of the object.

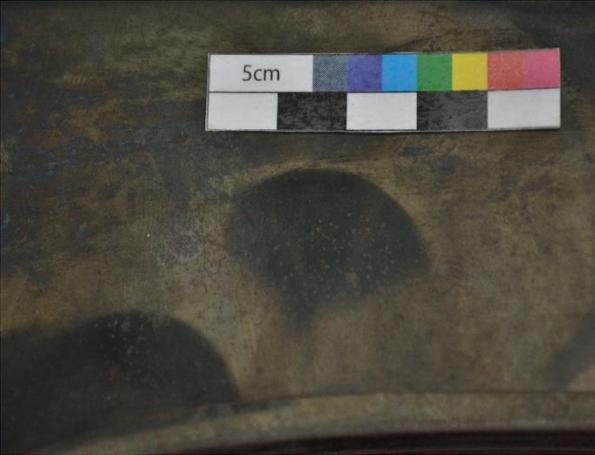
Localisation	Material	Surface alteration	Structural alteration	Functional alteration	Modifications, previous restorations	Diagnostic	Picture
Lantern, upper part	Ferrous alloy, blued steel				Sinking	Sinking seem to be related to the modification of the upper part of the lantern. Another chimney has been fixed to it, generating these alterations.

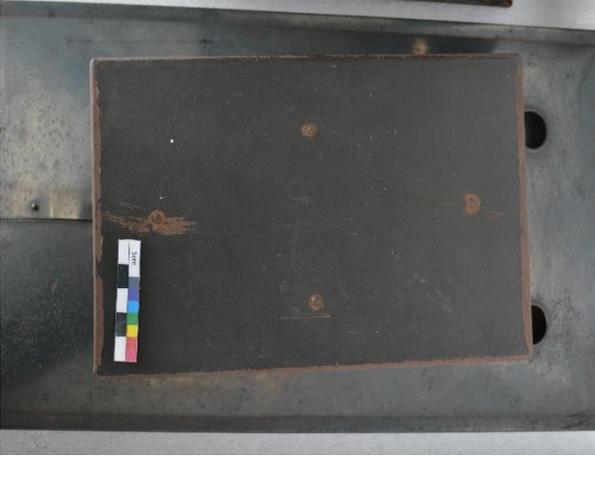
Lantern, upper part	Ferrous alloy, painted steel sheet				Non-linear orientation	The "new" chimney has been fixed to the upper part of the lantern in a non-linear orientation.

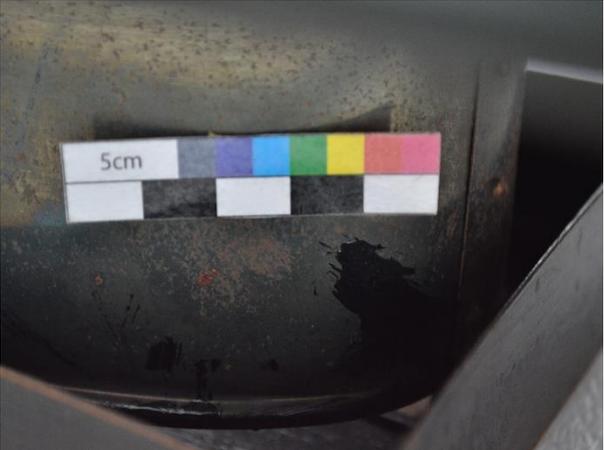
Localisation	Material	Surface alteration	Structural alteration	Functional alteration	Modifications, previous restorations	Diagnostic	Picture
Lantern, upper part	Ferrous alloy, painted steel sheet				Repaint	The inside of the "new" chimney has been painted black while the modification has been done.

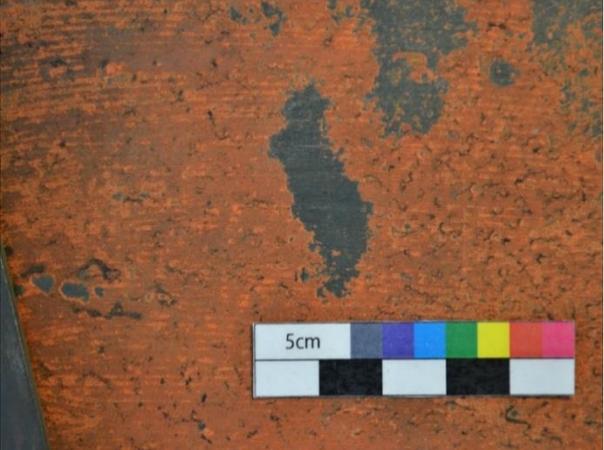
Lantern, back door	Ferrous alloy, blued steel, minium paint		Losses of the read lead layer			Adherence between the metallic sheet and the painting may have been poor, generating losses of the red lead layer.

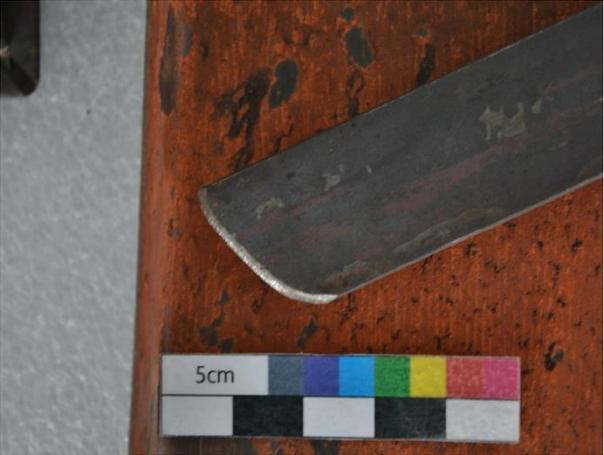
Localisation	Material	Surface alteration	Structural alteration	Functional alteration	Modifications, previous restorations	Diagnostic	Picture
<p>Lantern, back door, aperture closing system</p>	<p>Ferrous alloy, steel</p>				<p>Abrasion</p>	<p>Abrasion is here related to the manufacturing of the aperture and closing system of the back door.</p>

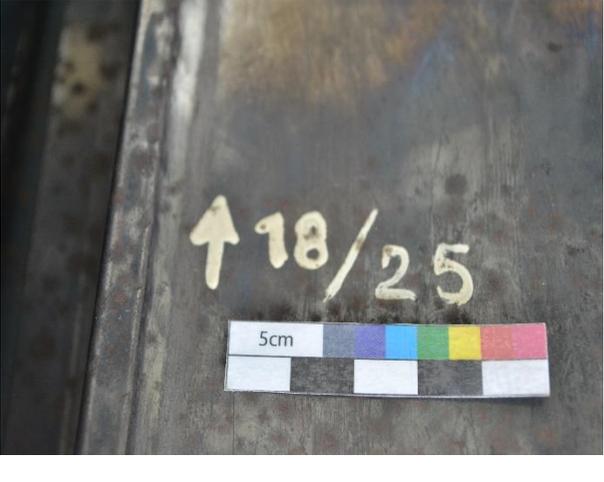
<p>Lantern, inside, bottom part</p>	<p>Ferrous alloy, blued steel, paint</p>				<p>Inscription "18/25"</p>	<p>It is an indication on the focusing parameters of the object.</p>

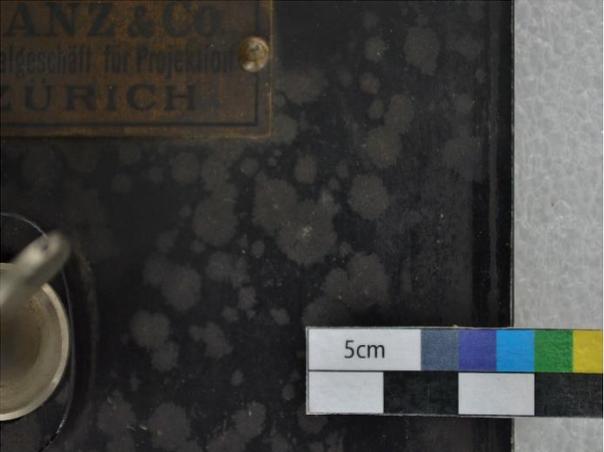
Localisation	Material	Surface alteration	Structural alteration	Functional alteration	Modifications, previous restorations	Diagnostic	Picture
<p>Lantern, inside, base of the light source</p>	<p>Ferrous alloy, painted steel</p>	<p>Halos</p>				<p>A lot of halos are visible on the object : it seems that it has been exposed to flows.</p>

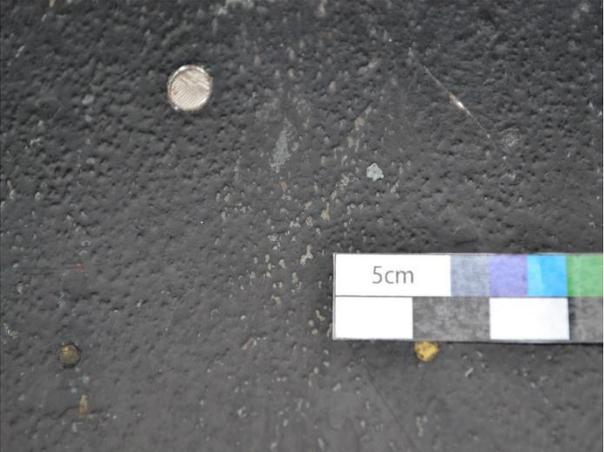
<p>Lantern, inside, base of the light source</p>	<p>Ferrous alloy, painted steel</p>		<p>Losses of the paint layer</p>			<p>Adherence between the metallic piece and the painting may have been poor and abrasion may have generated losses of the layer.</p>

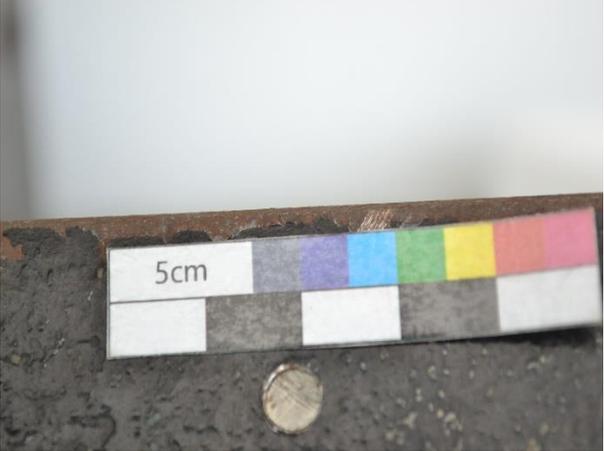
Localisation	Material	Surface alteration	Structural alteration	Functional alteration	Modifications, previous restorations	Diagnostic	Picture
Lantern, inside, base of the light source	Ferrous alloy, painted steel	Generalised corrosion				The losses of the paint layer, very probably caused by filiform corrosion, let the unprotected metallic surface in direct contact with relative humidity. As the object has been exposed to flows, it may have generated generalised corrosion. A general and even tapering of the metal occurs as it reacts with the atmosphere ⁴ .

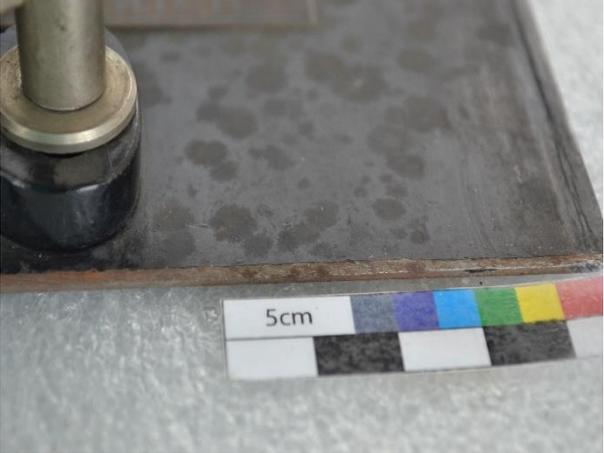
Lantern, inside, base of the light source	Ferrous alloy, painted steel				Cutting	The base of the light source has been cut intentionally, when all the modifications have been brought to the object.

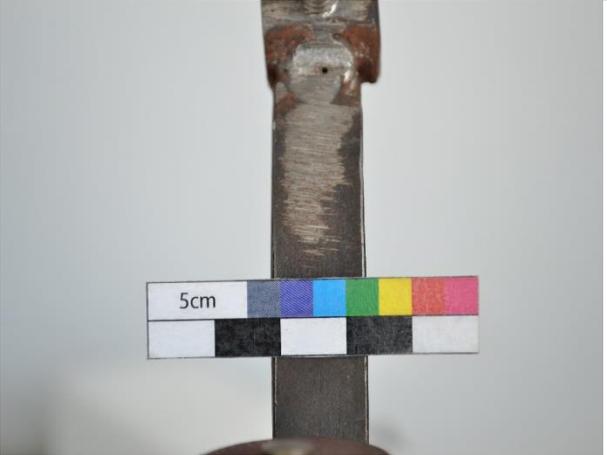
Localisation	Material	Surface alteration	Structural alteration	Functional alteration	Modifications, previous restorations	Diagnostic	Picture
Lantern, inside, base of the light source, steel rod	Ferrous alloy, painted steel				Abrasion	This rod carrying the condenser, seems to have been modified by abrasion. The whole support of the light source is concerned by modifications.

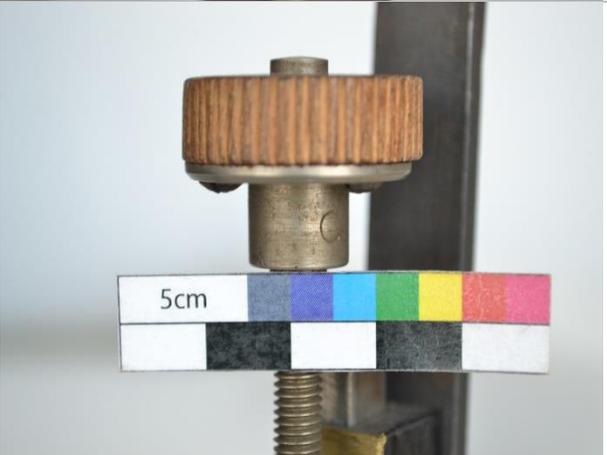
Lantern, inside, base of the light source, wheel	Ferrous alloy, galvanized steel	Pitting corrosion				Pitting corrosion can be related to weaknesses of the metallic coating, which, when in contact with high relative humidity, forms cavities at the surface of the metal, initiated by chloride ions ⁵ .

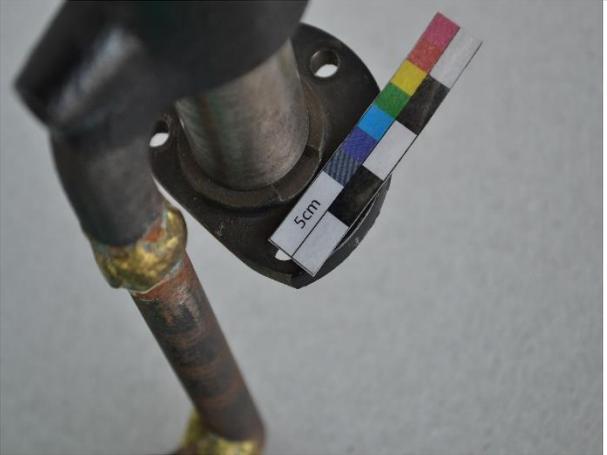
Localisation	Material	Surface alteration	Structural alteration	Functional alteration	Modifications, previous restorations	Diagnostic	Picture
Lantern, inside, base of the light source	Ferrous alloy, painted steel				Cutting	The circular part carrying the support of the bulb has been cut in order to obtain space for the rod carrying the bulb. It is part of the modifications brought to the object, concerning here a change of the light source.

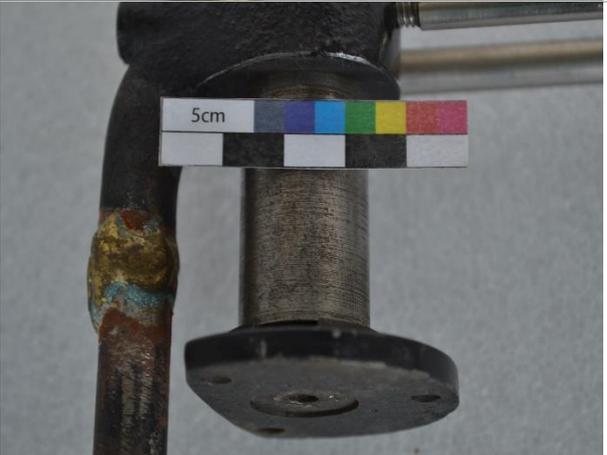
Lantern, inside, base of the light source	Ferrous alloy, steel	Pitting corrosion				Pitting corrosion forms cavities or pitting at the surface of the metal, generally because of the presence of chloride ions ⁶ .

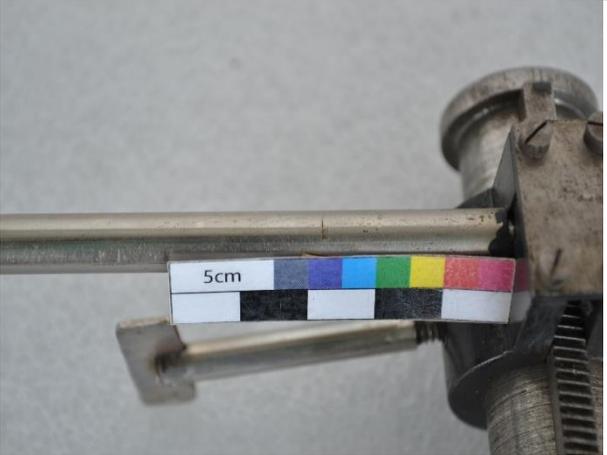
Localisation	Material	Surface alteration	Structural alteration	Functional alteration	Modifications, previous restorations	Diagnostic	Picture
Lantern, inside, base of the light source	Ferrous alloy, galvanized steel	Scratches				The manipulation of this rod and the support of the light source might have created scratches on the surface.

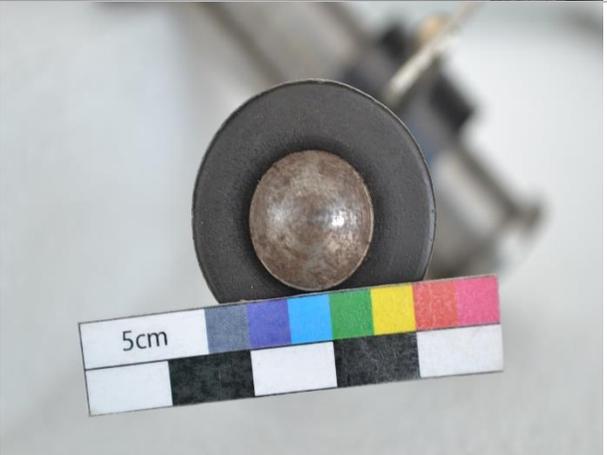
Lantern, inside, base of the light source	Ferrous alloy, galvanized steel	Pitting corrosion				Pitting corrosion forms cavities or pitting at the surface of the metal, generally because of the presence of chloride ions ⁷ .

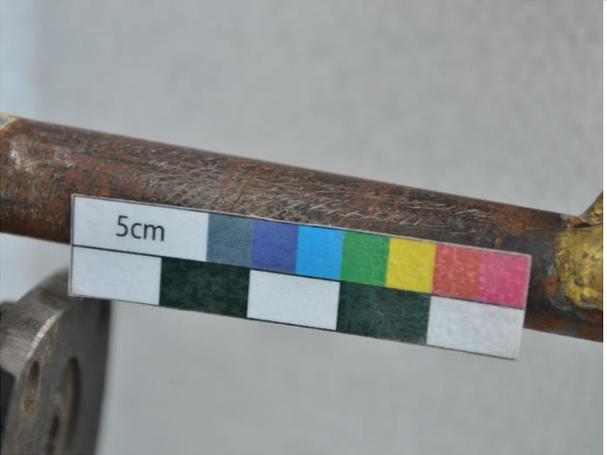
Localisation	Material	Surface alteration	Structural alteration	Functional alteration	Modifications, previous restorations	Diagnostic	Picture
Lantern, inside, base of the light source	Ferrous alloy, steel	Generalised corrosion				As the object has been exposed to flows, it may have generated generalised corrosion. A general and even tapering of the metal occurs as it reacts with the atmosphere ⁸ .

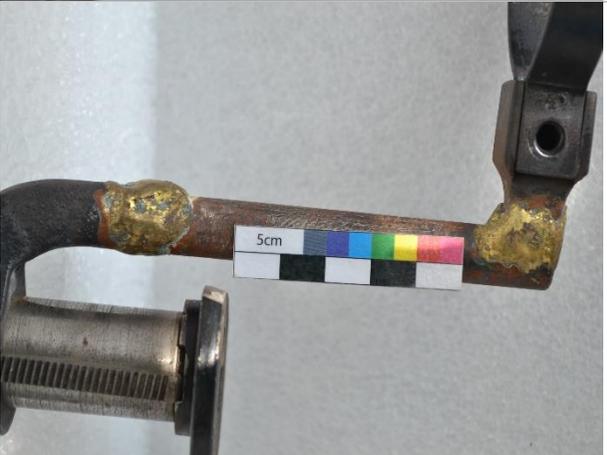
Lantern, inside, base of the light source	Copper alloy on ferrous alloy, steel				Soldering	Two solderings have been added to assemble the different part of the support of the light source. It is part of the modifications brought to the object, concerning here a change of the light source.

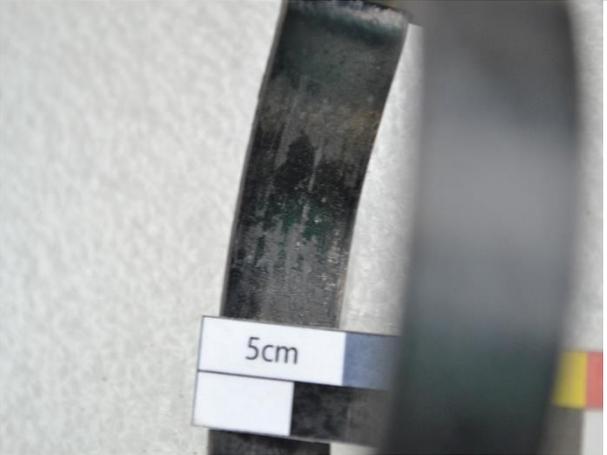
Localisation	Material	Surface alteration	Structural alteration	Functional alteration	Modifications, previous restorations	Diagnostic	Picture
Lantern, inside, base of the light source	Ferrous alloy, painted steel		Losses of the paint layer			Abrasion between the bulb and this ring carrying it may have altered the painting, as well as a lack of adhesion between the substrate and the paint.

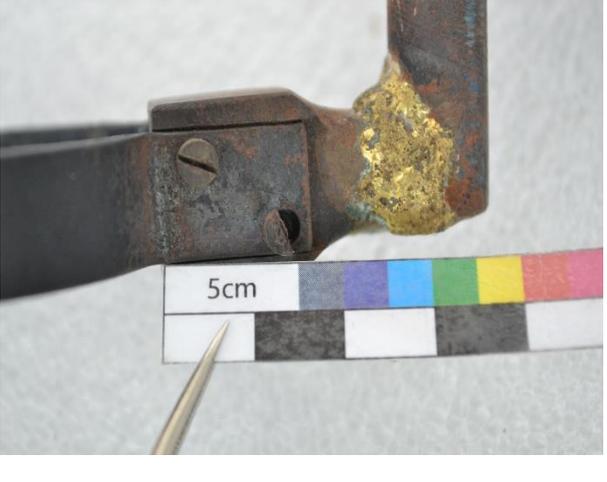
Lantern, inside, base of the light source	Ferrous alloy, steel			Partial loss of the screw head		This loss may be related to the setting and the maintenance of the light source.

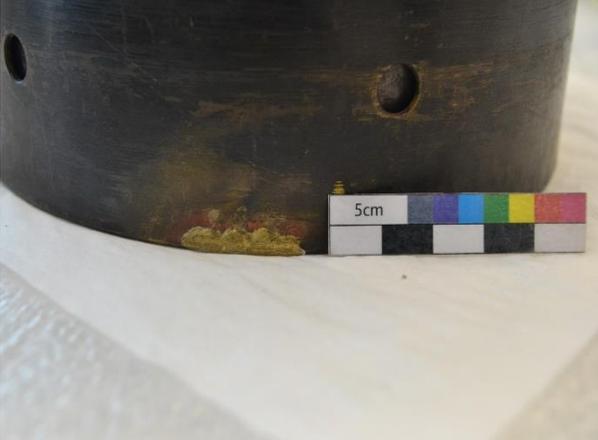
Localisation	Material	Surface alteration	Structural alteration	Functional alteration	Modifications, previous restorations	Diagnostic	Picture
Lantern, inside, lens	Copper alloy on ferrous alloy, steel				Solderings	<p>Three solderings have been added to the lens of the object. They are similar to those made to modify the light source of the object. We can consider that these solderings are also part of the modifications brought to the object.</p>

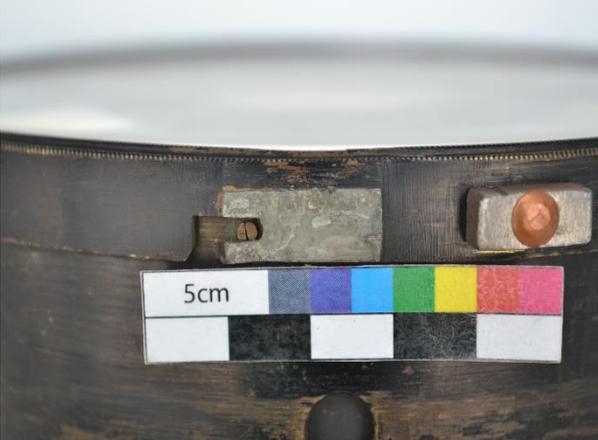
Lantern, inside, lens	Ferrous alloy, galvanized steel		Losses of the zinc layer			<p>A lack of adherence between the substrate and the metallic coating, the friction between the lens and the lens carrier as well as its manipulation may have caused losses of the zinc layer.</p>

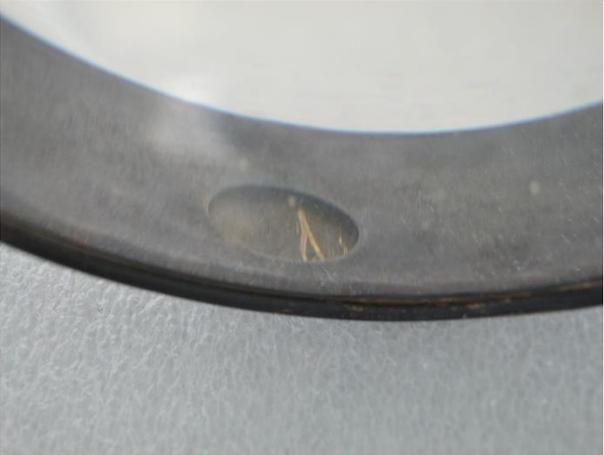
Localisation	Material	Surface alteration	Structural alteration	Functional alteration	Modifications, previous restorations	Diagnostic	Picture
Lantern, inside, lens	Ferrous alloy, metallic coating		Losses of the metallic coating			A lack of adherence between the substrate and the metallic coating and contact between the glass lens and its metallic structure may have caused losses of the zinc layer.

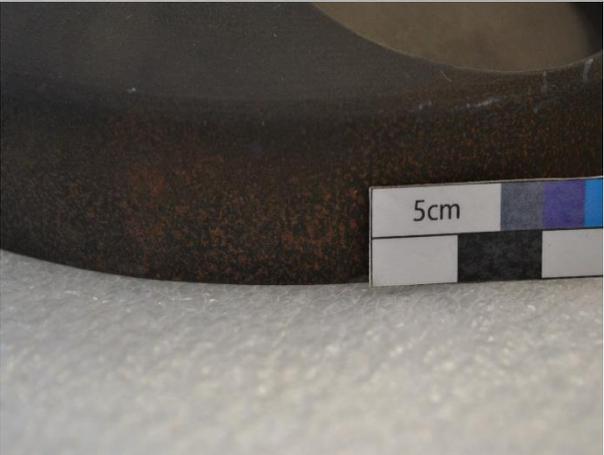
Lantern, inside, condenser	Ferrous alloy, painted steel	Pitting corrosion				Pitting corrosion forms cavities or pitting at the surface of the metal, generally because of the presence of chloride ions ⁹ . Also, the object has been exposed to flows.

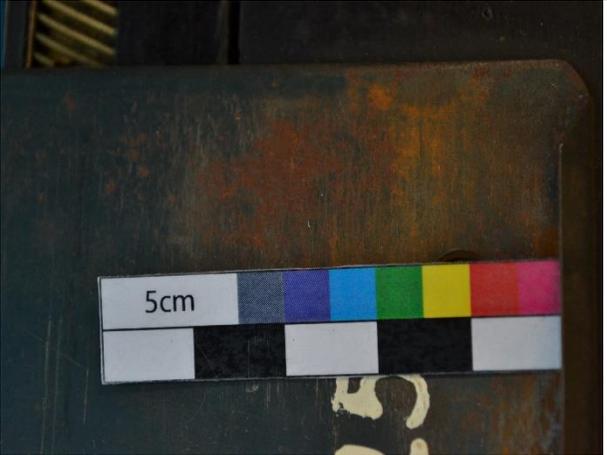
Localisation	Material	Surface alteration	Structural alteration	Functional alteration	Modifications, previous restorations	Diagnostic	Picture
Sliding plate under the lantern	Ferrous alloy, blued steel	Generalised corrosion				The porous nature of the blued layer and the manipulation of the object, causing scratches and weaknesses in the protective layer helps the development of generalised corrosion. A general and even tapering of the metal occurs as it reacts with the atmosphere ¹⁰ . Here, the generalised corrosion is located on the edges of the sliding plate.

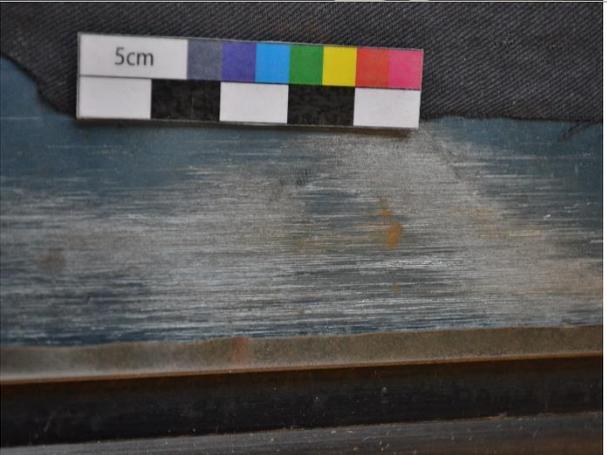
Sliding plate under the lantern	Ferrous alloy, blued steel		Losses of the blued steel layer			The sliding of the lantern of this plate seems to have caused losses of the blued layer, as it scratches the surface.

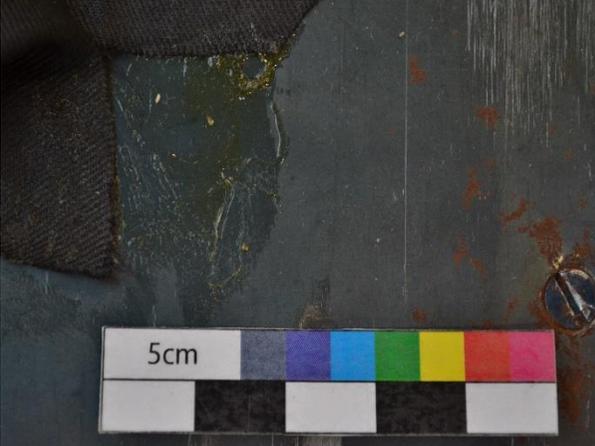
Localisation	Material	Surface alteration	Structural alteration	Functional alteration	Modifications, previous restorations	Diagnostic	Picture
Sliding plate under the lantern	Ferrous alloy, blued steel, adhesive		Yellowing			The chemical ageing of the adhesive has caused its yellowing.

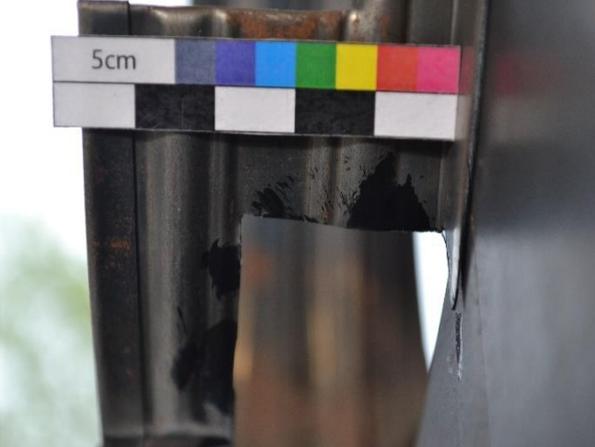
Wooden base of the lantern, half lens carrier	Ferrous alloy, blued steel				Repaint	Several parts of the object have been repainted while the modifications were brought to the object.

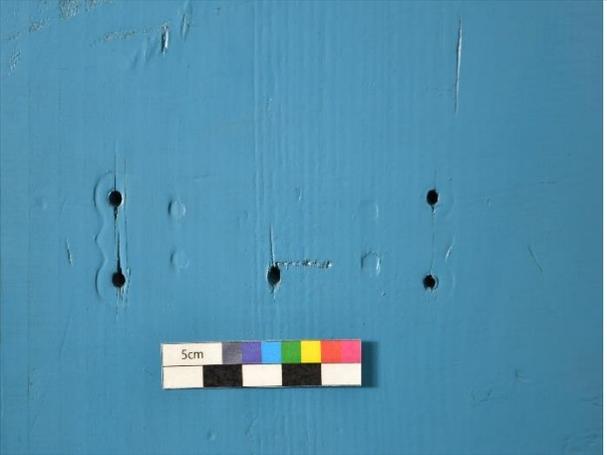
Localisation	Material	Surface alteration	Structural alteration	Functional alteration	Modifications, previous restorations	Diagnostic	Picture
Wooden box	Ferrous alloy, steel				Missing handles	Two handles are missing on the wooden box. This is very probably due to the modification of the box, from a trunk to its actual state or to a previous loss.

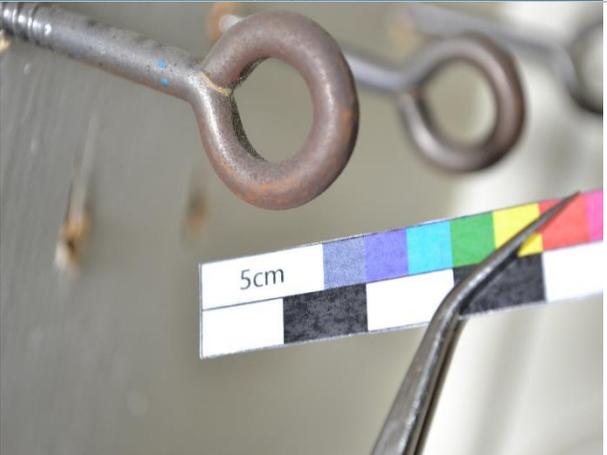
Wooden box, inside	Ferrous alloy, steel	Corrosion				An electrochemical reaction occurs between the metal and its atmosphere, causing its deterioration by reactions of oxidation and reduction ¹¹ .

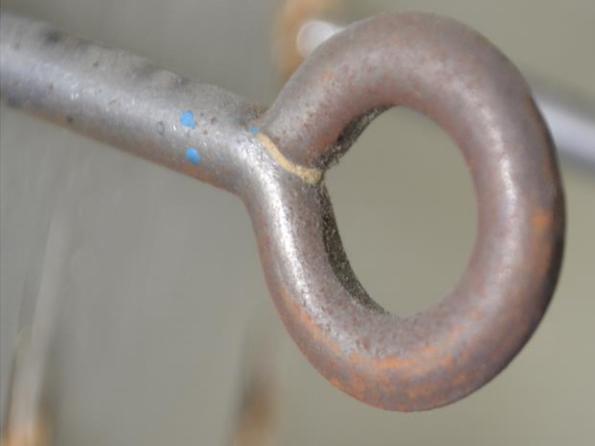
Localisation	Material	Surface alteration	Structural alteration	Functional alteration	Modifications, previous restorations	Diagnostic	Picture
Wooden box, inside	Ferrous alloy, steel				Stains of blue paint	The stain of blue paint shows that the repaint of the wooden box has been done afterwards. It may originally was in the wooden box before the modifications.

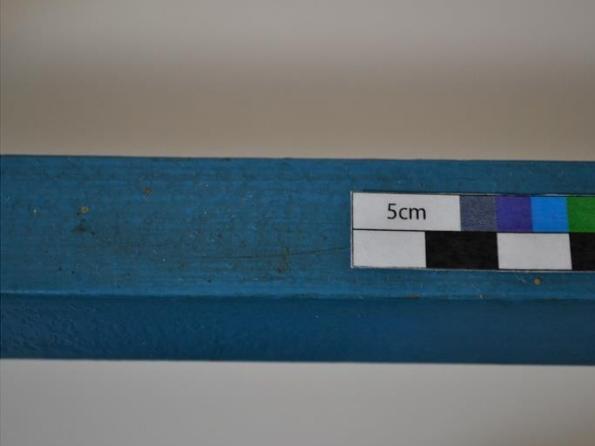
Metallic structure	Ferrous alloy, steel, paint	Soiling				The metallic structure is exposed to the atmosphere and could have been soiled easily during its active life and storage before it became heritage.

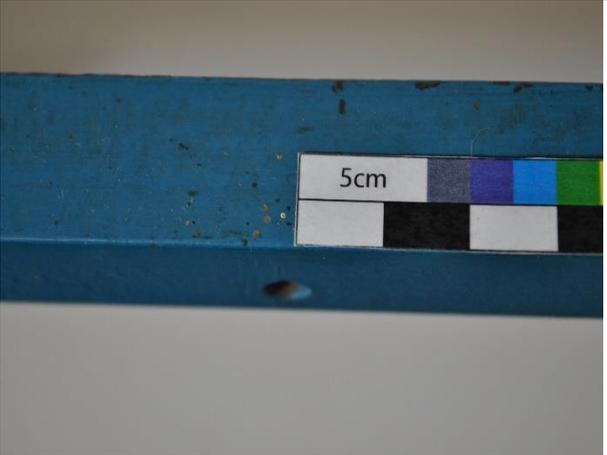
Localisation	Material	Surface alteration	Structural alteration	Functional alteration	Modifications, previous restorations	Diagnostic	Picture
Metallic structure	Ferrous alloy, steel, paint		Losses of the painting layer			A lack of adherence between the paint layer and the substrate may have caused the losses.

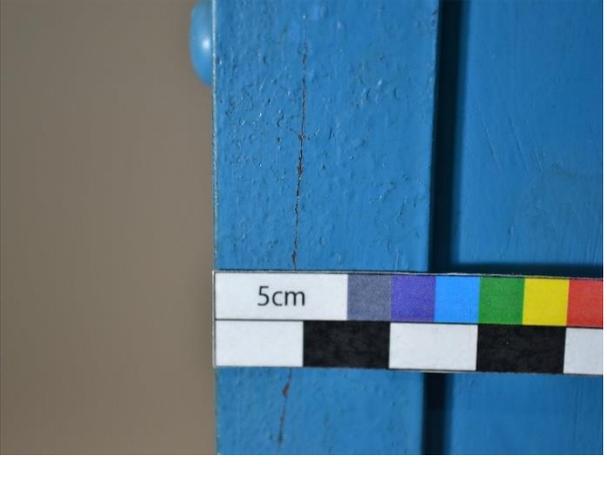
Metallic structure	Ferrous alloy, steel, paint	Scratches of the painting				The manipulation of this technical object may have generated scratches on the paint layer.

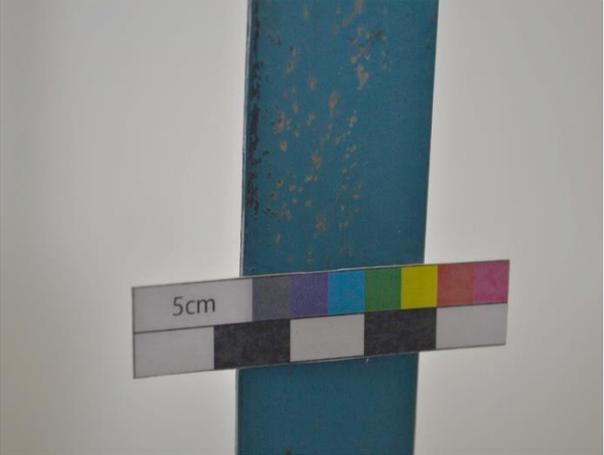
Metallic structure	Ferrous alloy, steel, paint	Brownish stains				The metallic structure is exposed to the atmosphere and could have been soiled easily during its active life and storage before it became heritage.

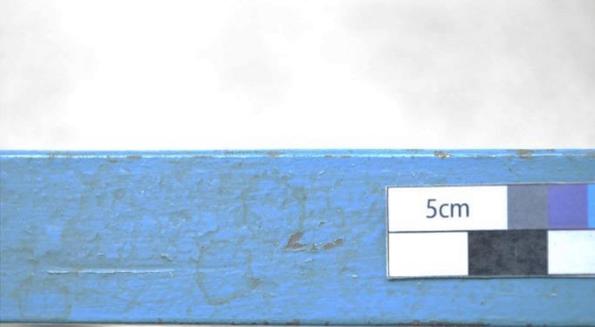
Localisation	Material	Surface alteration	Structural alteration	Functional alteration	Modifications, previous restorations	Diagnostic	Picture
Metallic structure	Ferrous alloy, steel, paint	Halos				The object has been exposed to flows, causing halos.

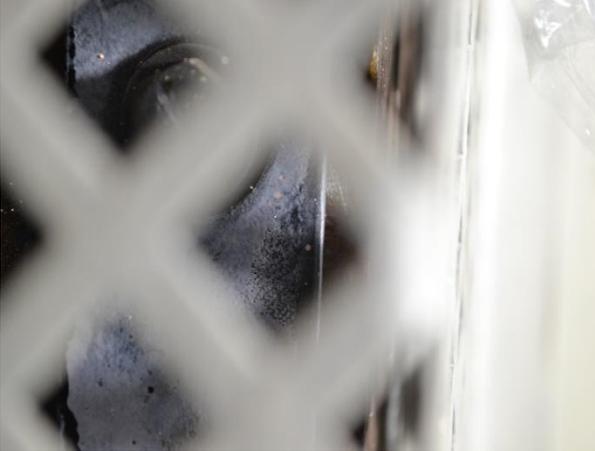
Wooden box, transformer	Ferrous alloy, steel	Generalized white deposits				The powdery white deposits were probably already present on the transformer during the modifications as a fingerprint removed a bit of it. As all the modifications brought to the object, they have been done in a very crafted way.

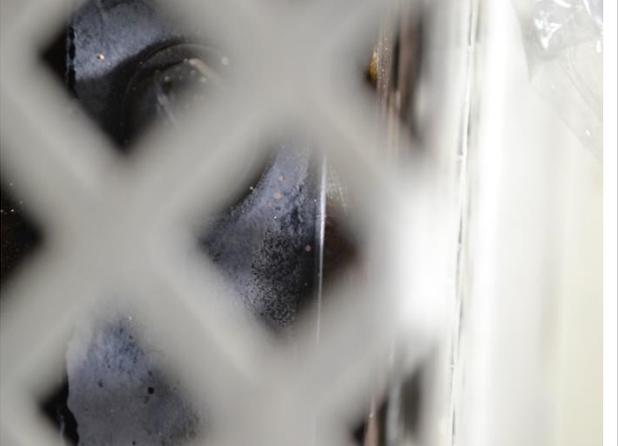
Localisation	Material	Surface alteration	Structural alteration	Functional alteration	Modifications, previous restorations	Diagnostic	Picture
Wooden box, transformer	Ferrous alloy, steel	Fingerprint				The manipulation of the transformer during its installation may have caused a fingerprint mark.

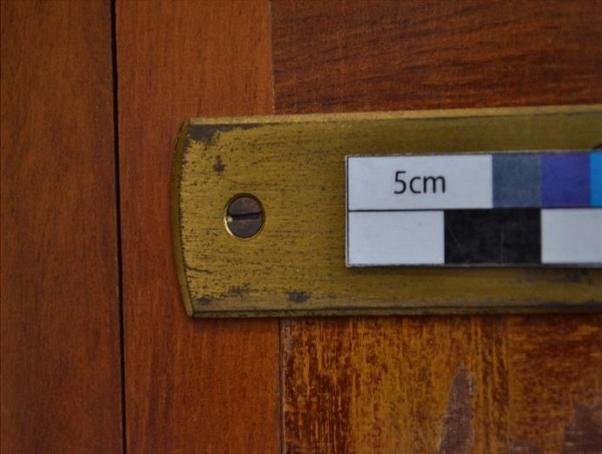
Localisation	Material	Surface alteration	Structural alteration	Functional alteration	Modifications, previous restorations	Diagnostic	Picture
Lantern: rivets, plates, handles of the side doors, peepholes' structure, lamp cap, rack-and-pinion drive	Copper alloy, varnish	Tarnishing				Copper alloys, when exposed to oxygen and humidity, develop tarnishing which is a discolouration of the surface of a metal when it is covered with a thin layer of corrosion products ¹² .

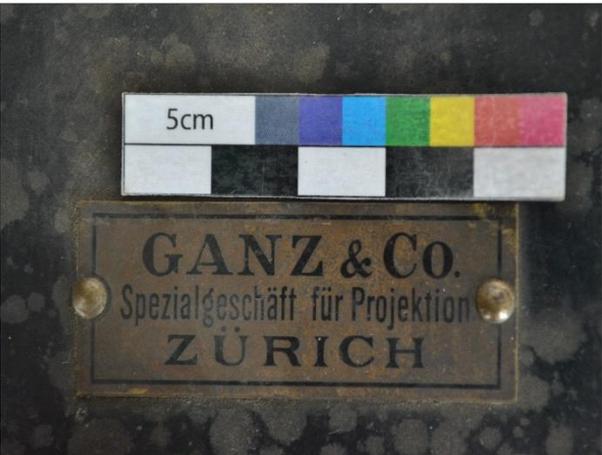
Lantern, inside, base of the light source	Copper alloy, brass, paint, varnish	Tarnishing				This plate has been highly exposed to flows, generating tarnishing of the brass plate.
