Blued steel sheets : history, manufacturing and conservation.

The case of a Ganz & Co projection and enlargement lantern
conserved at the Collection Centre of the Swiss National Museum.

Master of Arts HES-SO in Conservation-restoration
Specialized in scientific, technical and horological objects

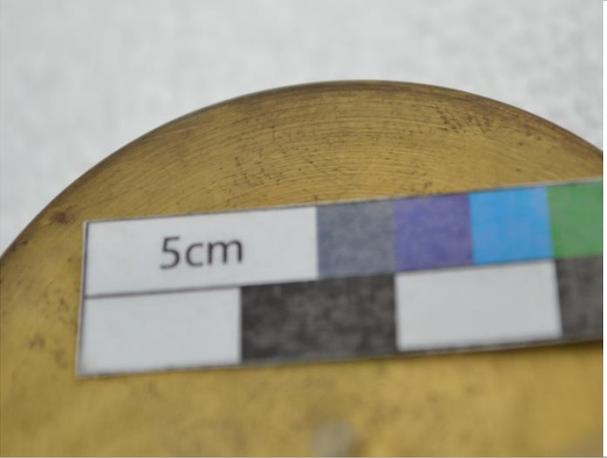
Lantern, sides, peepholes	Copper alloy, brass	Fingerprint				Fingerprints on brass are related to the manipulation of the object as well as the development of tarnishing where the potential chlorides of the finger have been placed.

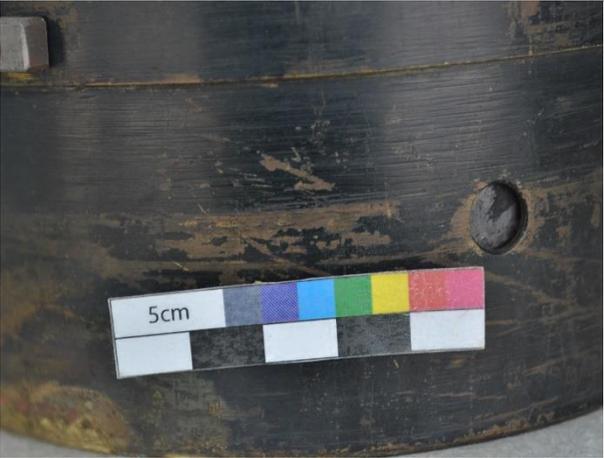
Localisation	Material	Surface alteration	Structural alteration	Functional alteration	Modifications, previous restorations	Diagnostic	Picture
Lantern, inside, lens	Copper alloy, painted brass		Losses of the paint			A lack of adhesion between the metal and the paint, as well as the friction between the lens and the lens carrier, may have caused losses of the paint.

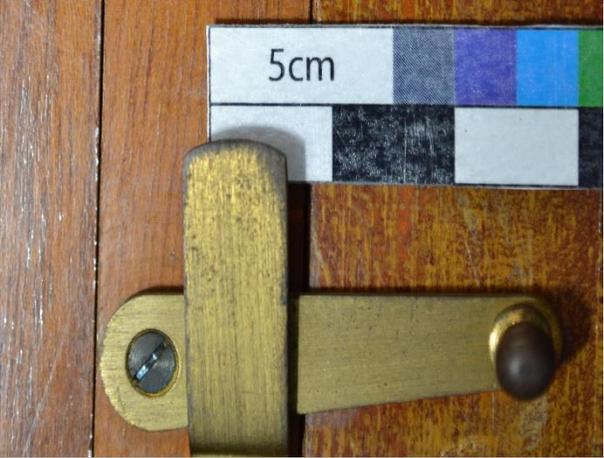
Wooden base of the lantern, front, lens carrier	Copper alloy, brass	Tarnishing				Copper alloys, when exposed to oxygen and humidity, develop tarnishing which is a discolouration of the surface of a metal when it is covered with a thin layer of corrosion products ¹⁷ .

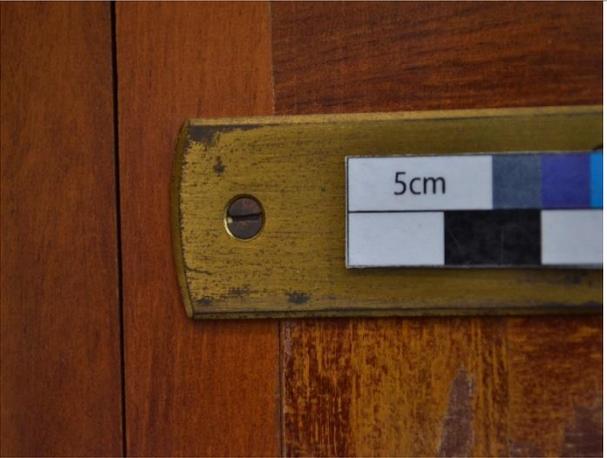
Localisation	Material	Surface alteration	Structural alteration	Functional alteration	Modifications, previous restorations	Diagnostic	Picture
Wooden base of the lantern	Copper alloy, brass	Pitting corrosion				Pitting corrosion forms cavities or pitting at the surface of the metal, generally because of the presence of chloride ions ¹⁸ . Also, the object has been exposed to flows.

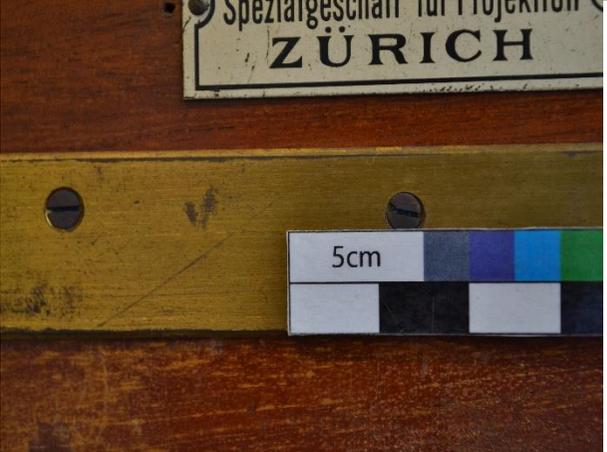
Wooden base of the lantern	Copper alloy, brass	Scratches				The manipulation of the object and the configuration of the settings may have caused scratches.

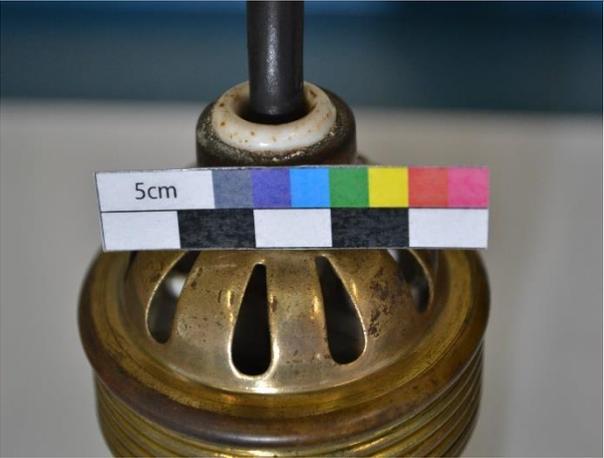
Localisation	Material	Surface alteration	Structural alteration	Functional alteration	Modifications, previous restorations	Diagnostic	Picture
Lantern, inside, socket	Copper alloy, brass	Tarnishing				Copper alloys, when exposed to oxygen and humidity, develop tarnishing which is a discolouration of the surface of a metal when it is covered with a thin layer of corrosion products ¹⁹ .

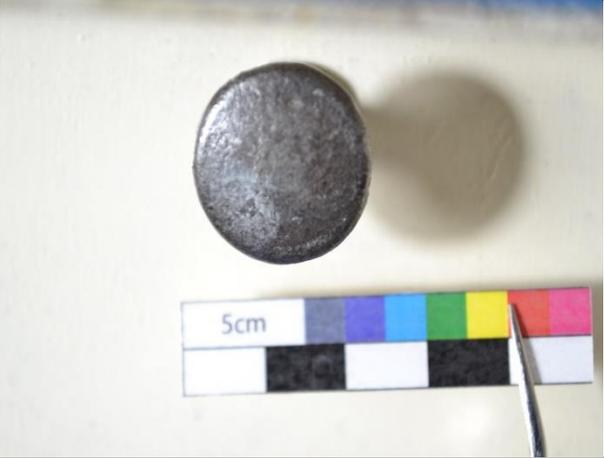
Wooden box, inside, cabinet	Ferrous alloy, galvanised steel	Corrosion				An electrochemical reaction occurs between the metal and its atmosphere, causing its deterioration by reactions of oxidation and reduction ²⁰ . The manipulation of the handle, favouring the deposit of chlorides, may have helped the process.

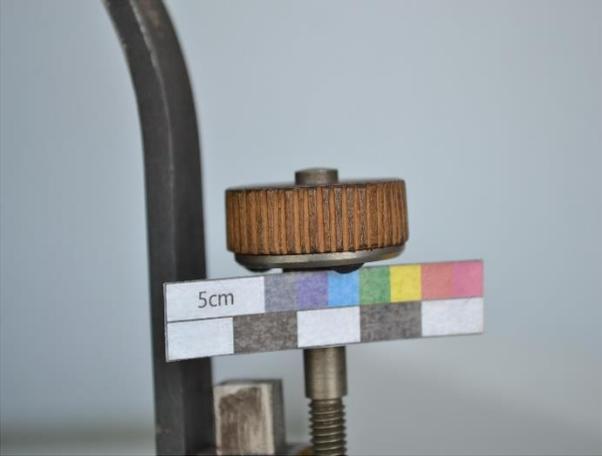
Localisation	Material	Surface alteration	Structural alteration	Functional alteration	Modifications, previous restorations	Diagnostic	Picture
Lantern, inside, base of the light source, wheel screw	Wood	Soiling				The soiling of this part of the object can be related to its manipulation, to get the right settings.

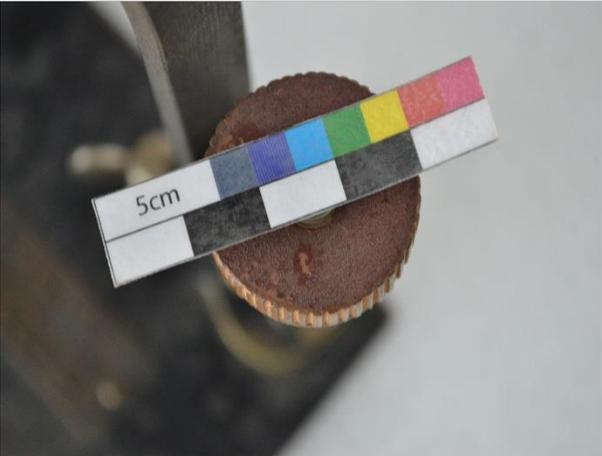
Lantern, inside, base of the light source, wheel screw	Painted wood		Losses of the paint layer			The losses of the paint layer can be related to a lack of adherence between the support and the painting.

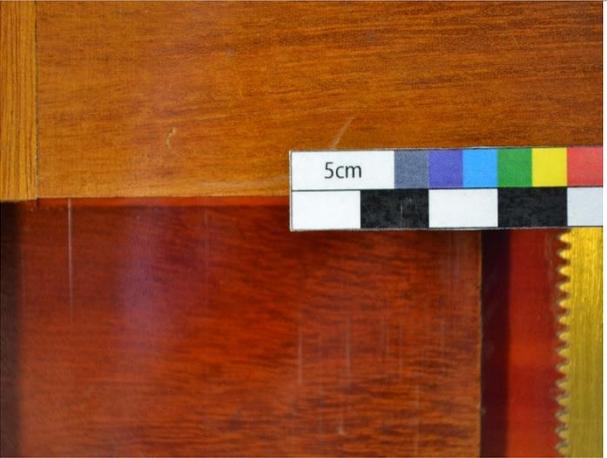
Localisation	Material	Surface alteration	Structural alteration	Functional alteration	Modifications, previous restorations	Diagnostic	Picture
Wooden base of the lantern, front, lens carrier	Varnished wood, shellac	Discolouration				The previous conditions of conservation and an exposition to UV light may have caused a discolouration.

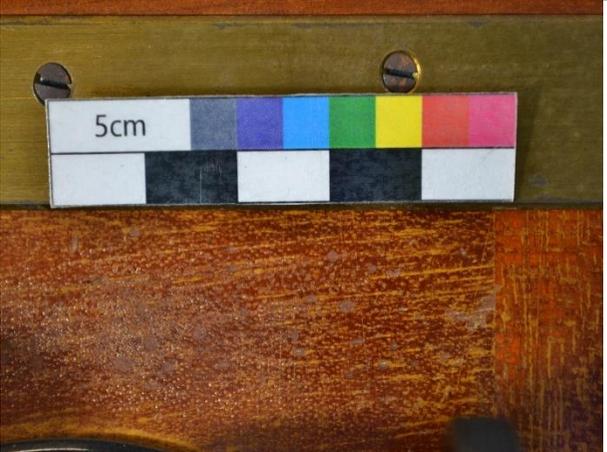
Wooden base of the lantern, front, lens carrier	Varnished wood, shellac		Cross-linking of the varnish			A heat input may have caused the reticulation of the varnish.

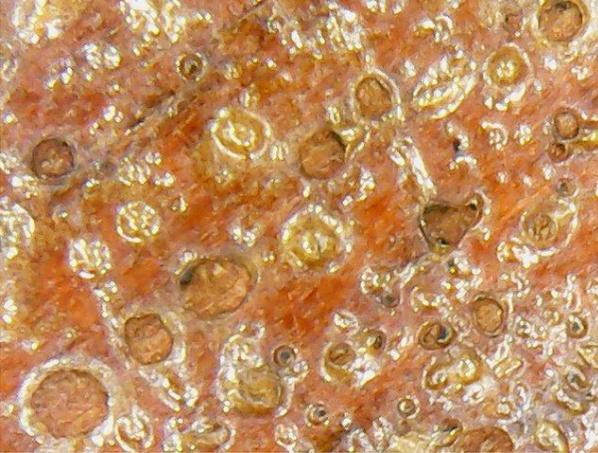
Localisation	Material	Surface alteration	Structural alteration	Functional alteration	Modifications, previous restorations	Diagnostic	Picture
<p>Wooden base of the lantern, front, lens carrier</p>	<p>Varnished wood, shellac</p>		<p>Blisters of the varnish</p>			<p>A heat input may have caused blisters of the varnish.</p>

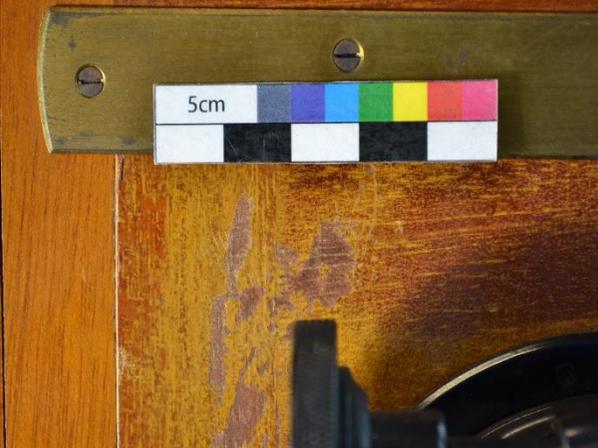
<p>Wooden base of the lantern, front, lens carrier</p>	<p>Varnished wood, shellac</p>		<p>Losses of the varnish</p>			<p>A heat input, causing the reticulation of the varnish as well as blisters, has consequently generated losses of the varnish.</p>

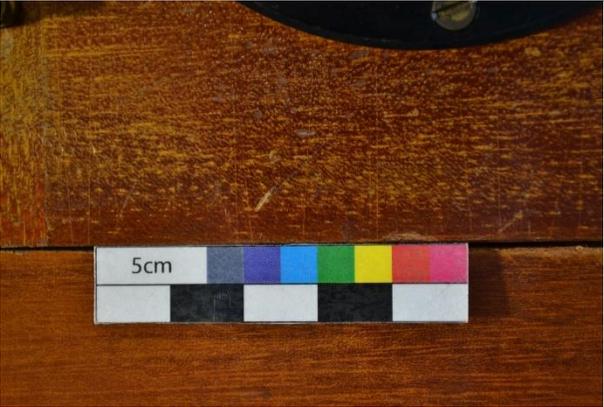
Localisation	Material	Surface alteration	Structural alteration	Functional alteration	Modifications, previous restorations	Diagnostic	Picture
<p>Wooden base of the lantern, front, lens carrier</p>	<p>Varnished wood, shellac</p>	<p>Scratches</p>				<p>The manipulation of the lens carrier may have caused scratches.</p>

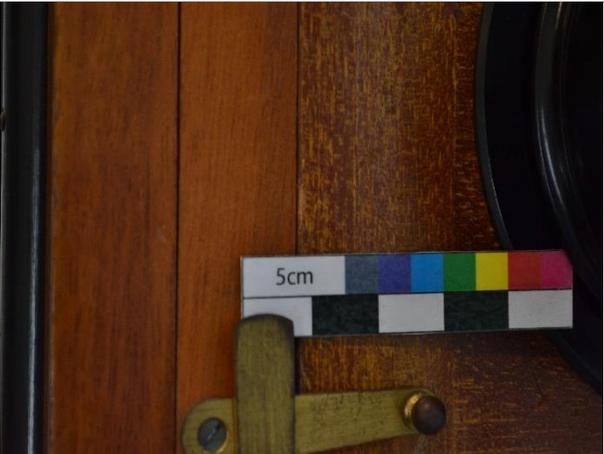
<p>Wooden base of the lantern, front, lens carrier</p>	<p>Varnished wood, shellac</p>		<p>Losses of the wood</p>			<p>The manipulation of the lens carrier may have caused losses of the wood.</p>

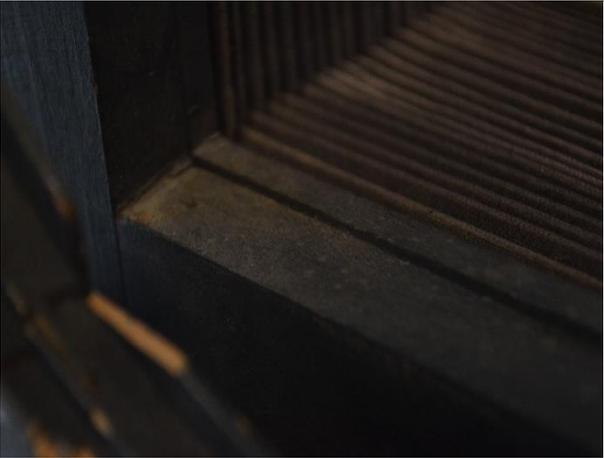
Localisation	Material	Surface alteration	Structural alteration	Functional alteration	Modifications, previous restorations	Diagnostic	Picture
Wooden base of the lantern	Painted wood	Soiling				The previous conditions of conservation of the object have caused an agglomeration of soiling.

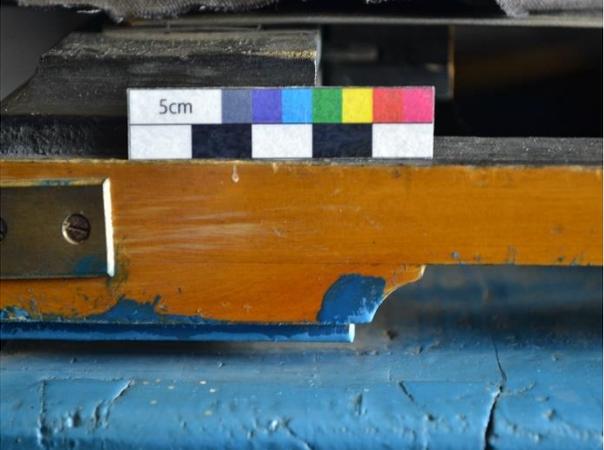
Wooden base of the lantern	Varnished wood	White deposits				The previous conditions of conservation and the repaint of some parts of the object may have caused these white deposits.

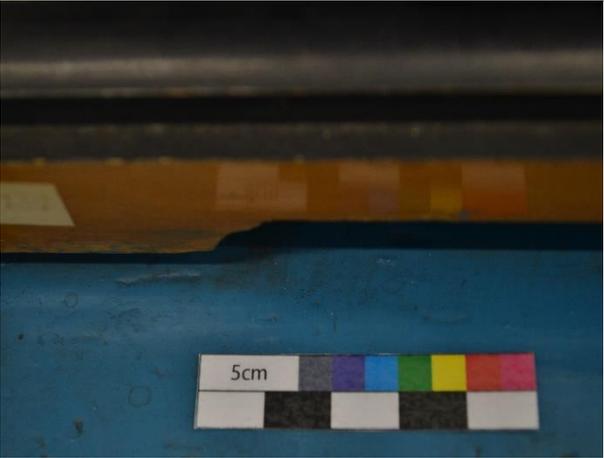
Localisation	Material	Surface alteration	Structural alteration	Functional alteration	Modifications, previous restorations	Diagnostic	Picture
Wooden box	Painted wood	Soiling				The previous conditions of conservation may have caused soiling.

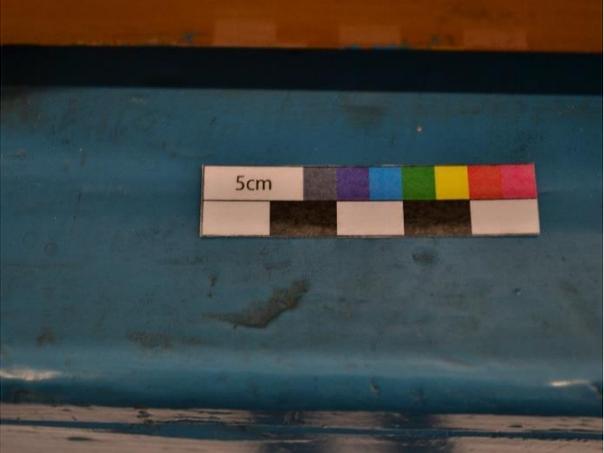
Wooden box	Painted wood	Dents				The blue repaint is still present on the dents, meaning that these alterations were made before the modification of the trunk as the wooden box of the projector.

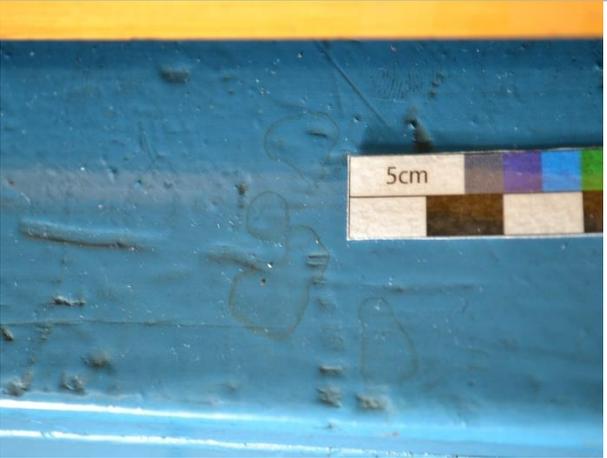
Localisation	Material	Surface alteration	Structural alteration	Functional alteration	Modifications, previous restorations	Diagnostic	Picture
Wooden box	Painted wood	Halos				The object has been exposed to flows, generating halos.

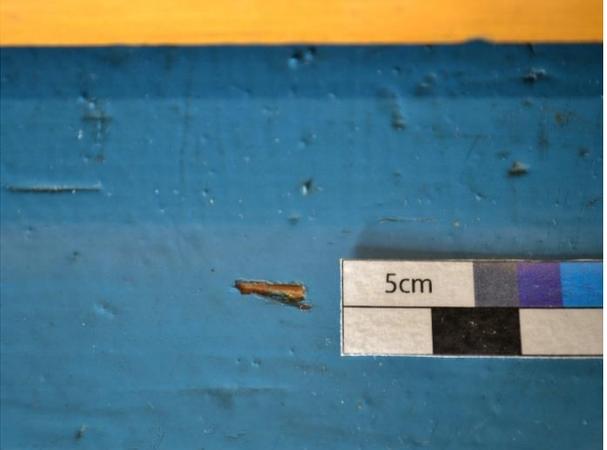
Wooden box	Painted wood		Losses of the wood			The losses of wood may be related to the manipulation and the use of this technical object.

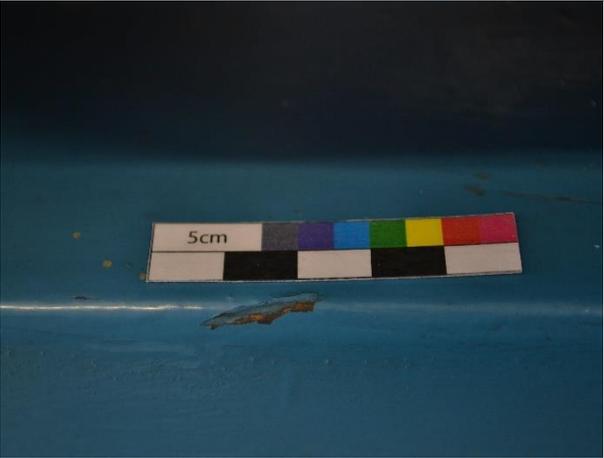
Localisation	Material	Surface alteration	Structural alteration	Functional alteration	Modifications, previous restorations	Diagnostic	Picture
Wooden box	Painted wood		Losses of the paint			The losses of paint may be related to the manipulation and the use of this technical object.

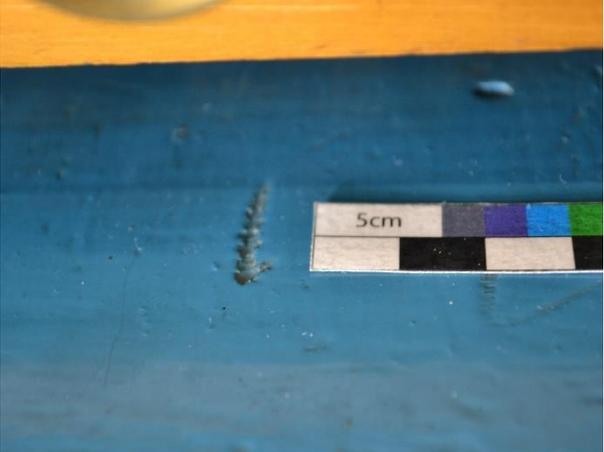
Wooden box	Painted wood	Scuffs				The blue repaint is still present on the scuffs, meaning that these alterations were made before the modification of the trunk as the wooden box of the projector.

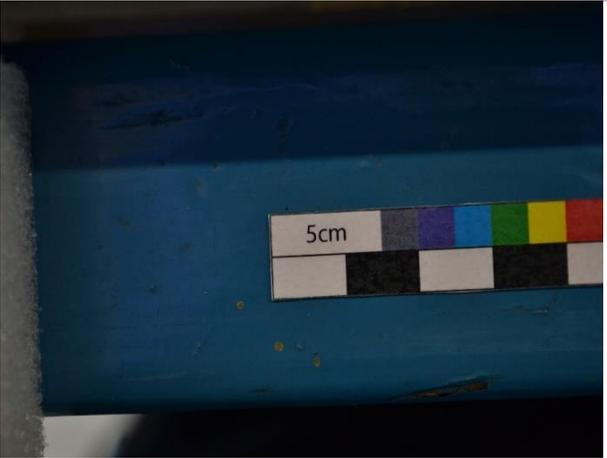
Localisation	Material	Surface alteration	Structural alteration	Functional alteration	Modifications, previous restorations	Diagnostic	Picture
Wooden box	Painted wood	White stains				The inside of the wooden box has been repainted white. These stains might be paint from this modification.

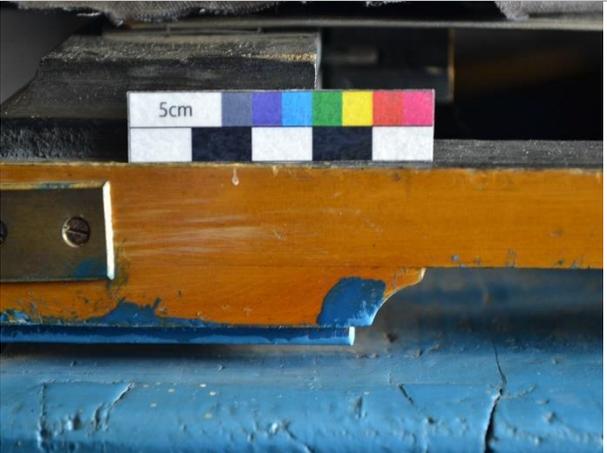
Wooden box	Painted wood				Repaint	While its modifications, the wooden box of the object has been repainted blue, after the technical assembly and modifications of the object.

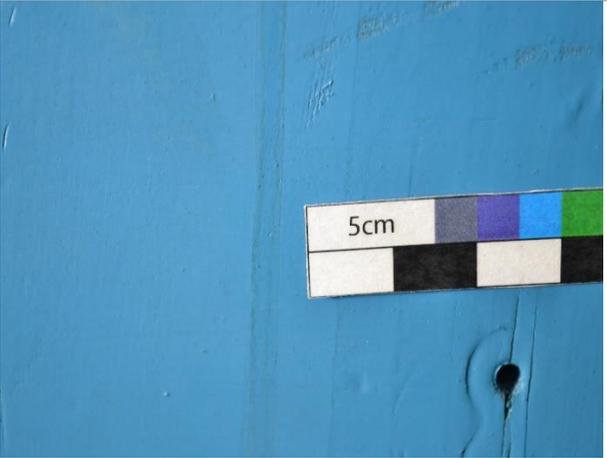
Localisation	Material	Surface alteration	Structural alteration	Functional alteration	Modifications, previous restorations	Diagnostic	Picture
Wooden box	Painted wood	Sags				The object has been exposed to flows, generating sags.

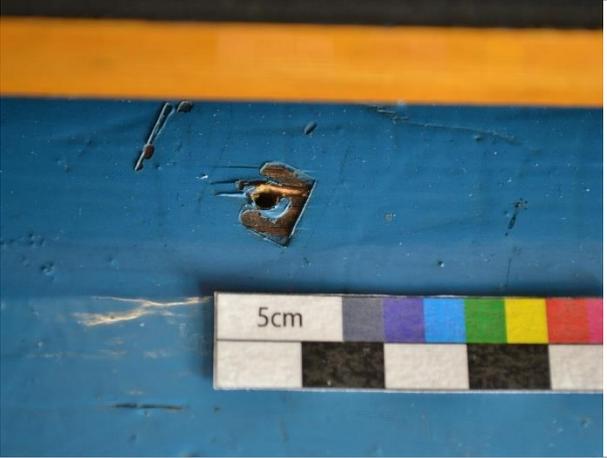
Wooden box	Painted wood				Hole	It may be part of the modifications of the object.

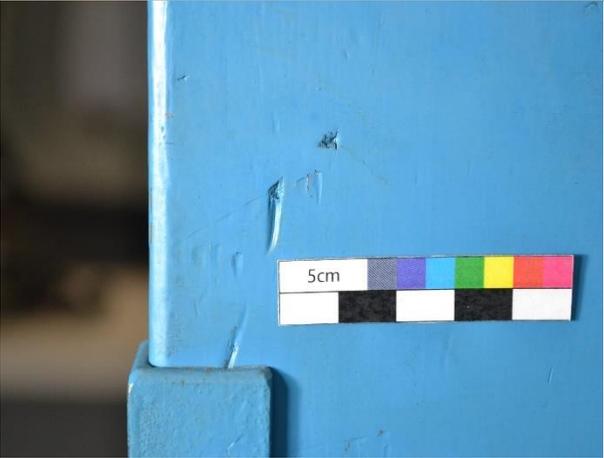
Localisation	Material	Surface alteration	Structural alteration	Functional alteration	Modifications, previous restorations	Diagnostic	Picture
Wooden box	Painted wood	Sinking				<p>The blue repaint is still present on the sinkings, meaning that these alterations were made before the modification of the trunk as the wooden box of the projector.</p>

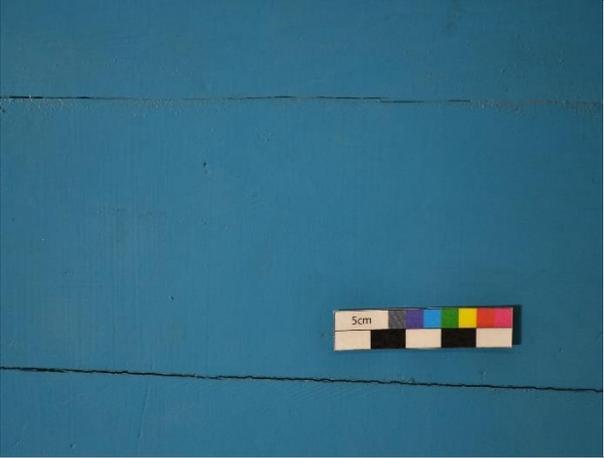
Wooden box	Painted wood		Cracks			<p>These straight-lined openings, more or less long, following the orientation of the internal structure of the material²¹, are caused by constraints in the material, generally because of the variations of the climate from a dry to a humid atmosphere.</p>

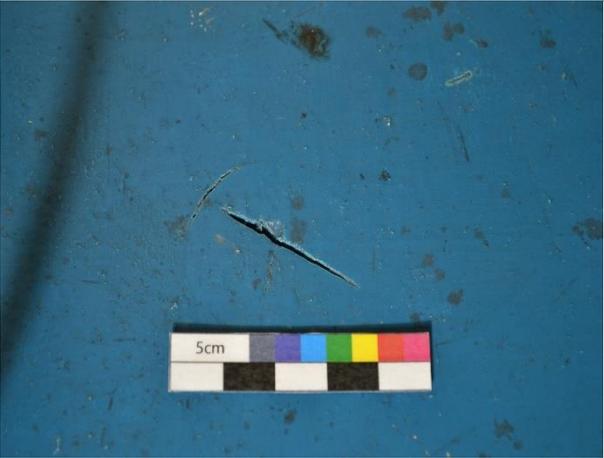
Localisation	Material	Surface alteration	Structural alteration	Functional alteration	Modifications, previous restorations	Diagnostic	Picture
Wooden box	Painted wood		Splits			These opening in the mass of the wood following an area of weakness ²² , are caused by the variations of the climate from a dry to a humid atmosphere.

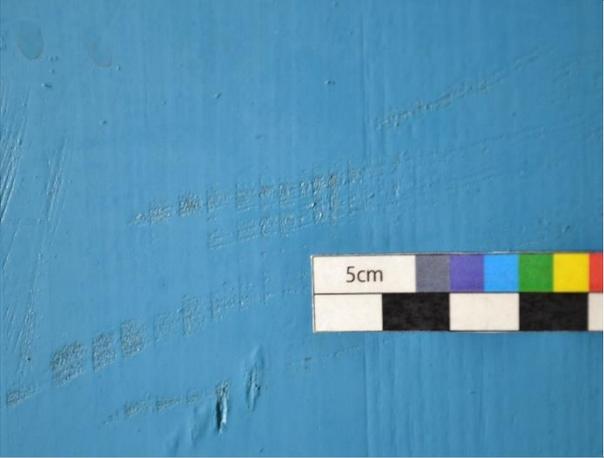
Wooden box	Painted wood	Scratches				The blue repaint is still present on the scratches, meaning that these alterations were made before the modification of the trunk as the wooden box of the projector.

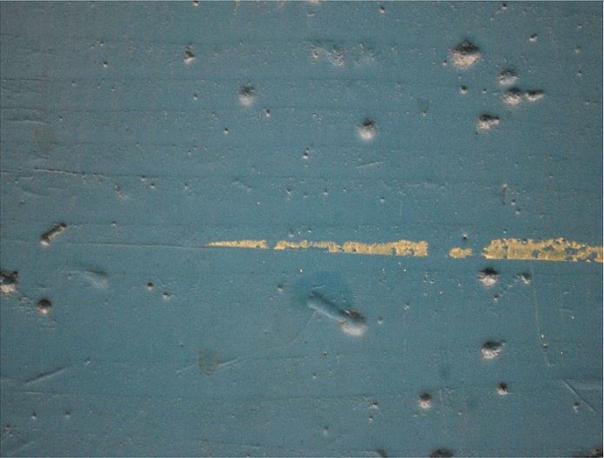
Localisation	Material	Surface alteration	Structural alteration	Functional alteration	Modifications, previous restorations	Diagnostic	Picture
Wooden box	Painted wood	Chalky deposit				The manipulation of the front door of the wooden box may have caused the accumulation of deposits.

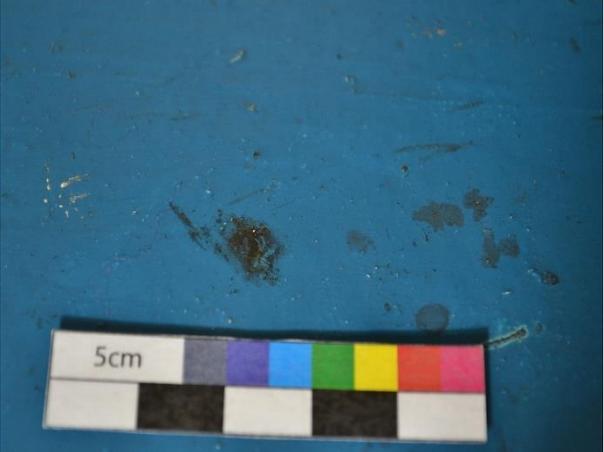
Wooden box, inside	Painted wood	Black deposit				Soiling could have accumulated easily on this technical object, during its use and after.

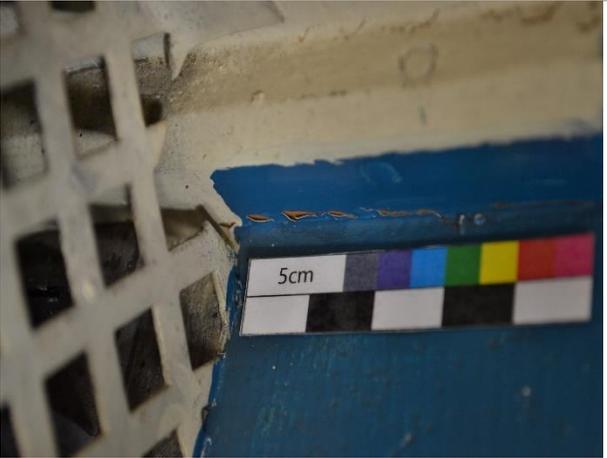
Localisation	Material	Surface alteration	Structural alteration	Functional alteration	Modifications, previous restorations	Diagnostic	Picture
Wooden box, inside	Painted wood		Lifting of the paint layer			A lack of adherence between the paint layer and the support may have caused the lifting of the paint layer.

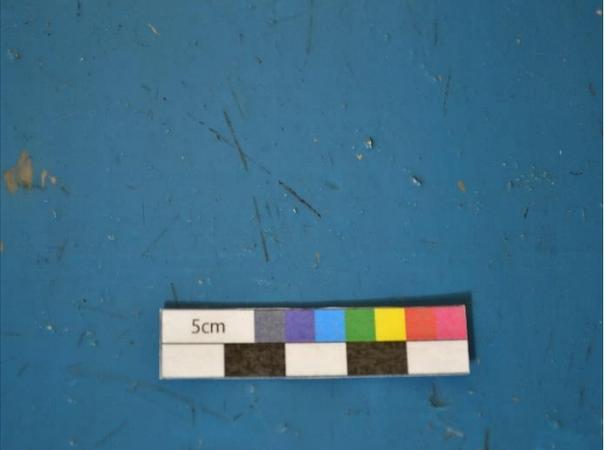
Wooden box, inside	Painted wood	Black deposits				Black deposits having the form of scuffs are visible inside the wooden box, on the bottom part. They might be related to the drop and output of the PVC cable laying in the box.

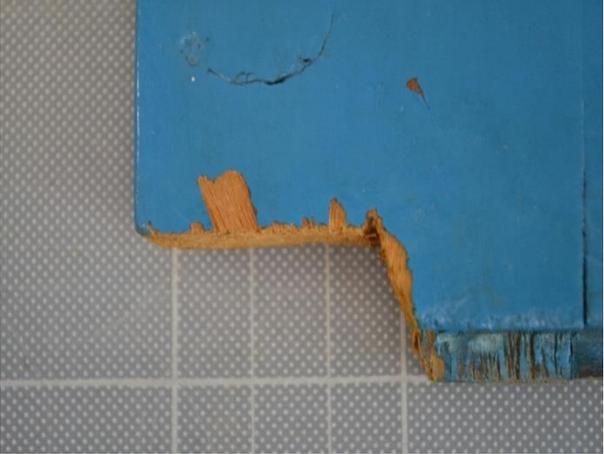
Localisation	Material	Surface alteration	Structural alteration	Functional alteration	Modifications, previous restorations	Diagnostic	Picture
Wooden box, front door	Painted wood				Cut	The cut is part of the modification of the object, to let the power cable out of the box.

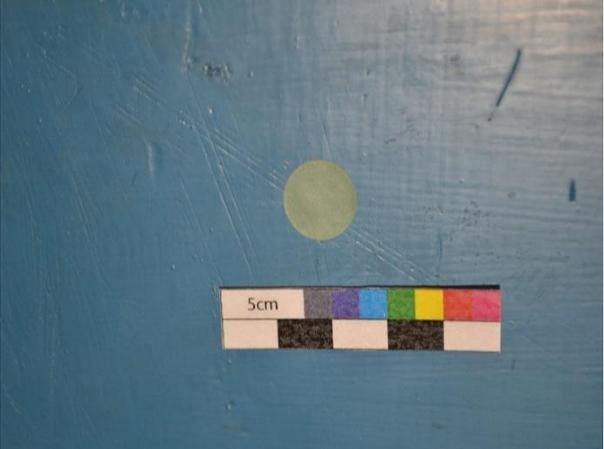
Wooden box	Painted wood				Adding of a sticker	The adding of a sticker might be part of the ancient inventory protocol.

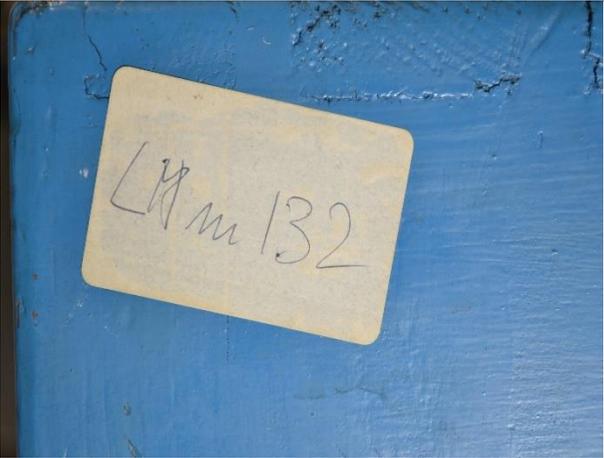
Localisation	Material	Surface alteration	Structural alteration	Functional alteration	Modifications, previous restorations	Diagnostic	Picture
Wooden box	Painted wood				Adding of two stickers with inventory numbers	The adding of two stickers may be part of the ancient inventory protocol.

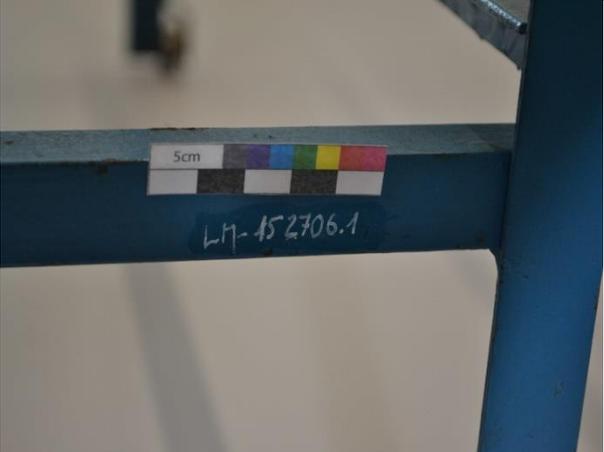
Wooden box	Painted wood				Adding of the inventory number	The current inventory number has been added to the object for identification.

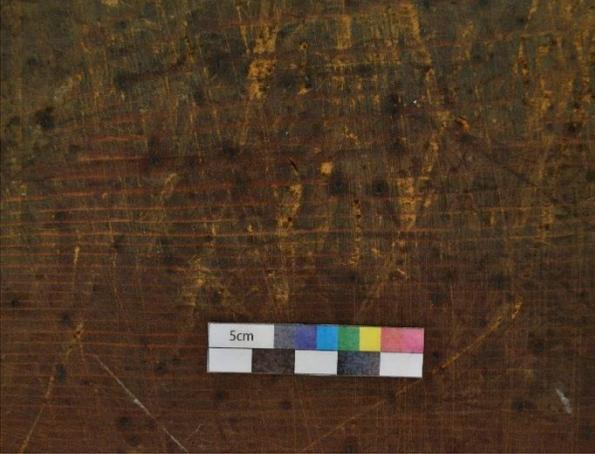
Localisation	Material	Surface alteration	Structural alteration	Functional alteration	Modifications, previous restorations	Diagnostic	Picture
Wooden box, bottom part	Bare wood	Abrasion				The previous use of the box as a trunk may have caused abrasion.

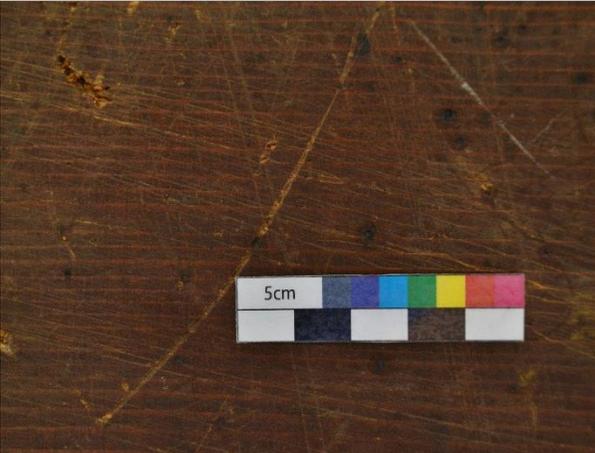
Wooden box, bottom part	Bare wood	Scratches				The previous use of the box as a trunk may have caused scratches.

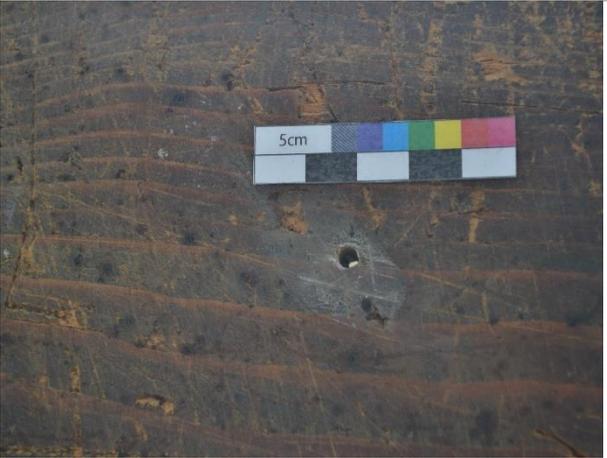
Localisation	Material	Surface alteration	Structural alteration	Functional alteration	Modifications, previous restorations	Diagnostic	Picture
Wooden box, bottom part	Bare wood		Holes			The holes may be part of the modifications brought to the box, or from its original state as a trunk.

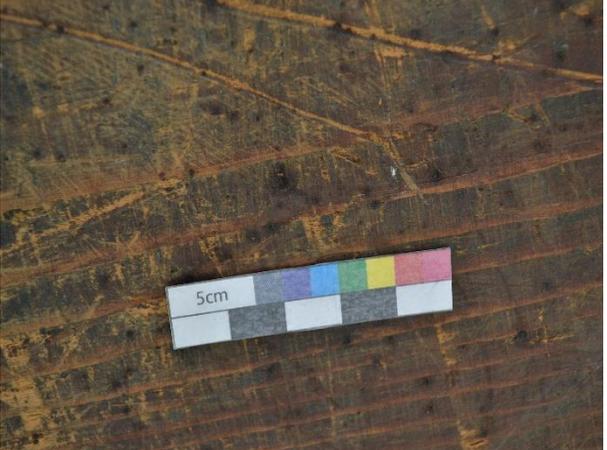
Wooden box, bottom part	Bare wood	Black shiny deposits				The deposits may have agglomerated to the wood while using it as a trunk, as it was probably moved from a floor to another.

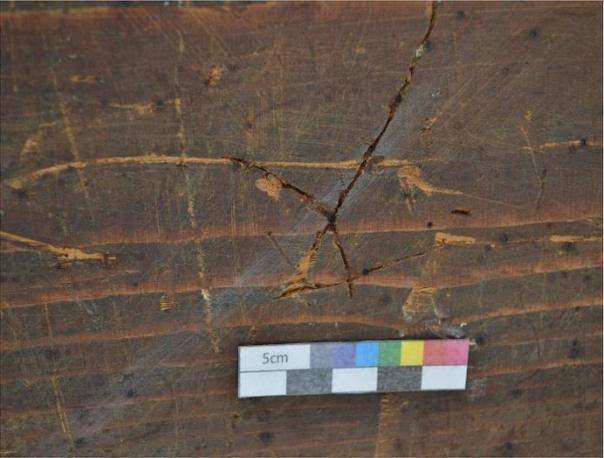
Localisation	Material	Surface alteration	Structural alteration	Functional alteration	Modifications, previous restorations	Diagnostic	Picture
Wooden box, bottom part	Bare wood		Split			Strain on wood may have caused a split.

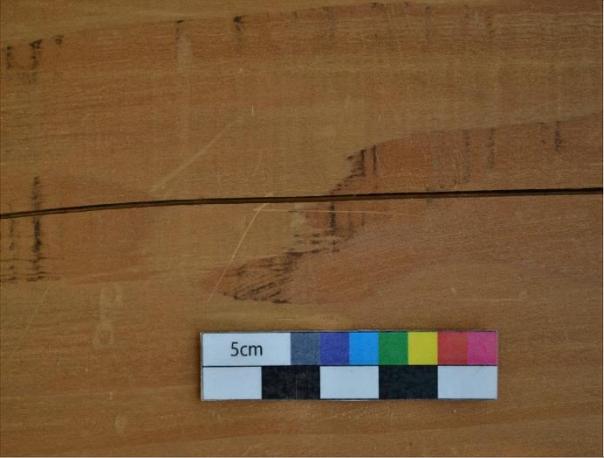
Wooden box, inside part of the door	Bare wood		Crack			These straight-lined openings, more or less long, following the orientation of the internal structure of the material ²³ , are caused by constraints in the material, generally because of the variations of the climate from a dry to a humid atmosphere.

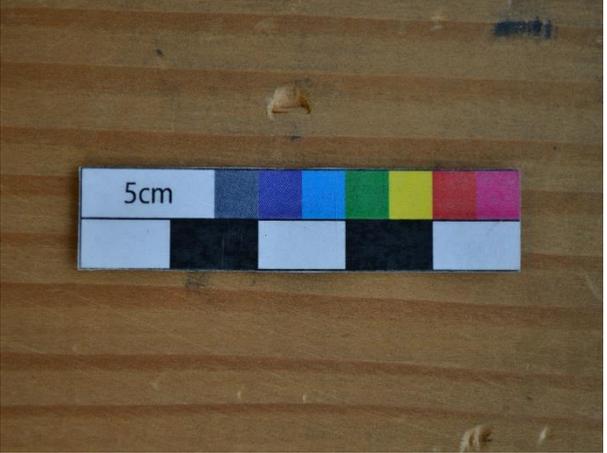
Localisation	Material	Surface alteration	Structural alteration	Functional alteration	Modifications, previous restorations	Diagnostic	Picture
Wooden box, inside part of the door	Bare wood		Losses of the wood			The manipulation of the removable door may have caused losses.

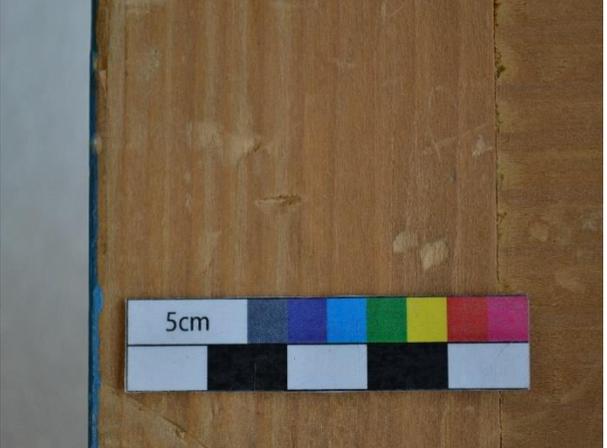
Wooden box, inside part of the door	Bare wood	Impacts				The manipulation of the removable door may have caused impacts.

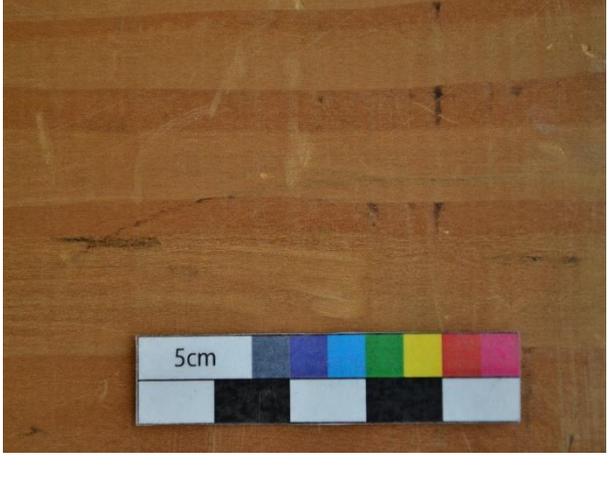
Localisation	Material	Surface alteration	Structural alteration	Functional alteration	Modifications, previous restorations	Diagnostic	Picture
Wooden box, inside part of the door	Bare wood	Abrasion				The manipulation of the removable door may have caused abrasion.

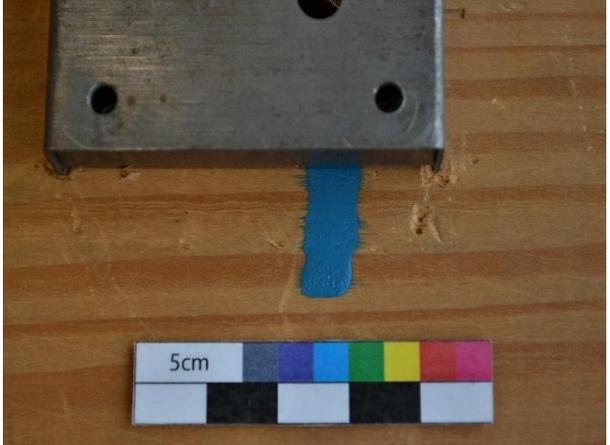
Wooden box, inside part of the door	Bare wood				Sag of blue paint	The repaint of the wooden box has generated a sag of blue paint.

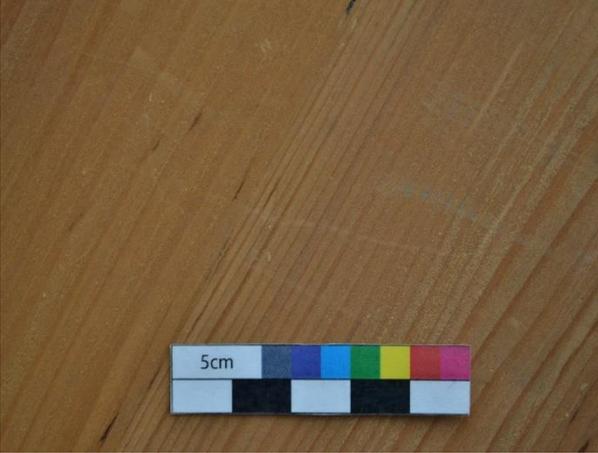
Localisation	Material	Surface alteration	Structural alteration	Functional alteration	Modifications, previous restorations	Diagnostic	Picture
Wooden box, inside part of the door	Bare wood	Scratches				The manipulation of the removable door may have caused scratches.

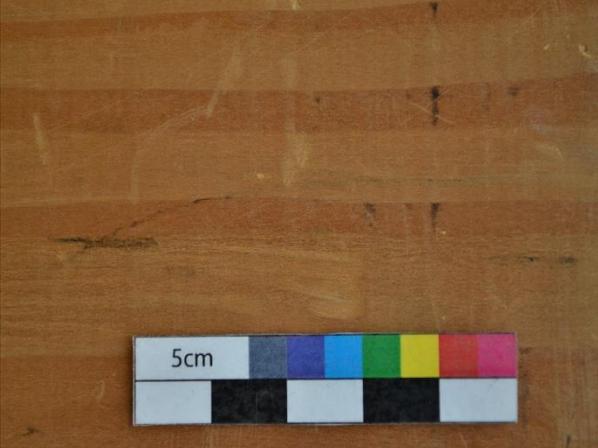
Wooden box, inside part of the door	Bare wood	Black deposits				The manipulation of the removable door may have generated black deposits while it was laid on surfaces.

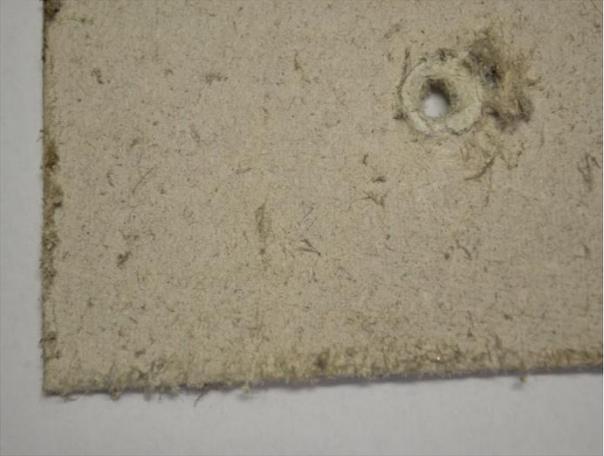
Localisation	Material	Surface alteration	Structural alteration	Functional alteration	Modifications, previous restorations	Diagnostic	Picture
General	Asbestos	Lifting of fibres				Asbestos plates are support which are unstable by nature, as they are mode of an agglomeration of sheets of fibres. The lifting, detachment and fraying of the edges is then easy for this substrate.

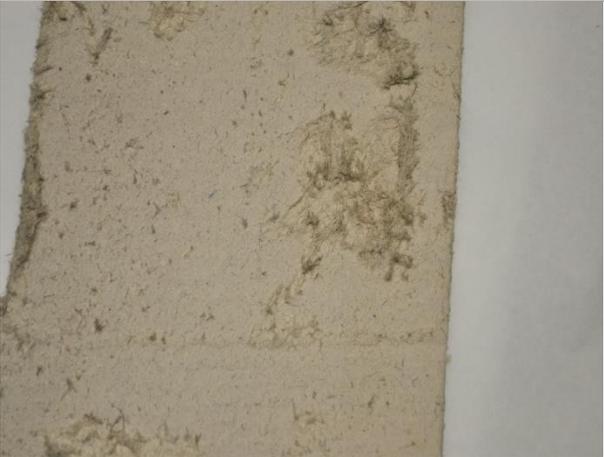
General	Asbestos		Detachment

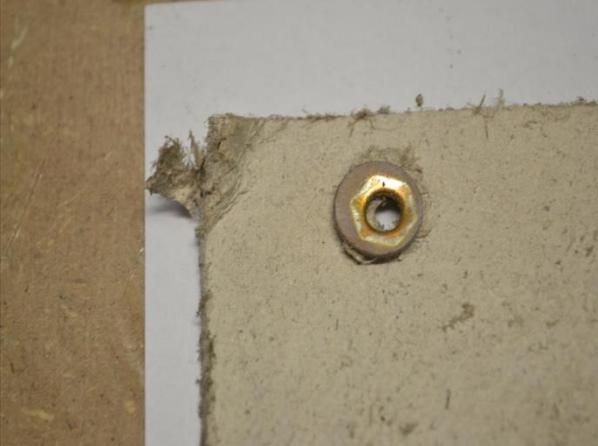
Localisation	Material	Surface alteration	Structural alteration	Functional alteration	Modifications, previous restorations	Diagnostic	Picture
General	Asbestos		Fraying of edges

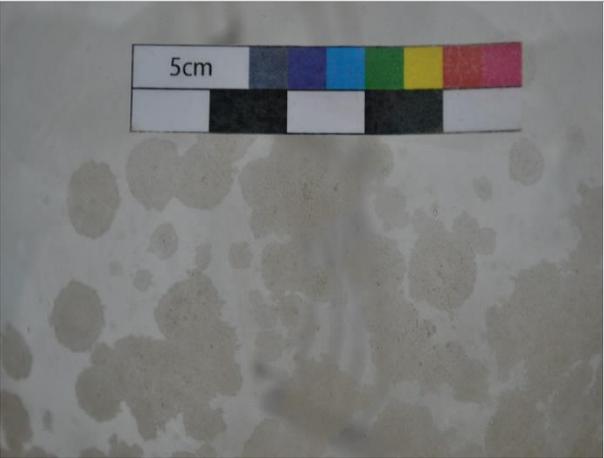
Localisation	Material	Surface alteration	Structural alteration	Functional alteration	Modifications, previous restorations	Diagnostic	Picture
Lantern, inside, bulb	Glass	Soiling				A lot of halos are visible on the object : it seems that it has been exposed to flows, generating here an agglomeration of soiling where the drops where standing.

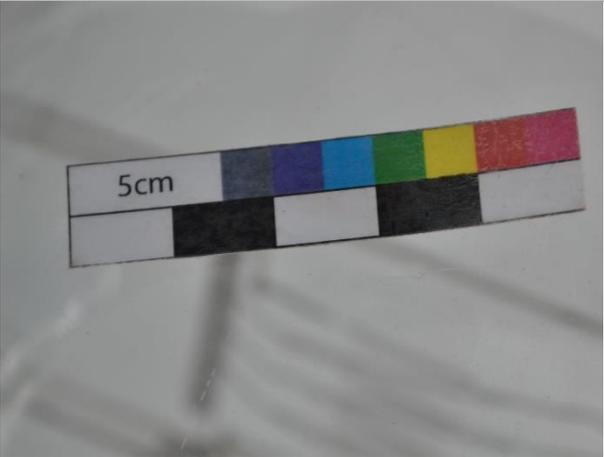
Lantern, inside, bulb	Glass	Scratches				Scratches on glass may be related to the manipulation of this fragile object.

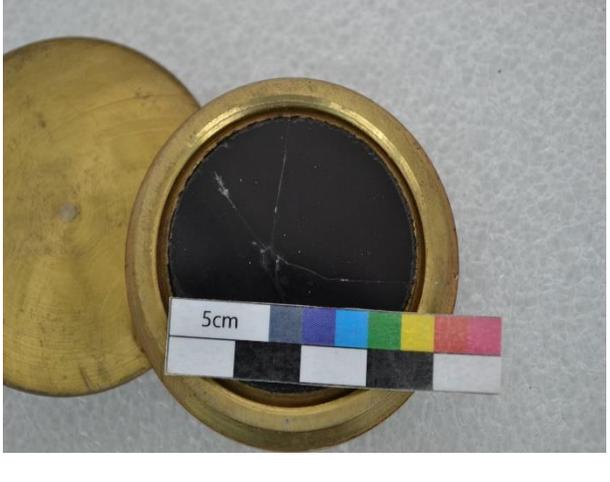
Localisation	Material	Surface alteration	Structural alteration	Functional alteration	Modifications, previous restorations	Diagnostic	Picture
Lantern, sides, peepholes	Tinted glass		Cracks			The cracks of the glass may be related to the manipulation of the peepholes or the doors of the lantern.

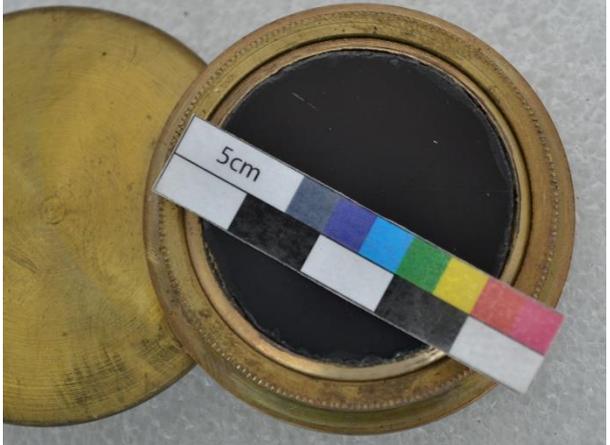
Lantern, sides, peepholes	Tinted glass	Scratches				The scratches of glass may be related to the manipulation of the doors of the lantern.

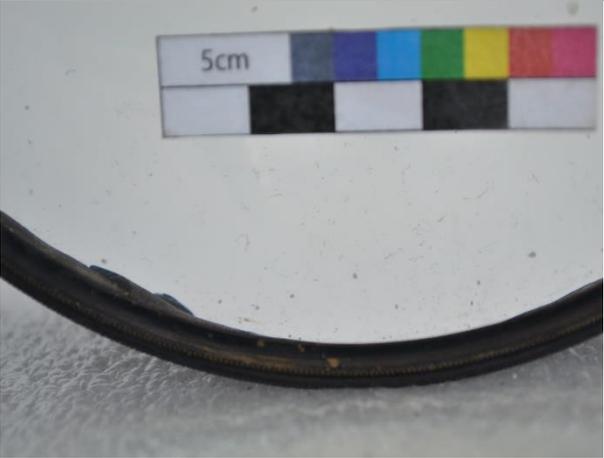
Localisation	Material	Surface alteration	Structural alteration	Functional alteration	Modifications, previous restorations	Diagnostic	Picture
Lantern, lens	Glass	Soiling				The lens is supported by the front of the lantern, which does not protect completely the object from the dust and grime.

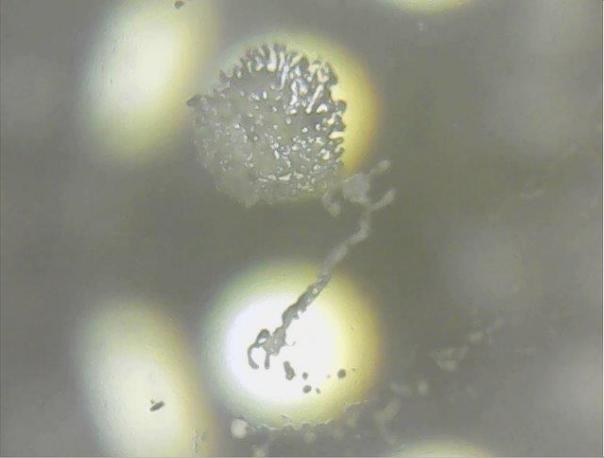
Lantern, lens	Glass	Corrosion				Glass corrosion is due to electrochemical reactions of the material with its atmosphere, generally water attack or acid or alkaline chemical attacks ²⁴ . In the case of this object, the water attack would be plausible.

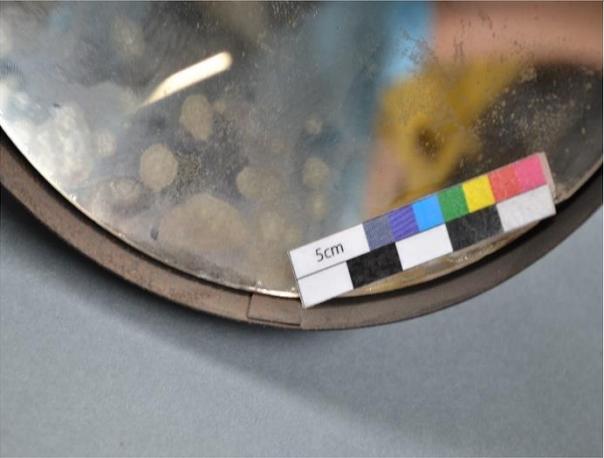
Localisation	Material	Surface alteration	Structural alteration	Functional alteration	Modifications, previous restorations	Diagnostic	Picture
Lantern, inside, condenser	Glass, silver coating	Corrosion				Glass corrosion is due to electrochemical reactions of the material with its atmosphere, generally water attack or acid or alkaline chemical attacks ²⁵ . In the case of this object, the water attack would be plausible.

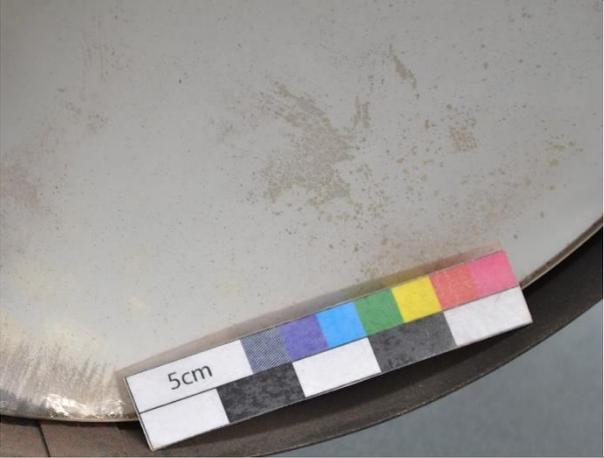
Lantern, inside, condenser	Glass, silver coating	Tarnishing				Glass is covered with a silver coating to obtain a mirror surface thanks to silvering by electroless plating ²⁶ . Silver can tarnish when exposed to sulphur gazes in reduced oxidation state (hydrogen sulphur or carbonyl sulphur) and elementary sulphur.

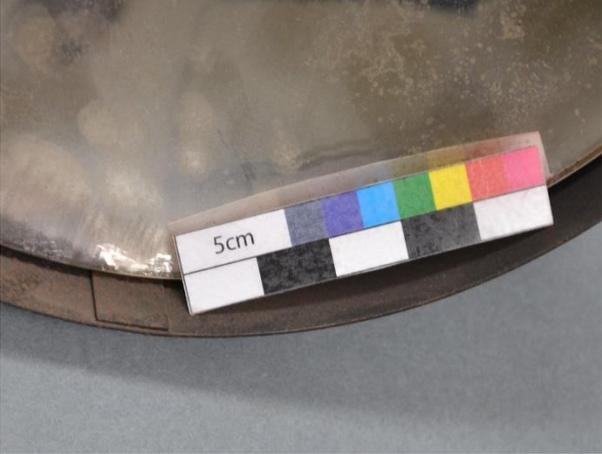
Localisation	Material	Surface alteration	Structural alteration	Functional alteration	Modifications, previous restorations	Diagnostic	Picture
Lantern, inside, condenser	Glass, silver coating	Chipping				The manipulation of the condenser while parameterizing the settings may have caused chipping.

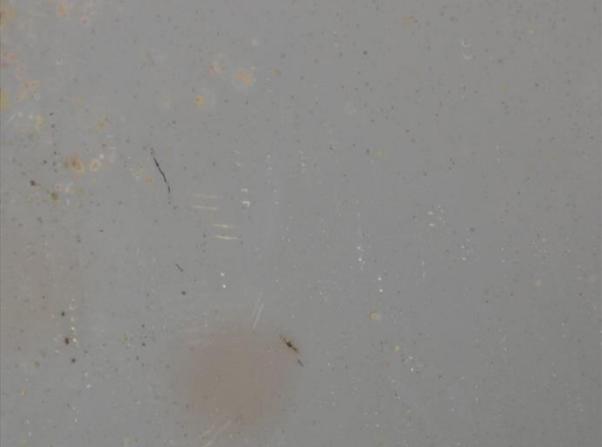
Lantern, inside, condenser	Glass, silver coating	Scratches				The manipulation of the condenser while parameterizing the settings may have caused scratches.

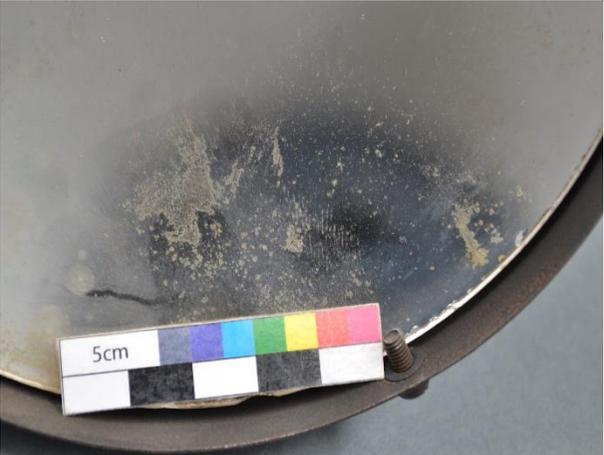
Localisation	Material	Surface alteration	Structural alteration	Functional alteration	Modifications, previous restorations	Diagnostic	Picture
Lantern, inside, condenser	Glass, silver coating	Fingerprint				<p>The manipulation of the condenser, generating the filing of chlorides on the surface of the glass, as well as the expositions to flows may have generate the marking of the fingerprint.</p>

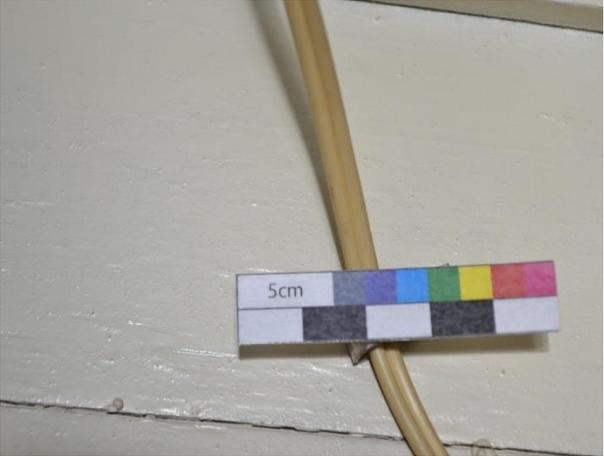
Localisation	Material	Surface alteration	Structural alteration	Functional alteration	Modifications, previous restorations	Diagnostic	Picture
Wooden box, inside, unconnected cable from the transformer	Plastic, PVC?	Yellowing				Photo-oxidation has caused the yellowing of the cable, being directly exposed to the light source of the lantern. It is related to the loss of hydrogen chloride from the plastic ²⁷ .
