Blued steel sheets : history, manufacturing and conservation.

The case of a Ganz & Co projection and enlargement lantern
conserved at the Collection Centre of the Swiss National Museum.

Master of Arts HES-SO in Conservation-restoration
Specialized in scientific, technical and horological objects

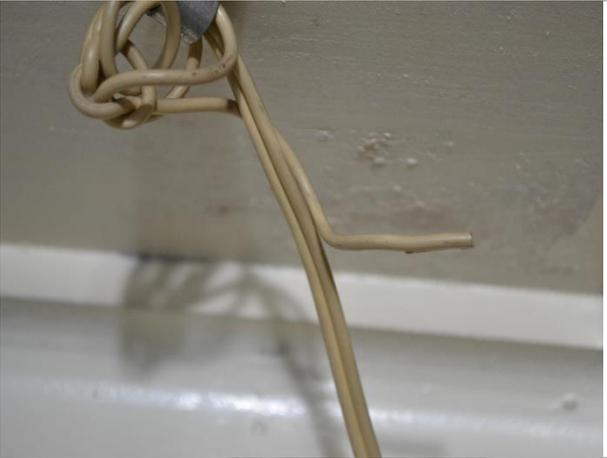
Localisation	Material	Surface alteration	Structural alteration	Functional alteration	Modifications, previous restorations	Diagnostic	Picture
Wooden box, inside, unconnected cable from the transformer	Plastic, PVC?		Hardening			The loss of plasticizers causes brittleness and hardening of plastics ²⁸ .

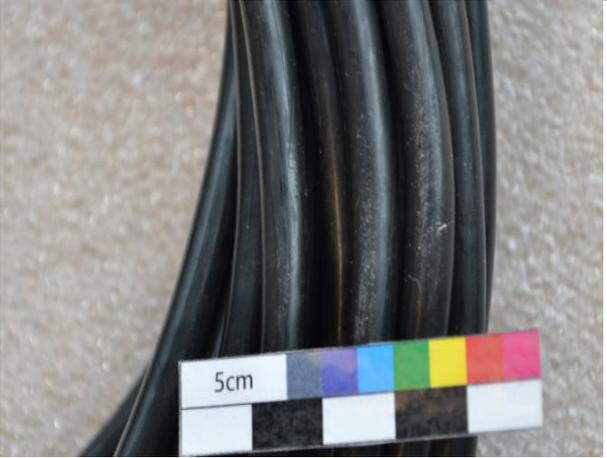
Wooden box, inside, power cable	Plastic, PVC	Surface dust				The power cable, during its use and storage, was easily in contact with dust.

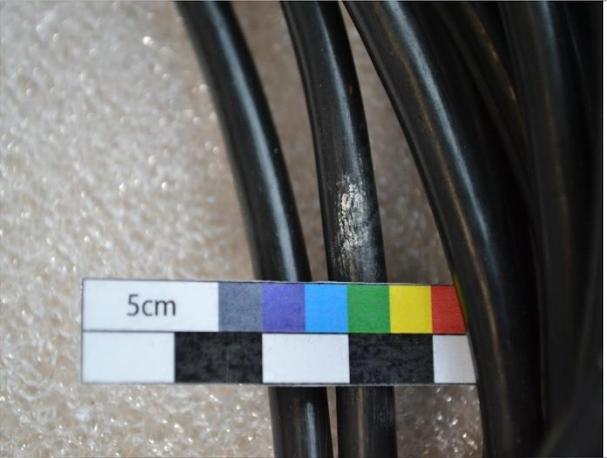
Localisation	Material	Surface alteration	Structural alteration	Functional alteration	Modifications, previous restorations	Diagnostic	Picture
Wooden box, inside, power cable	Plastic, PVC	Painting deposit and fingerprint				The repaint of the wooden box has been done after the technical modifications of the object.

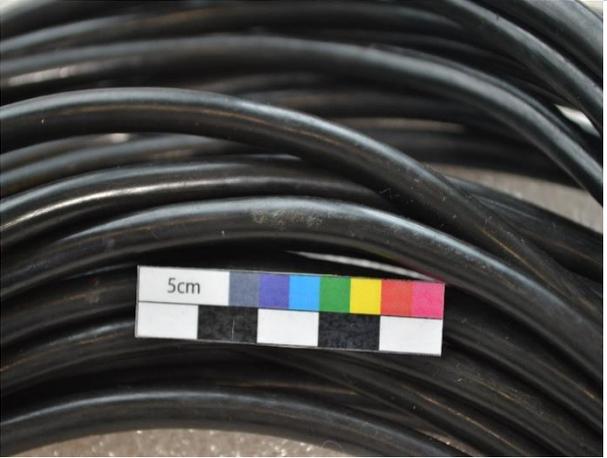
Wooden box, inside, power cable	Plastic, PVC	Bloom				Ancient flexible PVC are generally very unstable chemically. Their plasticizer migrates at the surface, being sticky first and crystallising as bloom. Also, the loss of lubricant from the PVC (stearic acid) is common, as it is a very non-polar material in comparison with PVC. It results in the deposit of white crystals at the surface ²⁹ .

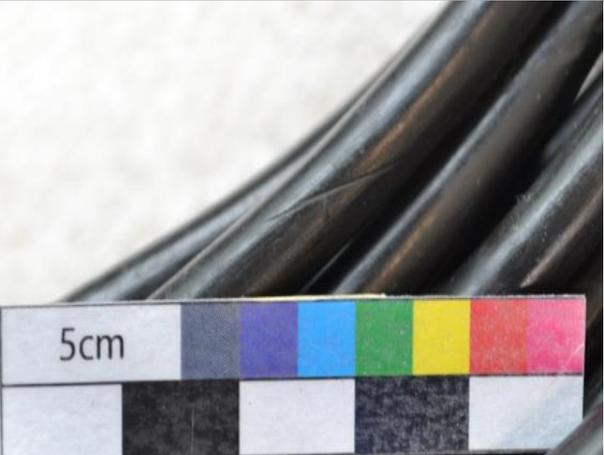
Localisation	Material	Surface alteration	Structural alteration	Functional alteration	Modifications, previous restorations	Diagnostic	Picture
Wooden box, inside, power cable	Plastic, PVC	Scratch				The manipulation and use of the power cable may have caused scratches.

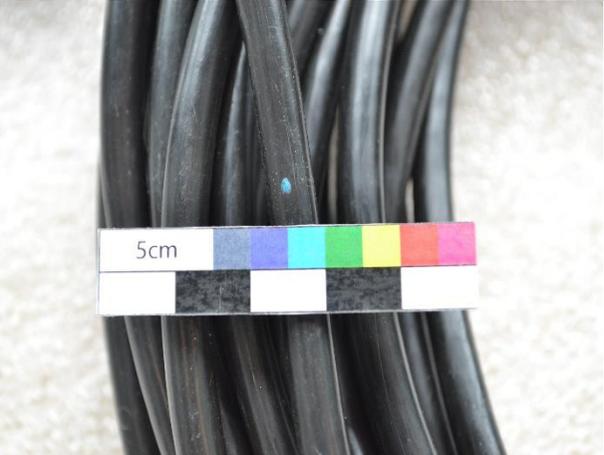
Wooden box, inside, power cable	Plastic, PVC				Spot of blue paint	The repaint of the wooden box has been done after the technical modifications of the object.

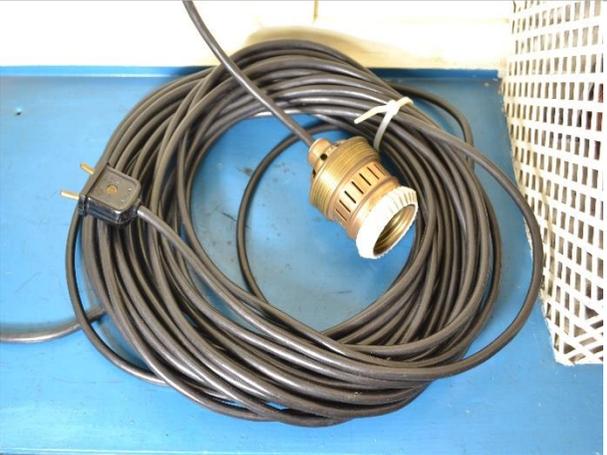
Localisation	Material	Surface alteration	Structural alteration	Functional alteration	Modifications, previous restorations	Diagnostic	Picture
Wooden box, inside, power cable	Plastic, PVC		Smell of new car seats			The chemical degradation of PVC, volatilizing its plasticizer ³⁰ , allows this smell.

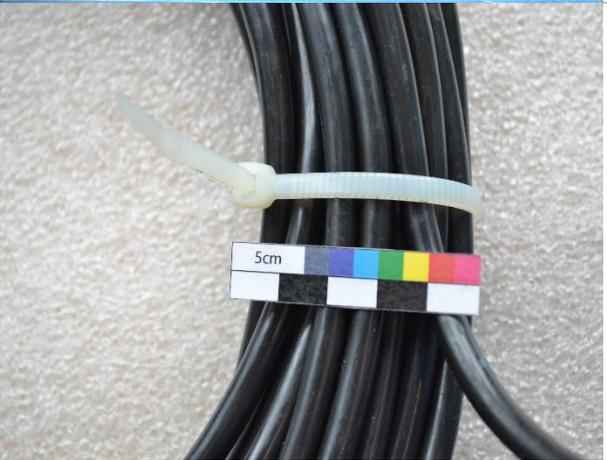
Wooden box, inside, power cable	Plastic, PVC				Plastic tie	A plastic tie has been added after the final use of this object.

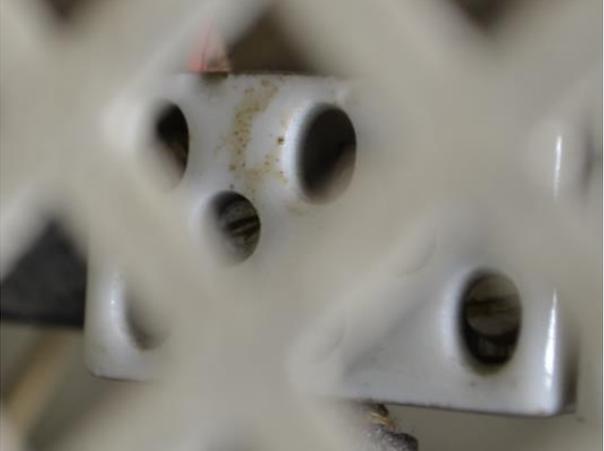
Localisation	Material	Surface alteration	Structural alteration	Functional alteration	Modifications, previous restorations	Diagnostic	Picture
Wooden box, inside, transformer, wire nut connectors	Plastic	Grime				Grime may have easily accumulated on this open part of the object.

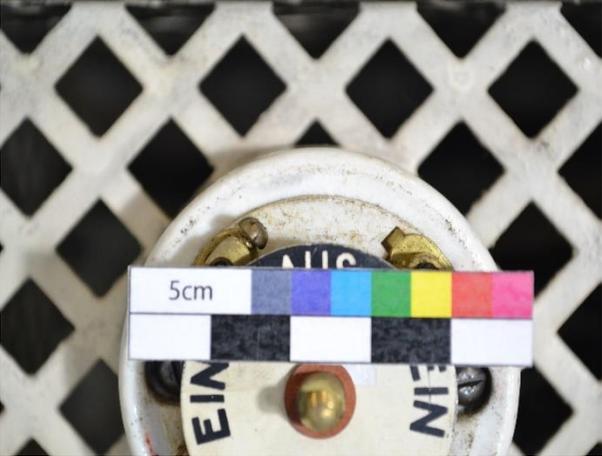
Localisation	Material	Surface alteration	Structural alteration	Functional alteration	Modifications, previous restorations	Diagnostic	Picture
Wooden box, inside, transformer switch	Ceramic	Grime				Grime could easily accumulate between the switch and its cover.

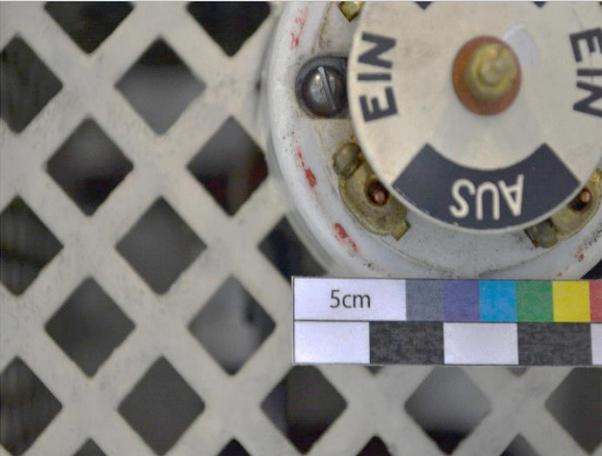
Wooden box, inside, transformer switch	Ceramic	Deposit of red paint				The red paint has been deposited by contact with the cover of the switch which is painted.

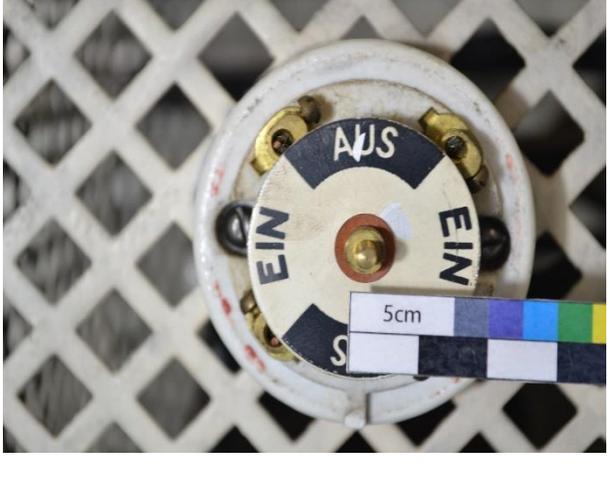
Localisation	Material	Surface alteration	Structural alteration	Functional alteration	Modifications, previous restorations	Diagnostic	Picture
Wooden box, inside, transformer switch	Ceramic	Painted ceramic		Loss of the paint layer		The low adherence between the paint and ceramic may have caused losses of the paint layer, as well as the vibrations .

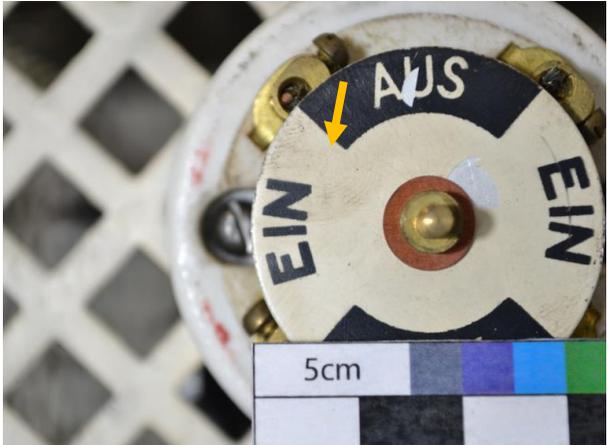
<p>A close-up photograph of a circular ceramic component, likely a transformer switch, mounted on a white lattice background. The component has a central red ring and a gold-colored screw. It is painted with black and white markings, including the letters 'EIN' and 'AUS'. A 5cm scale bar is visible at the bottom right of the image.</p>
Wooden box, inside, transformer switch	Ceramic	Fingerprint				The manipulation of the painted ceramic part of the object has generated fingerprint mark.

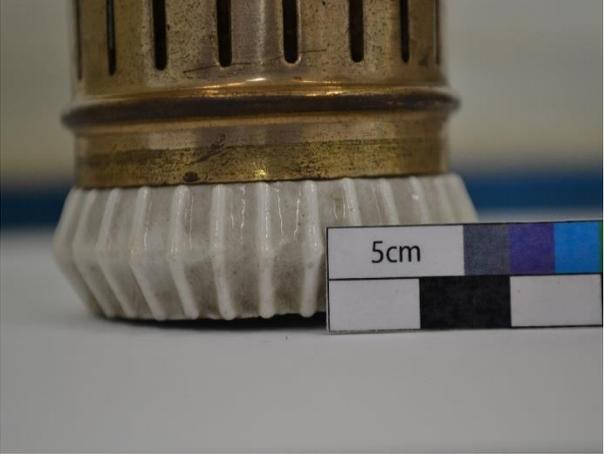
Localisation	Material	Surface alteration	Structural alteration	Functional alteration	Modifications, previous restorations	Diagnostic	Picture
Lantern, inside, socket	Ceramic	Grime				The socket was easily exposed to dust and grime in the lantern.

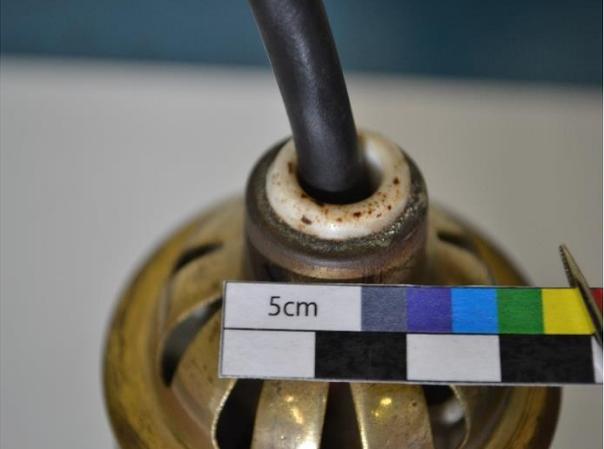
Lantern, inside, socket	Ceramic	Brownish deposits				Soiling has accumulated on this part of the socket.

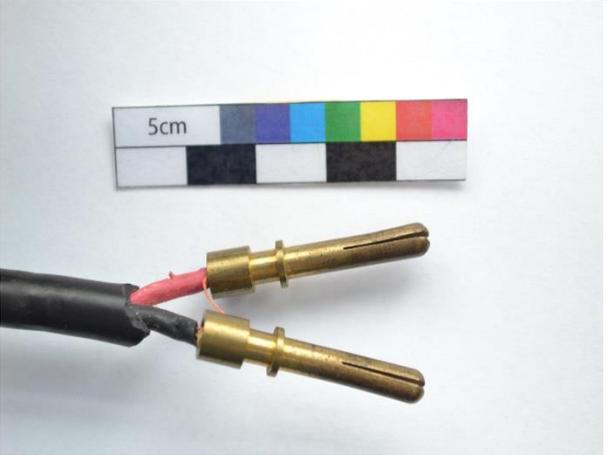
Localisation	Material	Surface alteration	Structural alteration	Functional alteration	Modifications, previous restorations	Diagnostic	Picture
Wooden box, edge of the power cable	Textile		Fraying			The edge of the power cable has required to cut the cable, meaning its plastic and textile elements. Fraying can then be expected here.

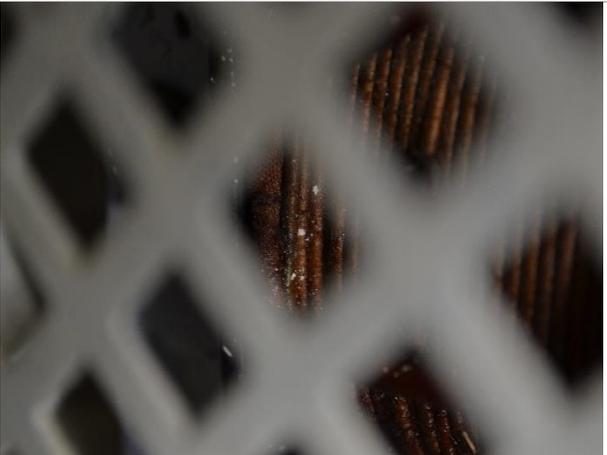
Wooden box, transformer	Coated textile	Paint stains				The repainting of the inside of the box may have caused paint stains on the transformer.

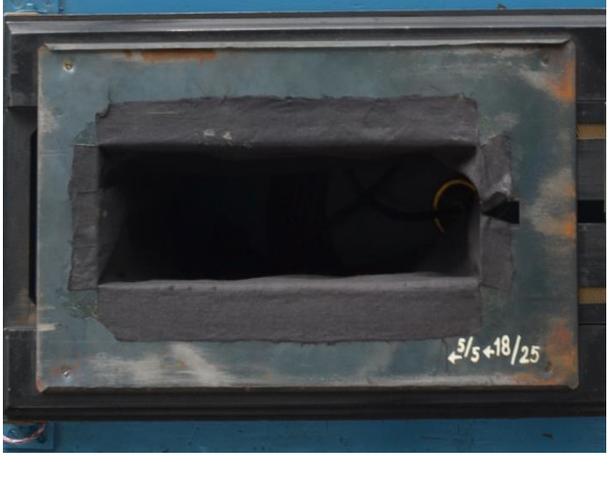
Localisation	Material	Surface alteration	Structural alteration	Functional alteration	Modifications, previous restorations	Diagnostic	Picture
Sliding plate under the lantern	Textile on ferrous alloy, blued steel				Adding of a piece of textile	A piece of textile has been added while all the modifications have been brought to the object, in order to avoid the penetration of light between the wooden base of the lantern and the wooden box.

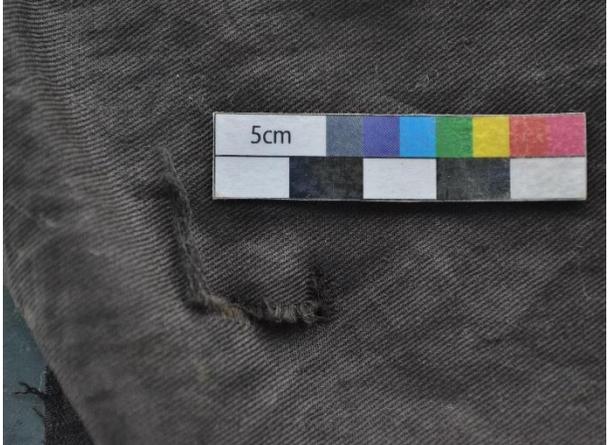
<p>A photograph showing a rectangular opening in a blue-painted metal plate. A piece of dark, textured fabric is inserted into the opening, filling it. The plate is mounted on a wooden surface. In the bottom right corner of the plate, there is a handwritten number '5/5 ← 18/25'.</p>
Sliding plate under the lantern	Textile		Holes			The holes may have been already present on the textile before it was stuck on the sliding plate under the lantern; or caused by the multiple settings of the technical object.

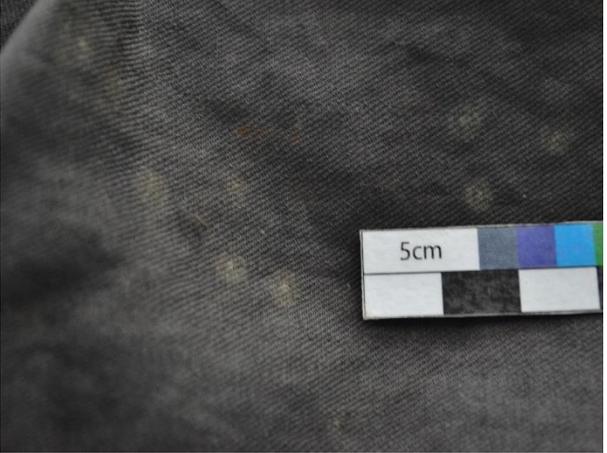
Localisation	Material	Surface alteration	Structural alteration	Functional alteration	Modifications, previous restorations	Diagnostic	Picture
Sliding plate under the lantern	Textile	White stains				The stains may be the result to an accumulation of grime when flows generated halos at the surface of the textile.

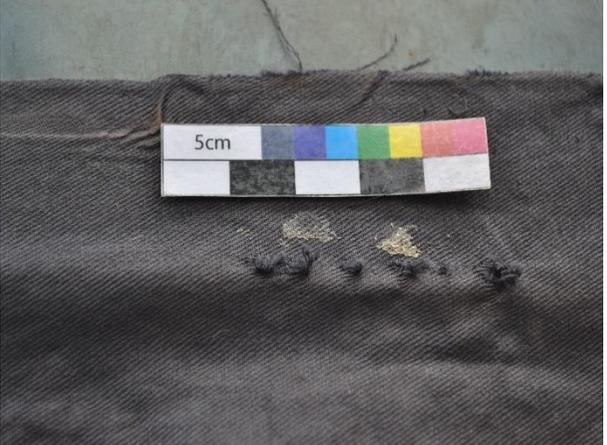
Sliding plate under the lantern	Textile		Fraying			The fraying may have been already present on the textile before it was stuck on the sliding plate under the lantern; or caused by the multiple settings of the technical object.

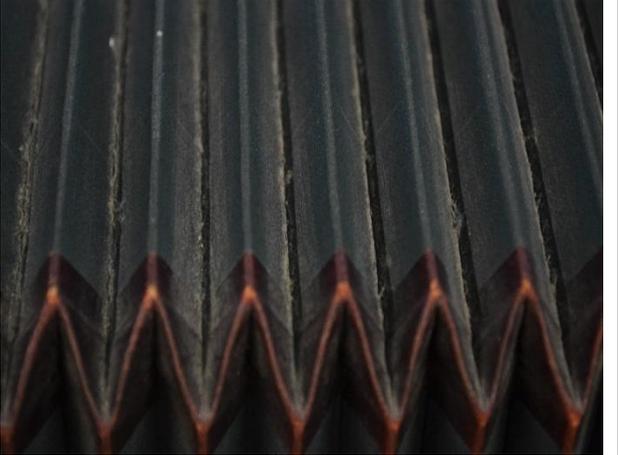
Localisation	Material	Surface alteration	Structural alteration	Functional alteration	Modifications, previous restorations	Diagnostic	Picture
Bellow	Coated paper, leather	Dust				The outside parts of the bellow are directly exposed to the ambient atmosphere. Dust could easily accumulate on its surface.

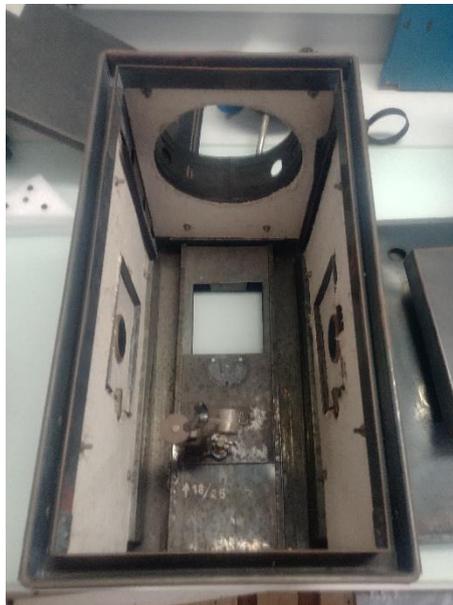
- 2 wide plates of low clustered asbestos covering the sides ;
- 1 medium plate of low clustered asbestos covering the front of the lantern ;
- 2 small plates of low clustered asbestos covering the side doors (*Picture 1*);
- A textile contaminated with asbestos fibres (*Picture 2*).

Picture 1 : View of the 5 plates of asbestos inside the lantern, in the hood and protective tent ©HE Arc CR, A.L

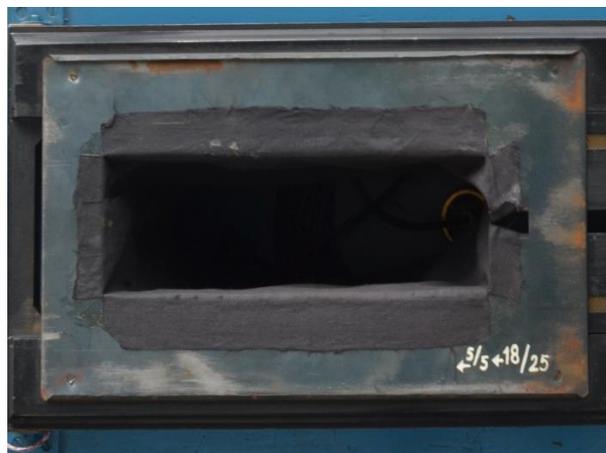
Picture 2 : View from the top of the contaminated textile, in the hood and protective tent ©HE Arc CR, A.L

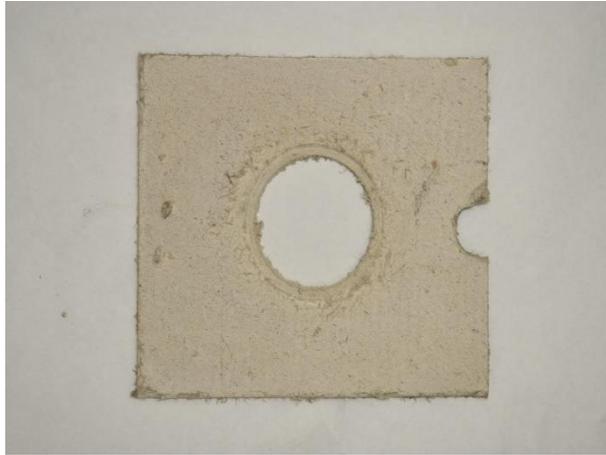
In this object, we deal with plates of low clustered asbestos (*Picture 3*), which are used as thermal insulators³⁵. Visually, it looks like a plate whose thickness is about 5 mm, and whose angles show an inception of several sheets of asbestos. The aspect of the material is very fibrous as it is low clustered (*Picture 4*). The fibres can then easily detach from the plates, contrary to highly clustered asbestos plates. They are fixed to the sides of the lantern with screws, flat washers and bolts. The small plates

Picture 3 : Low clustered plate of asbestos, in the hood and protective tent ©HE Arc CR, A.L

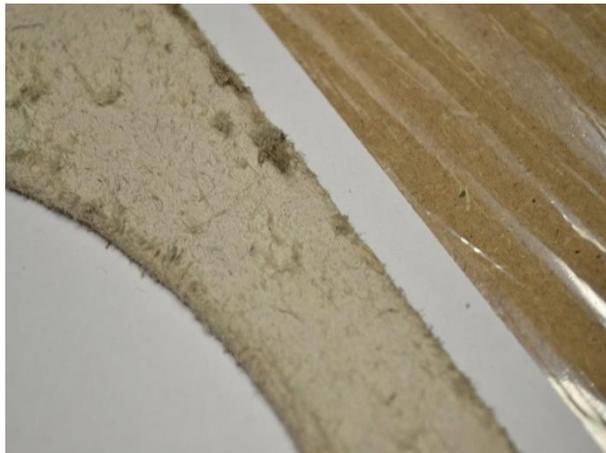
Picture 4 : Detachment of asbestos fibres, in the hood and protective tent ©HE Arc CR, A.L

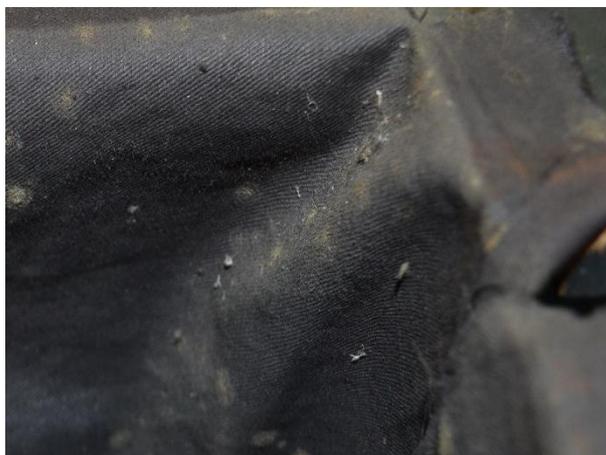
covering the side doors are mechanically fixed thanks to the brass structure of the peepholes. The textile is covered with asbestos fibres which detached from the asbestos plates (*Picture 5*).

Picture 5 : Asbestos fibres on the textile, in the hood and protective tent ©HE Arc CR, A.L

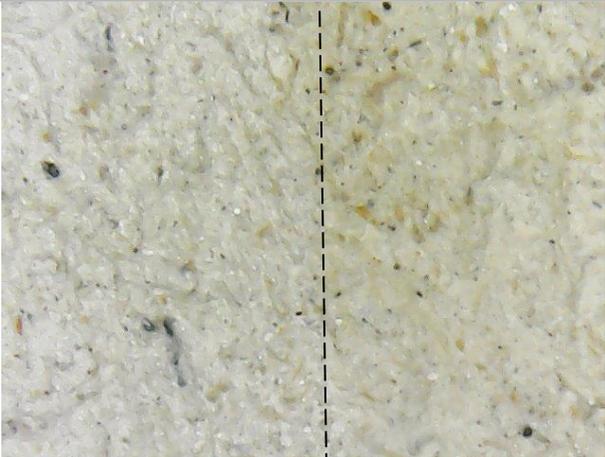
<p><i>Picture 7 : Before and after treatment ©HE Arc CR</i></p>

<i>Resin concentration</i>	<i>Application technique</i>	<i>Results</i>	<i>Pictures before and after treatment</i>
<p>10% in benzine 100/140</p>	<p>Syringe, 1 drop</p>	<p>Application</p> <p>+</p> <ul style="list-style-type: none"> - Can penetrate the substrate and the powdered edges - The fibres are not shifted <p>-</p> <ul style="list-style-type: none"> - The application gives an uneven result on the edges <p>Resin concentration</p> <p>+</p> <ul style="list-style-type: none"> - The surface keeps its matt finish <p>-</p> <ul style="list-style-type: none"> - Asbestos appear darker and slightly yellow - Unsure if all the fibres on the edges are well impregnated

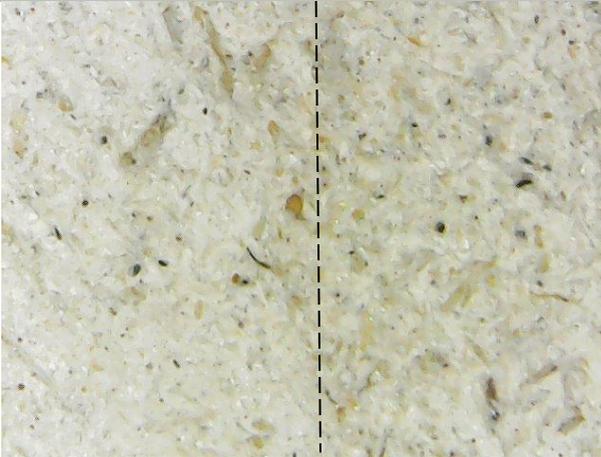
<p><i>Picture 9 : Before and after treatment ©HE Arc CR</i></p>

<p>10% in benzine 100/140</p>	<p>Flat brush, dropped on the surface</p>	<p>Application</p> <p>+</p> <ul style="list-style-type: none">- The application gives an even result <p>-</p> <ul style="list-style-type: none">- The brush collects a few fibres of asbestos- The application can move or flatten some fibres <p>Resin concentration</p> <p>+</p> <ul style="list-style-type: none">- The surface keeps its matt finish <p>-</p> <ul style="list-style-type: none">- Asbestos appear darker and more yellow than with the seringe- Fibres on the edges are well consolidated

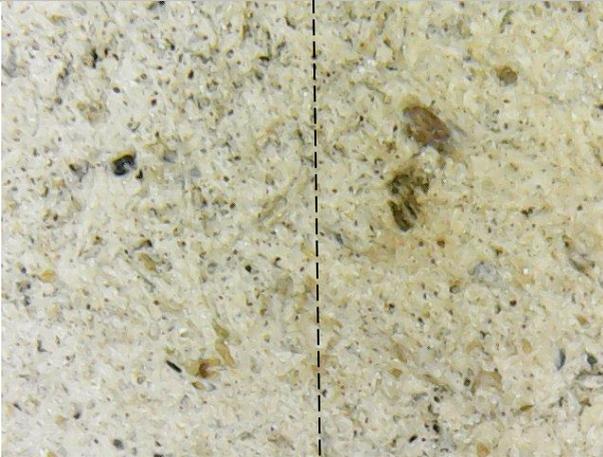
<p><i>Picture 11 : Before and after treatment ©HE Arc CR</i></p>

<p>10% in benzine 100/140</p>	<p>Soak, 2 seconds</p>	<p>Application</p> <p>+</p> <ul style="list-style-type: none">- Can penetrate the whole substrate- The application gives an even result- The fibres are not shifted <p>-</p> <ul style="list-style-type: none">- A drop of resin can take shape on the edge of the asbestos plate when removed from the soak, but can be easily removed <p>Resin concentration</p> <p>+</p> <ul style="list-style-type: none">- The surface keeps its matt finish- Fibres on the edges are well consolidated <p>-</p> <ul style="list-style-type: none">- Asbestos appear darker and slightly brown

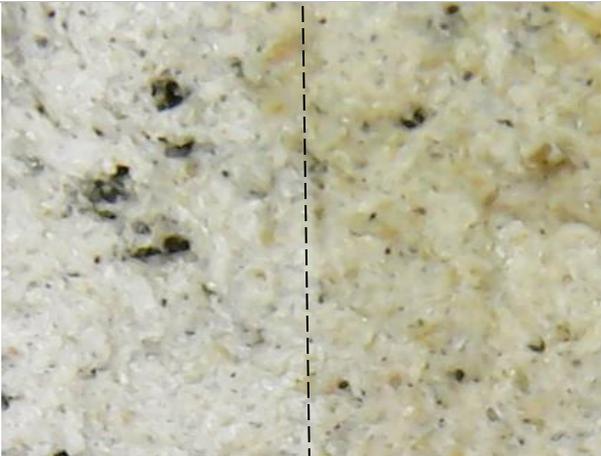
<p><i>Picture 13 : Before and after treatment @HE Arc CR</i></p>

<p>15% in benzine 100/140</p>	<p>Syringe, 1 drop</p>	<p>Application</p> <p>+</p> <ul style="list-style-type: none">- Can penetrate the substrate, as the powdered edges- The fibres are not shifted <p>-</p> <ul style="list-style-type: none">- The application gives an uneven result <p>Resin concentration</p> <p>+</p> <ul style="list-style-type: none">- The surface keeps its matt finish <p>-</p> <ul style="list-style-type: none">- Asbestos appear darker than with the 10% concentration applied with the syringe, and yellow- Unsure if all the fibres on the edges are well impregnated

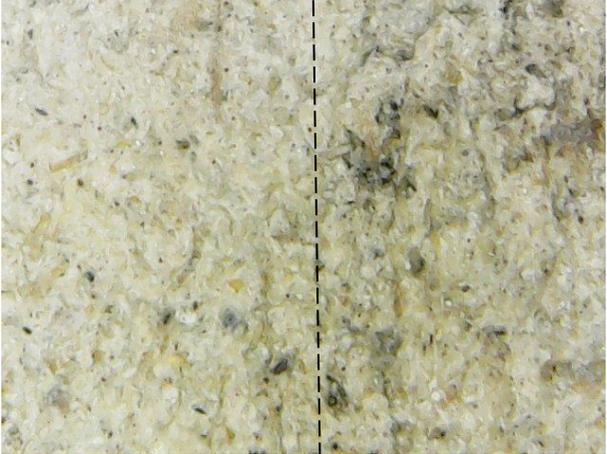
<p><i>Picture 15 : Before and after treatment @HE Arc CR</i></p>

<p>15% in benzine 100/140</p>	<p>Flat brush, dropped on the surface</p>	<p>Application</p> <p>+</p> <ul style="list-style-type: none"> - The application gives an even result <p>-</p> <ul style="list-style-type: none"> - The brush collects a few fibres of asbestos - The application can move or flatten fibres <p>Resin concentration</p> <p>+</p> <ul style="list-style-type: none"> - The surface keeps its matt finish <p>-</p> <ul style="list-style-type: none"> - Asbestos appear darker than with the 10% concentration applied with the brush, and more yellow than with the syringe - Fibres on the edges are well consolidated

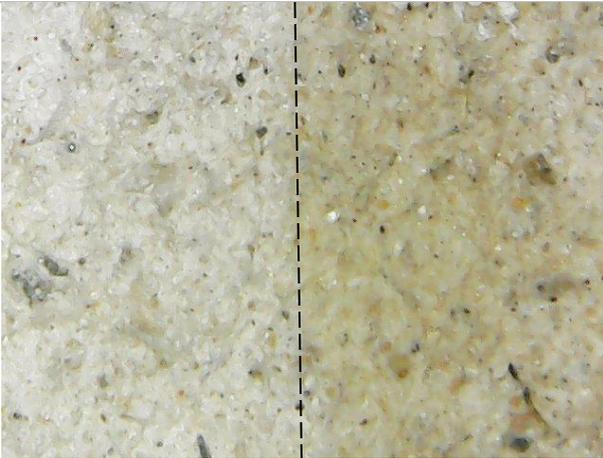
<p><i>Picture 17 : Before and after treatment @HE Arc CR</i></p>

<p>15% in benzine 100/140</p>	<p>Soak, 2 seconds</p>	<p>Application</p> <p>+</p> <ul style="list-style-type: none">- Can penetrate the whole substrate- The application gives an even result- The fibres are not shifted <p>-</p> <ul style="list-style-type: none">- A drop of resin can take shape on the edge of the asbestos plate when removed from the soak, but can be easily removed <p>Resin concentration</p> <p>+</p> <ul style="list-style-type: none">- The surface keeps its matt finish <p>-</p> <ul style="list-style-type: none">- Asbestos appear darker and slightly brown- Fibres on the edges are well consolidated

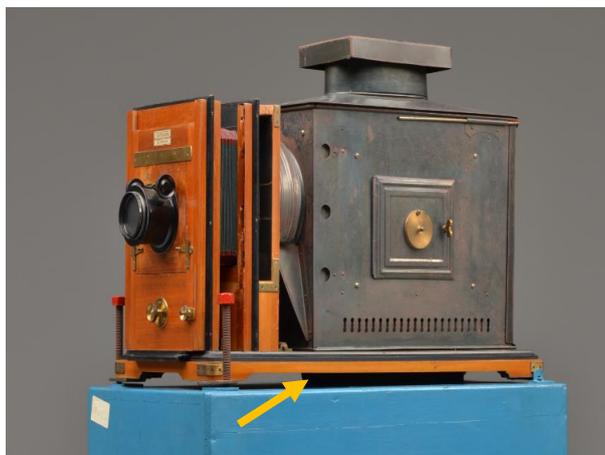
The textile in contact with asbestos fibres is stuck to the sliding plate under the lantern and avoid the entrance of light between the bottom of the lantern and the top of the wooden box. This small part of the textile is in contact with the atmosphere and can potentially release asbestos fibres.

Picture 19 : Localization of the contaminated textile in contact with the atmosphere @HE Arc CR, A.L

A textile contaminated with asbestos cannot be fully treated and must be packed to limit the release of fibres⁵⁶. The configuration of the piece of textile is complex here, as it is stuck to a part of the object. The aim of the intervention will be to vacuum clean the textile and limit the release of fibres from the small part of the textile in contact with the atmosphere.

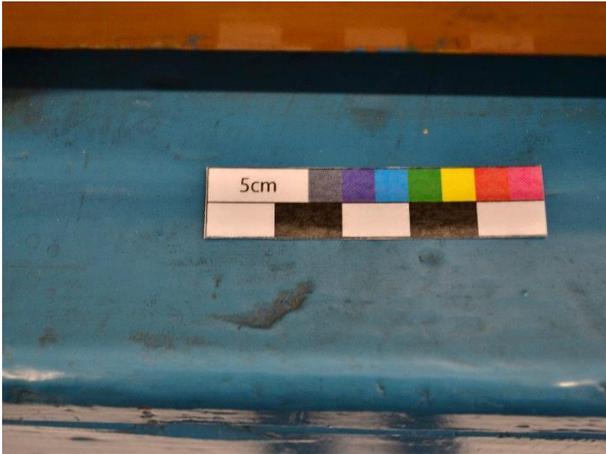
The wooden base of the lantern and the wooden box are both partly covered with a paint layer. They are covered with two types of soiling : dusty and soiling deposits (*Picture 26, Picture 29*) and stains generated by liquids or drops of repaint (*Picture 27, Picture 28*).

Picture 26 : Soiling of the blue paint ©HE Arc CR, A.L

A mechanical cleaning with a latex eraser has been tested on both types of deposits and has been considered efficient to mitigate the dusty soiling. On the contrary, stains and chemical deposits could not be mitigated.

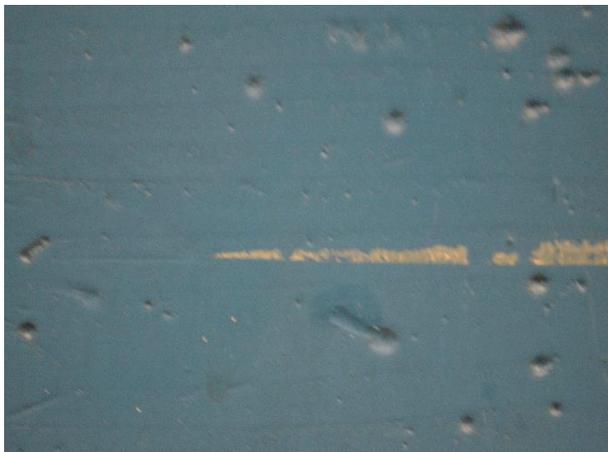
Figure 30 : White chalky deposit before cleaning
 ©HE Arc CR, A.L

It has not been buffered as the proteins buffer themselves around a pH of 7⁵⁹. However, it cleaned too deeply the white chalky deposits. The use of a scalpel allowed the removal of these deposits without an overcleaning of the painted surface around.

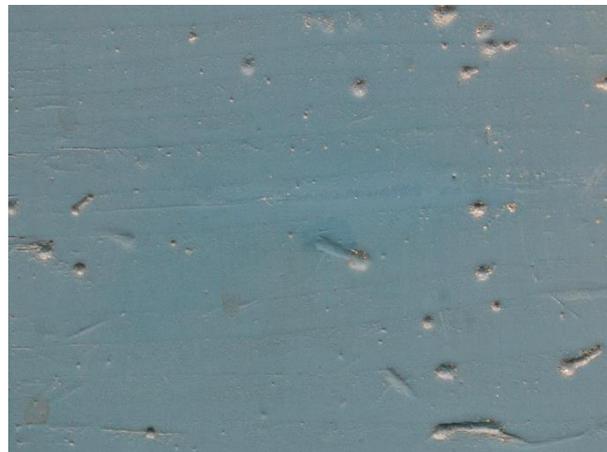
Figure 31 : Too deep cleaning test with Mucin
 ©HE Arc CR, A.L

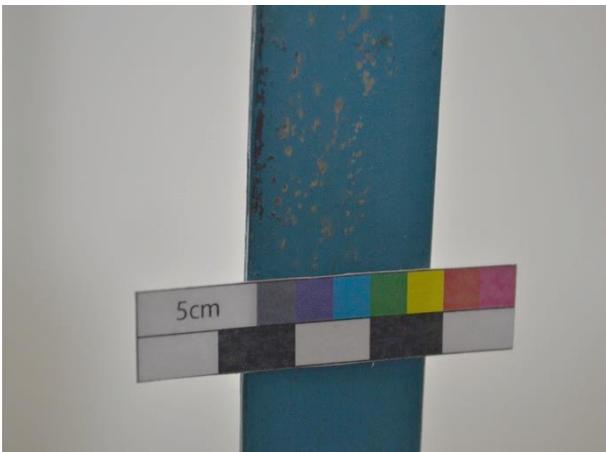
Two constitutive parts of the lantern made of painted steel are covered with two types of soiling : dusty and soiling deposits and stains generated by liquids or repaint (*Picture 34, Picture 35*). the structure carrying the wooden box (*Picture 32*), and the base of the light source (*Picture 33*).

Picture 34 : Soiling and repaint stains ©HE Arc CR, A.L

As for the painted surface of the wooden box, a mechanical cleaning with a latex eraser allowed the cleaning of dusty deposits. Deionised water with 2 drops of the surfactant Brij L4 buffered with HCl at a pH of 7 permitted the mitigation of the soiling from the surface. A combination of the application of the solution of artificial saliva in deionised water and the mechanical action of the scalpel allowed the removal of repaint stains.

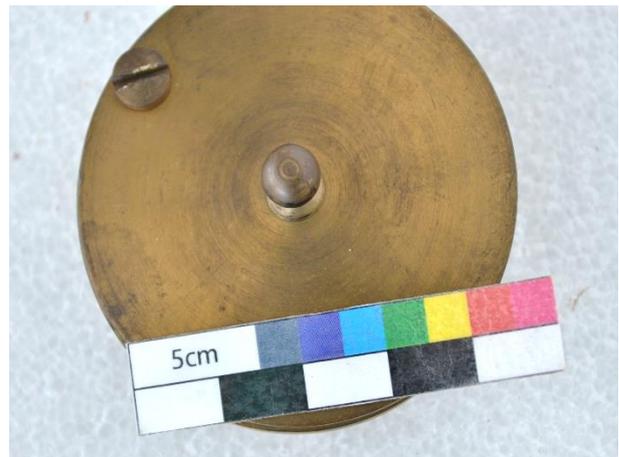
Several decorative and mechanical elements of the object are made of brass. All of them are concerned by a generalized soiling (*Picture 36, Picture 37*).

Picture 37 : Soiling of a peephole ©HE Arc CR, A.L

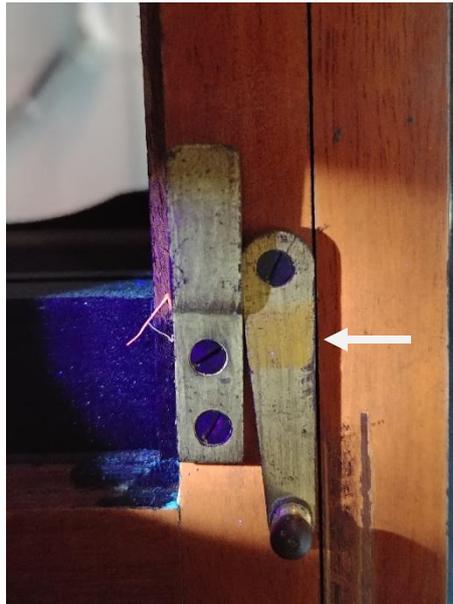
Each brass element has been observed under UV light in order to determine if they are covered with a varnish. A few remains of varnish were observed, mainly on hidden areas (*Picture 38*). The fluorescence being orange, shellac* was suspected, as it was frequently used on scientific and technical objects from the 18th to the 20th century. A mechanical cleaning with a latex eraser has first been tested and a non-polar solvent has been tried to avoid the removal of this varnish.

Picture 38 : Remains of varnish on a hidden area ©HE Arc CR, A.L

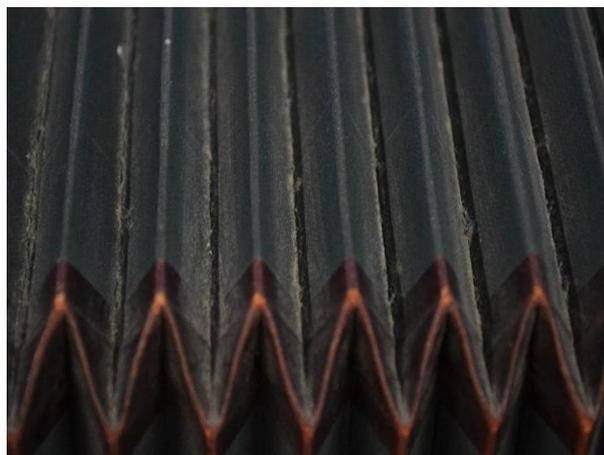
The gusset of the lantern, made of coated paper, is entirely covered with powdery soiling (*Figure 39*).

Figure 39 : Powdery soiling at the surface of the gusset ©HE Arc CR, A.L

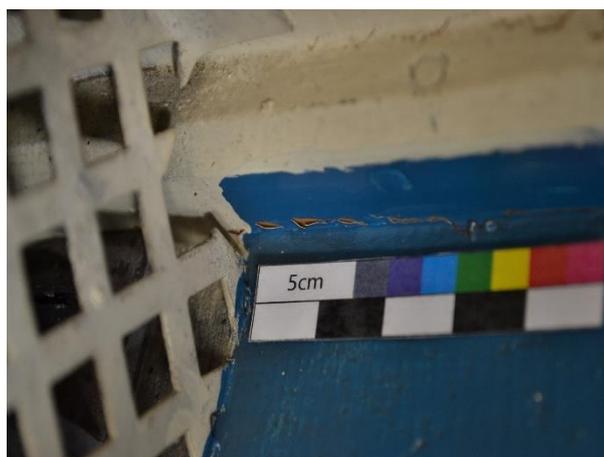
Some liftings of the painting are visible in the wooden box, on the right side, in front of the transformer (*Picture 40*).

Picture 40 : Lifting of the paint inside the wooden box ©HE Arc CR, A.L

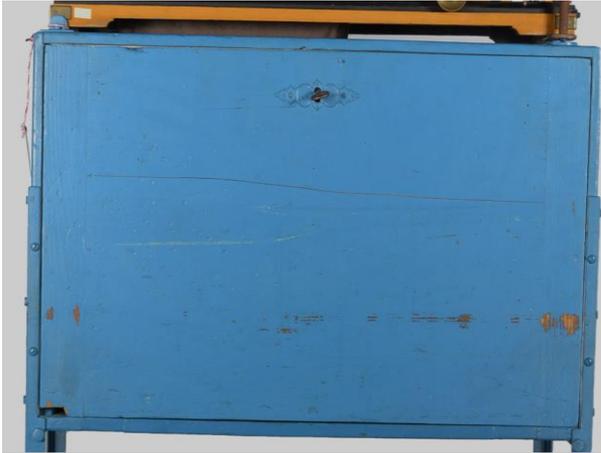
Some losses on the door of the wooden box are extremely noticeable on the door of the wooden box, as their colour is way clearer than the losses nearby. A mitigation of these losses is requested. The painting is sensitive to alcohols (*Picture 41, Picture 42*).

Picture 41 : Localization of the losses

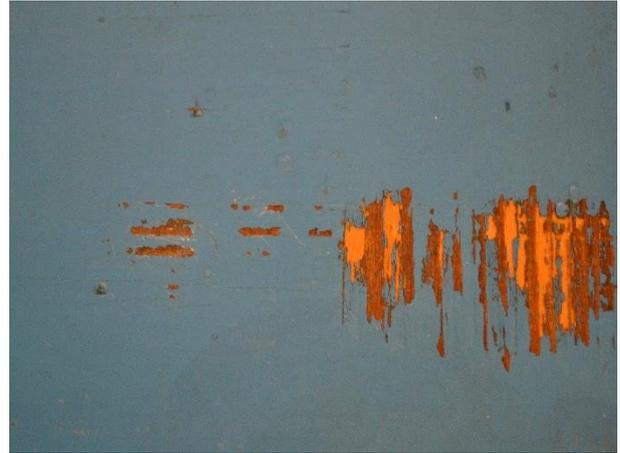
Picture 42 : Detail of the losses

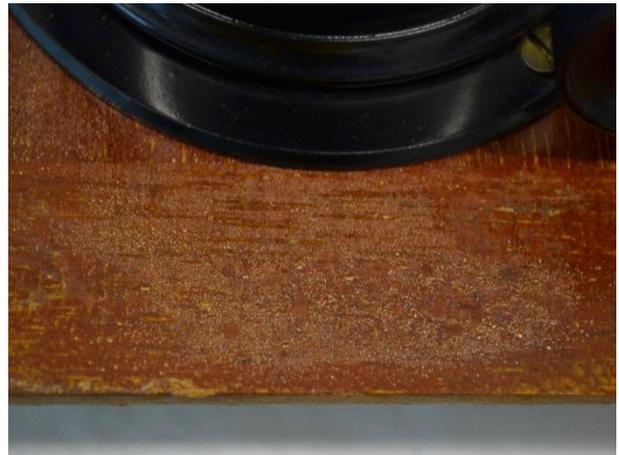
The lens carrier at the front of the lantern (*Picture 43*) is covered with a lifted varnish (*Picture 44*), causing a difference of perception of its initial colour as air is located in between the wood medium and the varnish. The aim is to resettle the varnish on its surface. A small area of the top of the wooden structure of the lantern is also concerned with this issue (*Picture 45*).

*Picture 44 : Detail of the lifted varnish
©HE Arc CR, A.L*

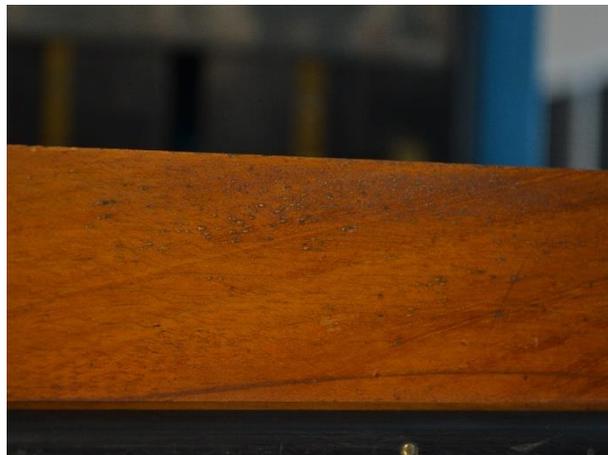
*Picture 45 : Detail of the lifted varnish at the top of the
wooden structure ©HE Arc CR, A.L*

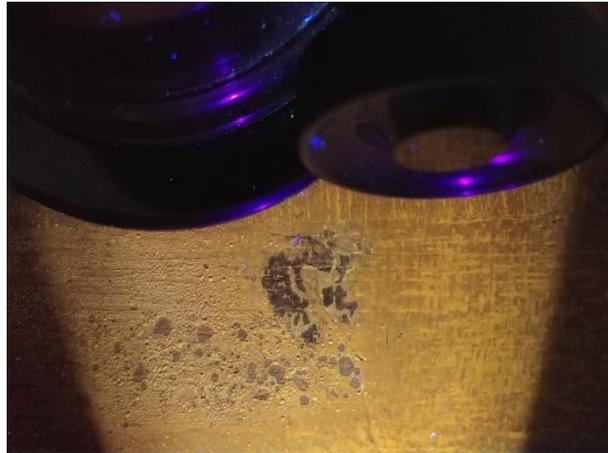
An observation under ultraviolet light of the varnish has been achieved to determine the nature of the varnish. An orange fluorescence has been observed (*Picture 46*). We suspect a natural shellac varnish, as for the brass elements of the object (II.2.4.2).

Picture 46 : Ultraviolet fluorescence of the varnish of the lens carrier ©HE Arc CR, A.L

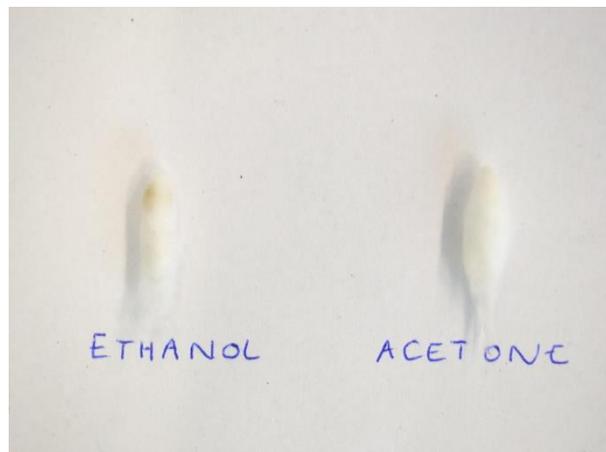
The solubility of the varnish has also been tested. While it is soluble in ethanol, it is not sensitive to acetone (*Figure 47*).

Figure 47 : Solubility of the varnish of the lens carrier in ethanol and acetone ©HE Arc CR, A.L

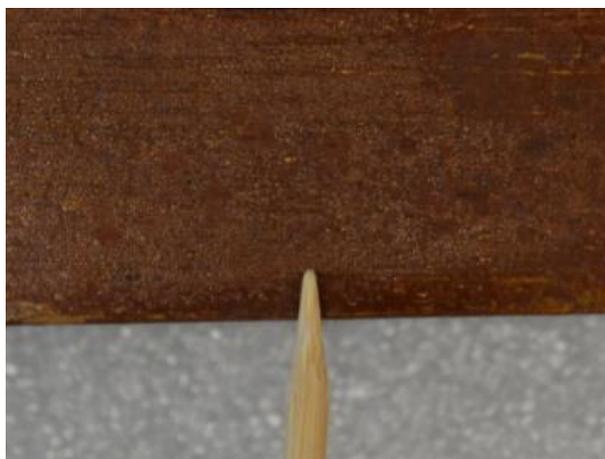
A test with the first method combining ethanol, a Mylar® sheet and a cotton swab has been carried out on a small varnished area. The method reduces the irregularities of the varnished surface but didn't resettle the varnish on the wood (*Picture 48*).

Picture 48 : Test of resettling of the varnish with ethanol and Mylar® film ©HE Arc CR, A.L

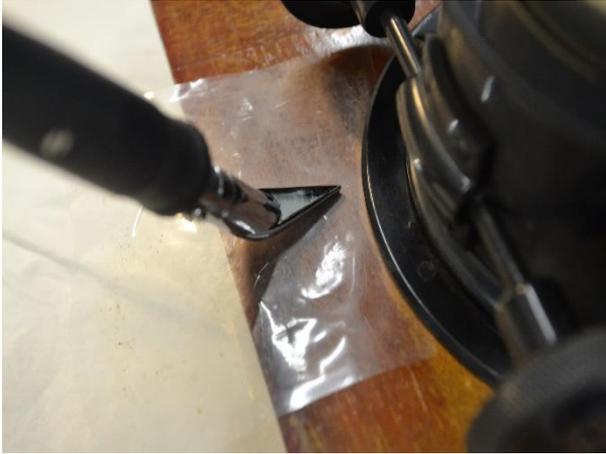
Picture 49 : Resettling of the varnish with a heat spatula ©HE Arc CR, A.L

The second method implying the use of Mylar® film and a heat spatula has been tested starting at a temperature of 60°C (*Picture 49*). The heat spatula was leaved a few seconds on the Mylar® to localize the heating and allow the varnish to reactivate. Then, the spatula was gently rubbed from left to right on the surface to allow the varnish to resettle. A temperature of 130°C was satisfying to resettle the varnish (*Picture 50*).

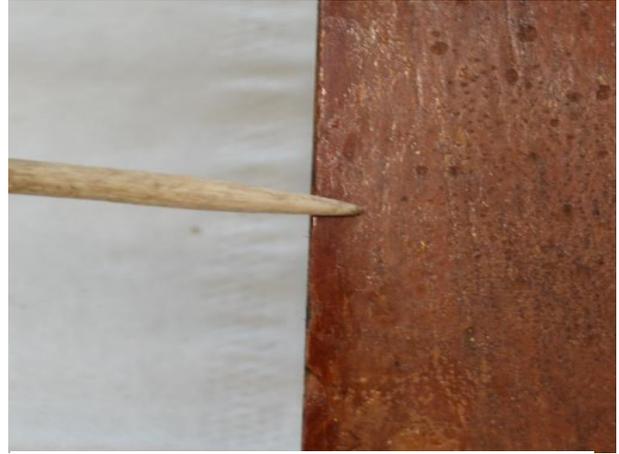
Picture 50 : After testing the resettling of the varnish with a heat spatula ©HE Arc CR, A.L

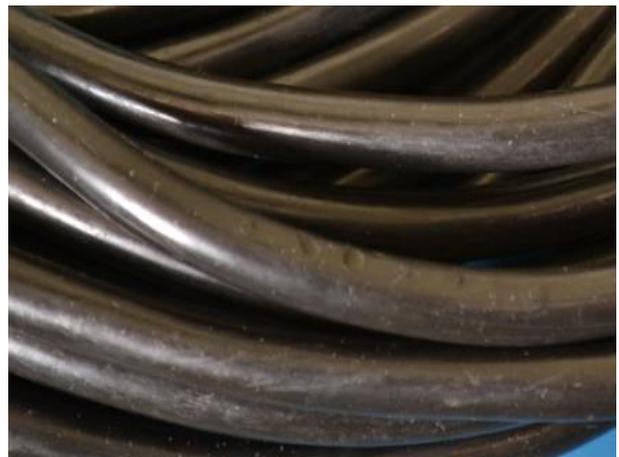
The power cable of the object (*Picture 51*) is made of poly vinyl chloride (PVC) plasticized with phthalate. Ancient flexible PVC are generally very unstable chemically. Their plasticizer migrates at the surface, being sticky first and crystallising as bloom. Also, the loss of lubricant from the PVC (stearic acid) is common, as it is a very non-polar material in comparison with PVC. It results in the deposit of white crystals at the surface (*Picture 52*)⁶⁹.

Picture 52 : Blooms and accumulated dust on the PVC surface ©HE ARC CR, A.L

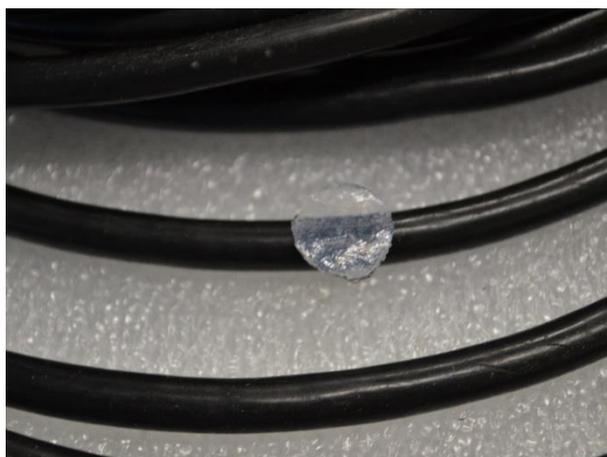
Picture 53 : Application of the Agar gel to measure pH and conductivity of the plastic ©HE Arc CR, A.L

pH and conductivity of the plastic have been measured to work in isotonic conditions on this sensitive material. A gel of Agar at 4% has been applied during 1 minute for this purpose (*Picture 53*). A pH of 6.84 and a conductivity of $\sim 200\mu\text{S}/\text{cm}$ have been measured. As the material is conductive, it should be possible to remove the blooms with water. Thus, a solution of deionised water with 2 drops of non-ionic surfactant buffered with HCl at a pH of 7 and a conductivity of $\sim 200\mu\text{S}/\text{cm}$ has been prepared as well as deionised water buffered at a pH of 7 for rinsing.

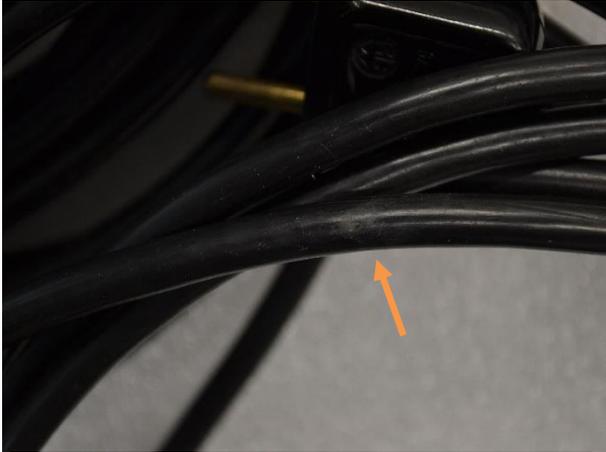
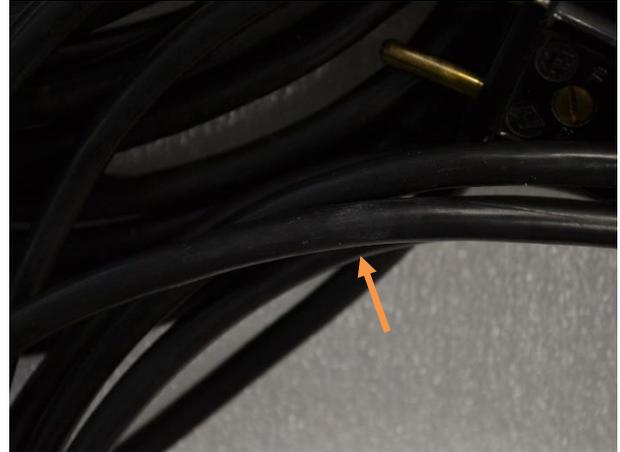
*Picture 54 : Blooms at the surface of the PVC cable
before testing ©HE Arc CR, A.L*

*Picture 55 : Surface of the PVC cable after testing
©HE Arc CR, A.L*

The cleaning test with a solution of deionised water with 2 drops of non-ionic surfactant buffered with HCl at a pH of 7 and a conductivity of $\sim 200\mu\text{S}/\text{cm}$ applied with a cotton swab allowed the removal of the bloom at the surface of the PVC (*Picture 54, Picture 55*). The deionised water rinsing solution buffered at a pH of 7 with NaOH has also been applied with a cotton swab, and dried with a soft paper.

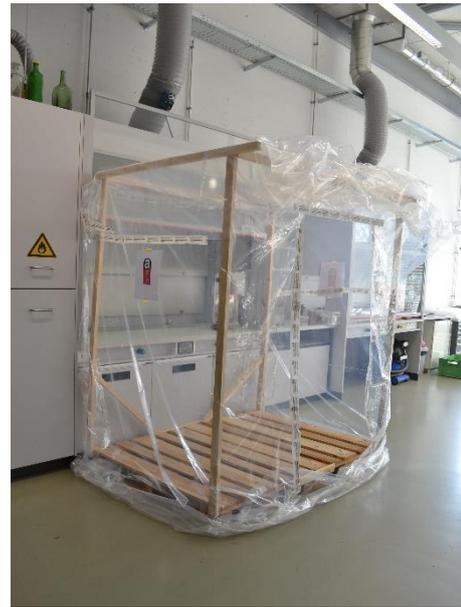
Picture 56 : General view of the semi-confined space ©HE Arc CR, A.L

In order to work in a safe space for all the collaborators, a semi-confined space has been created around the hood of the workshop in order to be able to dismantle the asbestos plates and vacuum clean the object in a safe area (*Diagram 1*). A tent has been built from 2 pallets, a made to measure wood structure and a double layer of polyethylene film fixed with staples and adhesive tape (*Picture 56*). It has been directly connected to the hood which is equipped with a H filter. A second layer of polyethylene film covers the opening at the front of the tent. Overpressure is limited as the air can flow at the bottom of the tent, under the pallets. The exhaust air of the Renggli AG hood was set at 720 m³/h. Asbestos signage has been displayed on the tent.

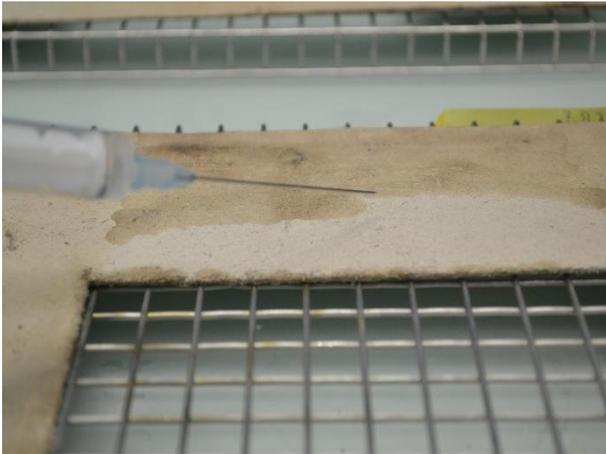
*Picture 59 : Covering of an asbestos plate by injection
(undried surface) ©HE Arc CR, A.L*

The covering of the asbestos plates has been achieved in the hood, on metal grids to allow their drying. They have been covered with a 10% Plexigum PQ611 resin in benzine 100/140. The flat surfaces were treated by injection with a syringe (Picture 59) and the edges by dropping a flat nylon brush on the surfaces (Picture 60). The injection has been carefully done drop by drop, by areas to allow an even drying of the adhesive. The collaborator was equipped with a P3 mask, protective glasses, a blouse and single use gloves.

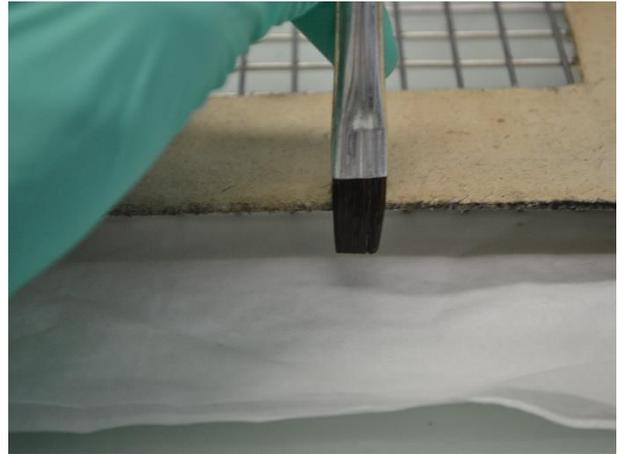
*Picture 60 : Covering of the edges of an asbestos
plate with a flat brush ©HE Arc CR, A.L*
