Blued steel sheets : history, manufacturing and conservation.

The case of a Ganz & Co projection and enlargement lantern
conserved at the Collection Centre of the Swiss National Museum.

Master of Arts HES-SO in Conservation-restoration
Specialized in scientific, technical and horological objects

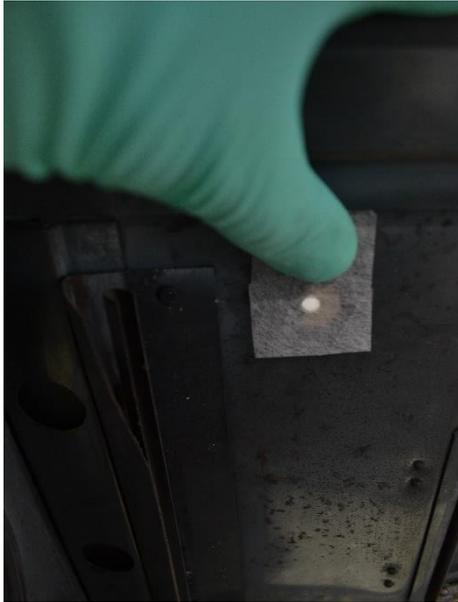
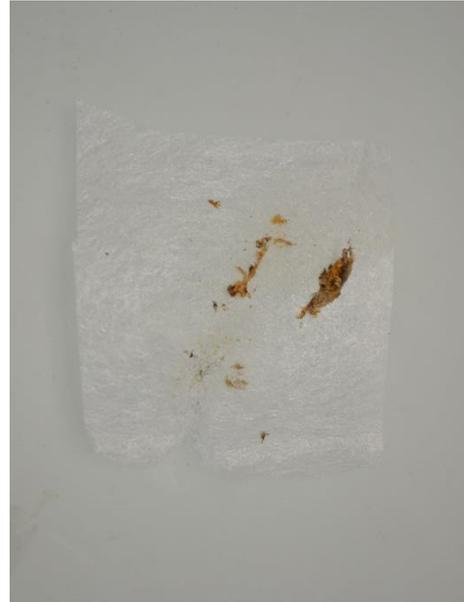
The screw threads allowing the settling of the asbestos plate and the holes welcoming the peepholes has amounts of asbestos fibres stuck on these areas, because of the mechanical constraint of the mounting. It has been decided to remove these amounts of fibres to secure the reassembly of the object for the collaborator and also for further dismantling in the future.

Picture 61 : Non-woven fabric applied on the surface covered with asbestos ©HE Arc CR, A.L

Picture 62 : After the deposit of the bunch of asbestos fibres ©HE Arc CR, A.L

A method has been developed to achieve this issue. A non-woven fabric has been placed against the surface of the object and 10% Plexigum PQ611 resin in benzine 100/140 has been injected through the fabric to trap the asbestos fibres (*Picture 61*). The fabric has then been carefully removed from the surface and a scalpel could be used to help placing the consolidated bunch of asbestos fibres on it if necessary. The fabric covered with asbestos was then re-injected with adhesive to ensure that the fibres will stay on the medium and put in the specific waste bag (*Picture 62*).

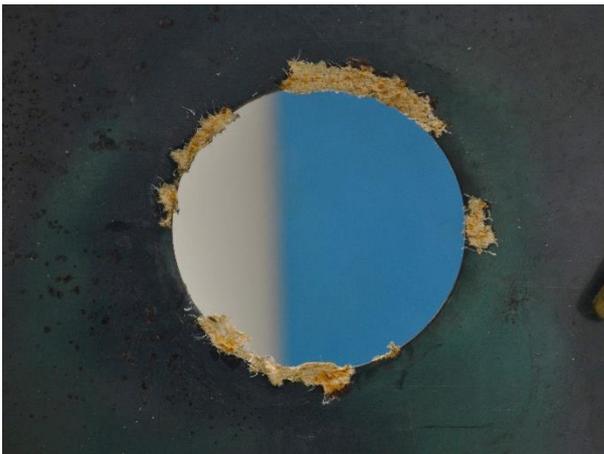
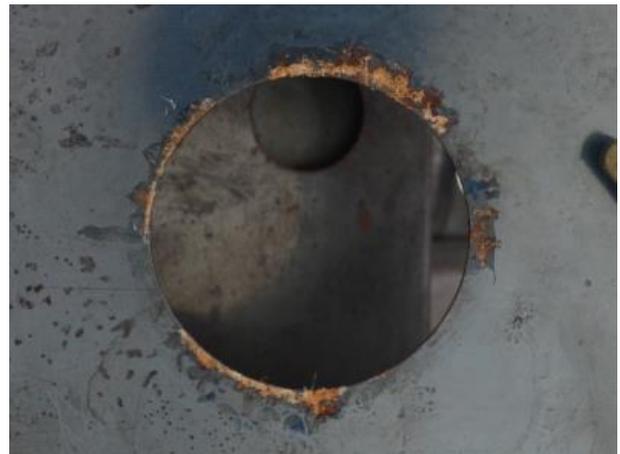
Picture 63 : Before mitigating the bunch of asbestos on the peephole ©HE Arc CR, A.L

Picture 64 : After mitigating the bunch of asbestos on the peephole ©HE Arc CR, A.L

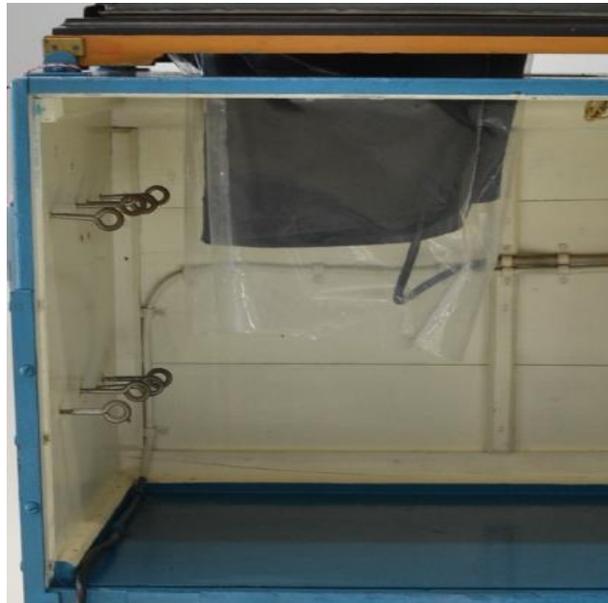
Picture 65 : Polyethylene packaging fixed with magnets to limit the release of asbestos fibres between the lantern and the wooden box ©HE Arc CR, A.L

Concerning the contaminated textile, after a careful vacuum cleaning, a made to measure polyethylene packaging has been sewn with nylon thread (*Picture 65*). Both materials have been chosen for their inert and stability characteristics. It has been fixed to the bottom of the sliding plate of the lantern with 4 thin magnets to limit the release of asbestos fibres between the lantern and the wooden box. The bottom of the packaging had to be left opened as the socket carrying the light bulb of the lantern goes through the textile. A collaborator who would like to open the door of the wooden box or of the lantern should then wear protection equipment as a P3 mask, a blouse, gloves and protective glasses, but the object could be exhibited this way in a showcase. Although, asbestos

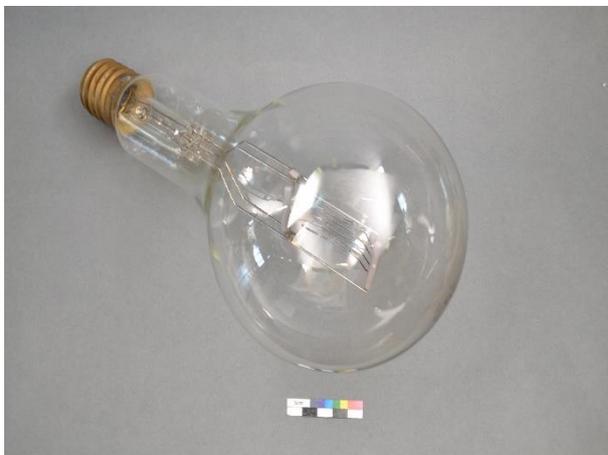
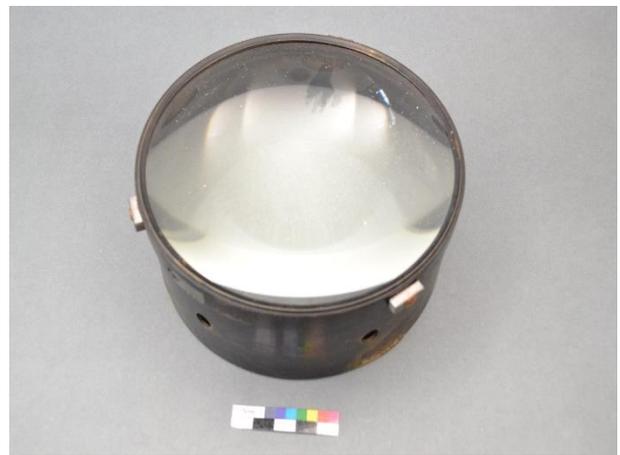
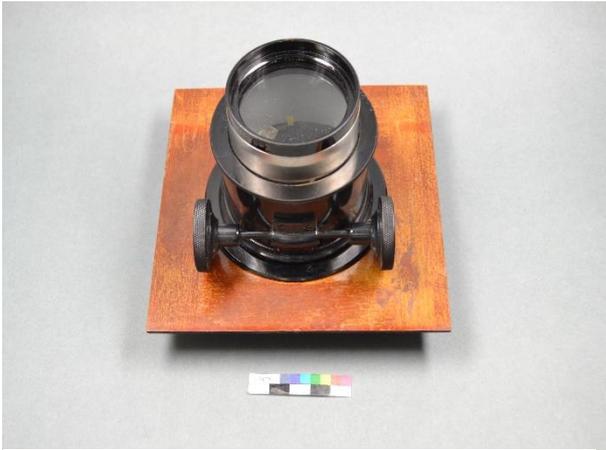
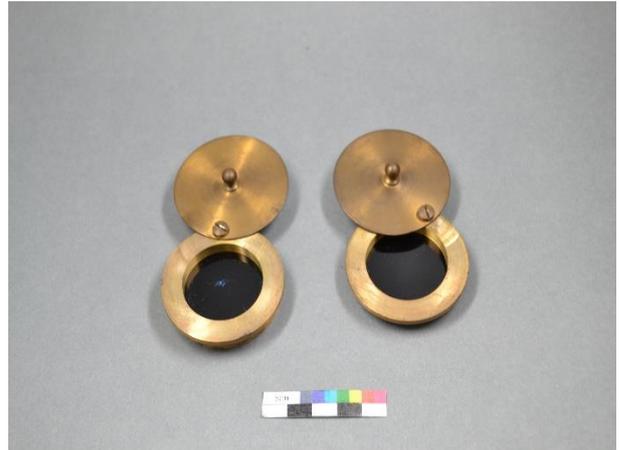
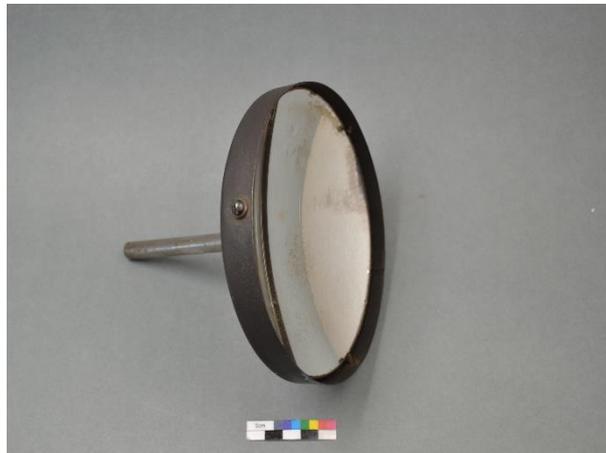
Picture 66 : Bulb after restoration ©HE Arc CR, A.L

Picture 67 : Lens after restoration ©HE Arc CR, A.L

Picture 68 : Emil Busch A.G lens after restoration

Picture 69 : Peepholes after restoration

Picture 70 : Condenser after restoration

Deionised water applied with a cotton swab has been used to mitigate the soiling on glass objects. A soft paper removed the excess of water on the glass surface (*Picture 66, Picture 67, Picture 68, Picture 69, Picture 70*).

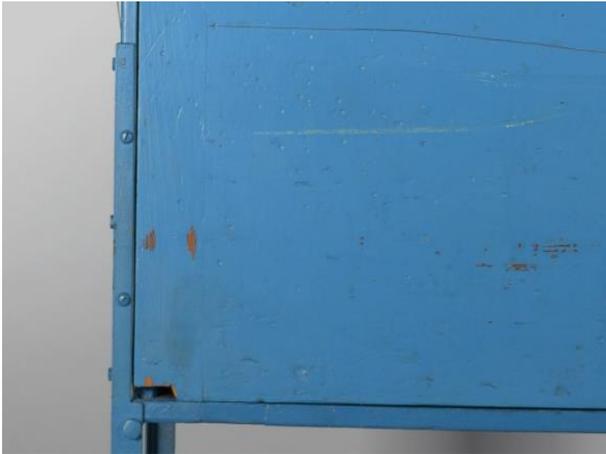
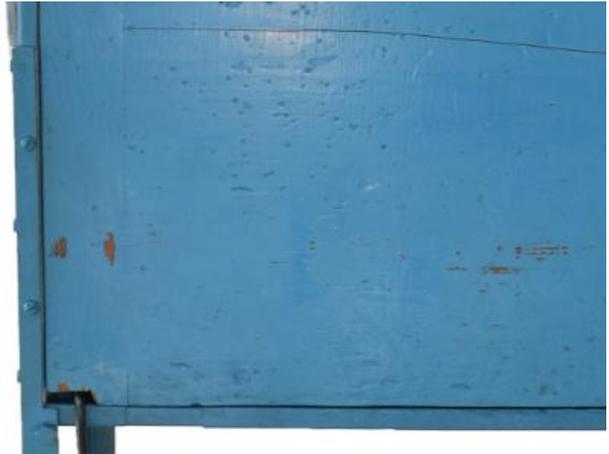
Picture 71 : Painted wood before restoration
©HE Arc CR, A.L

Picture 72 : Painted wood after restoration
©HE Arc CR, A.L

Powdery deposits have been removed with a latex eraser, while the mitigating of the soiling has been carried out with a solution of deionised water with 2 drops of non-ionic surfactant Brij L4 buffered with HCl at a pH of 7 with a cotton swab. The white chalky deposits have been removed with a scalpel while the surface was wet. A rinsing has been performed with deionised water buffered with NaOH at a pH of 7 with a cotton swab. The deposits in the irregularities of the painted wood have been mitigated with a solution of deionised water and artificial saliva (Mucin). A soft paper has been used to absorb the excess of water on the surface (*Picture 71, Picture 72*).

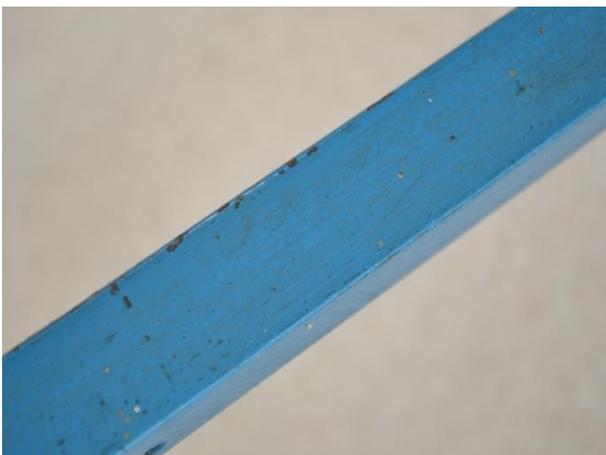
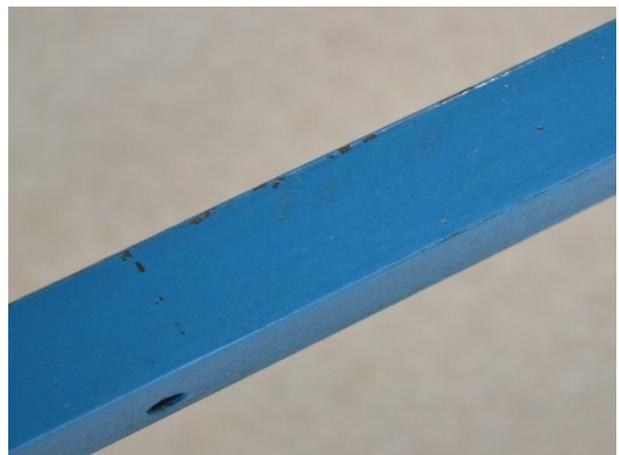
Picture 73 : Painted metal before restoration
©HE Arc CR, A.L

Picture 74 : Painted metal after restoration
©HE Arc CR, A.L

As for the painted surface of the wooden box, a mechanical cleaning with a latex eraser allowed the cleaning of dusty deposits on the metallic structure of the object. A cotton swab with deionised water with 2 drops of the surfactant Brij L4 buffered with HCl at a pH of 7 permitted the mitigation of the soiling from the surface. It has then been rinsed with a cotton swab and deionised water buffered with NaOH at a pH of 7. A combination of the application of the solution of artificial saliva in deionised water and the mechanical action of the scalpel allowed the removal of repaint stains (*Picture 73, Picture 74*).

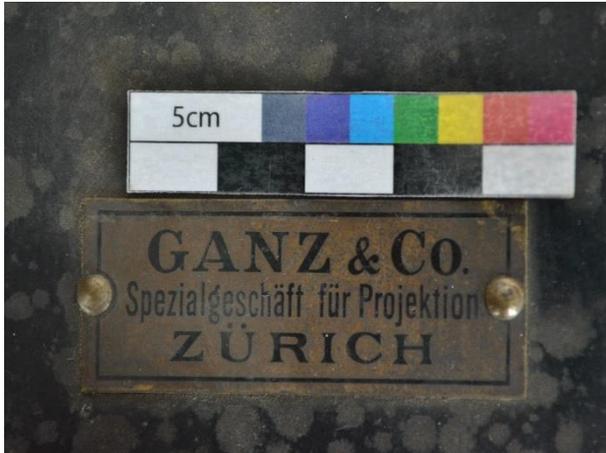
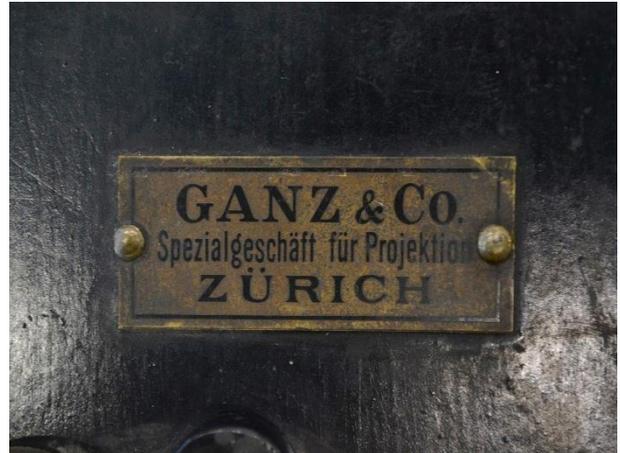
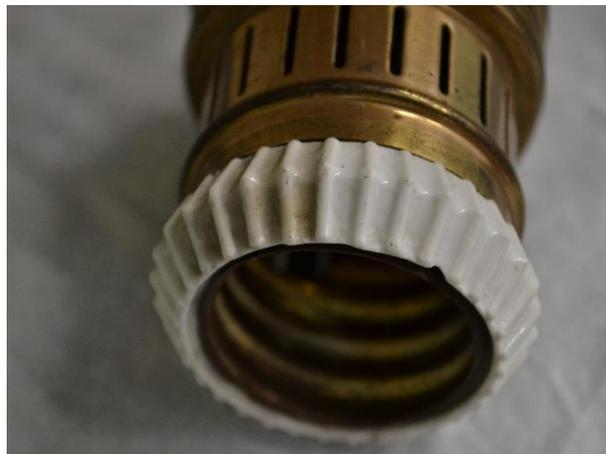
Picture 75 : Base of the light source before restoration

Picture 76 : Base of the light source after restoration

Picture 77 : Before and after cleaning of a ceramic element ©HE Arc CR, A.L

On the base of the light source and on ceramic, a soft cleaning with a latex eraser permitted the reducing of the dusty soiling. A cotton swab with deionised water allowed the removal of the halos from the surface. The materials were then carefully dried with a soft paper (*Picture 75, Picture 76, Picture 77*).

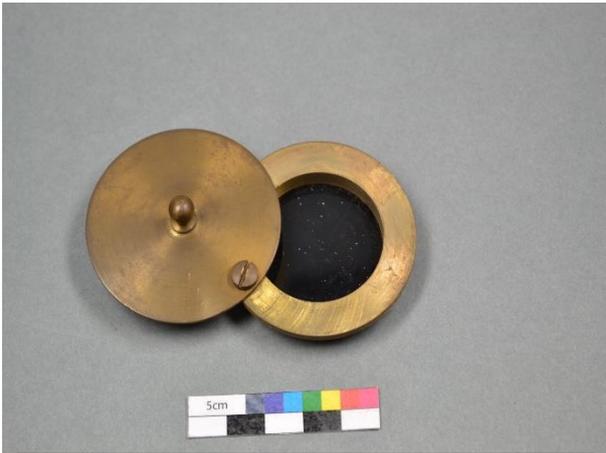
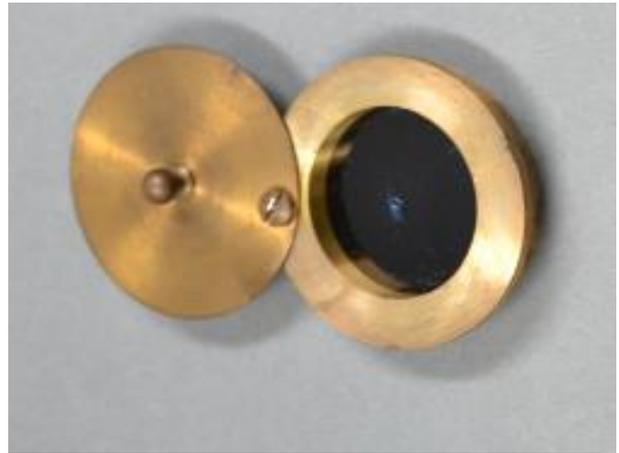
Picture 78 : Copper element before restoration
©HE Arc CR, A.L

Picture 79 : Copper element after restoration
©HE Arc CR, A.L

A mechanical removal of the dusty deposits has been carried out with a latex eraser and the degreasing of the copper pieces has been achieved with a cotton swab and Shellsol T. A soft paper has been used to absorb the surplus of solvent (*Picture 78, Picture 79*).

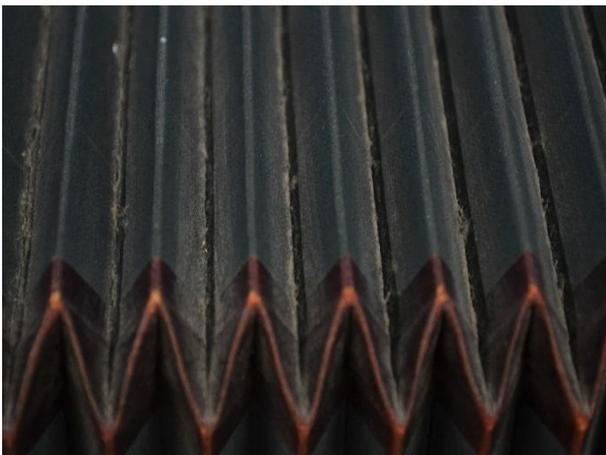
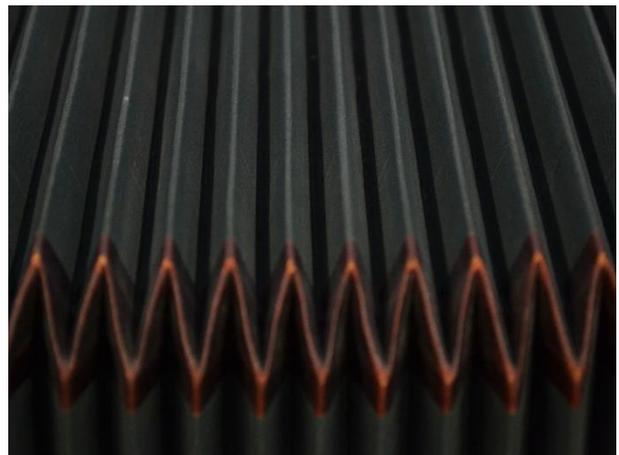
Picture 80 : Coated paper before restoration
©HE Arc CR, A.L

Picture 81 : Coated paper after restoration ©HE Arc
CR, A.L

A combination of vacuum cleaning and a slight brushing with a nylon brush allowed the cleaning of the dust and powdery deposits on the coated paper (*Picture 80, Picture 81*).

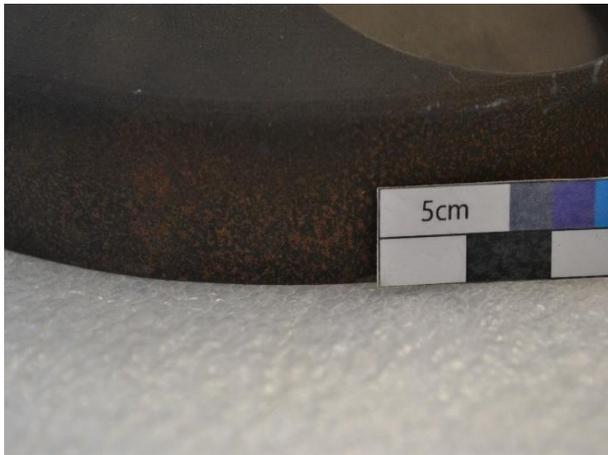
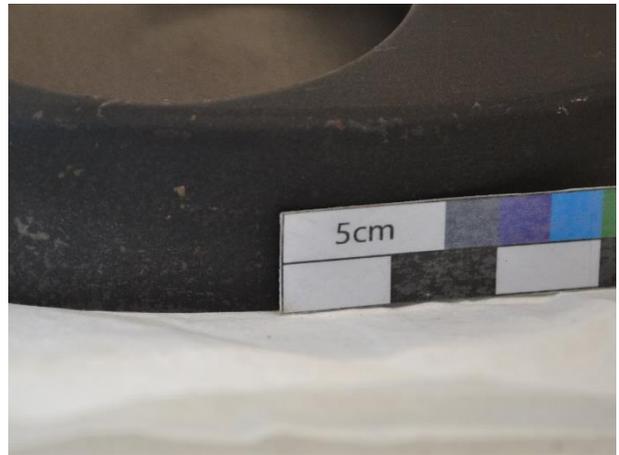
Picture 82 : Corroded painted surface of the condenser before restoration ©HE Arc CR, A.L

Picture 83 : Painted surface of the condenser after restoration ©HE Arc CR, A.L

The corrosion products on painted or galvanised surfaces have been mitigated with the same method than the protocol used on blue steel. Steel wool 000 has been carefully rubbed on the surfaces. An eraser as then been used to remove the corrosion products (*Picture 82, Picture 83*).

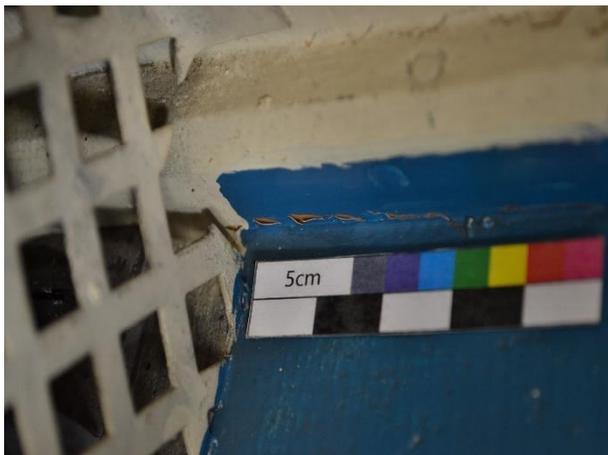
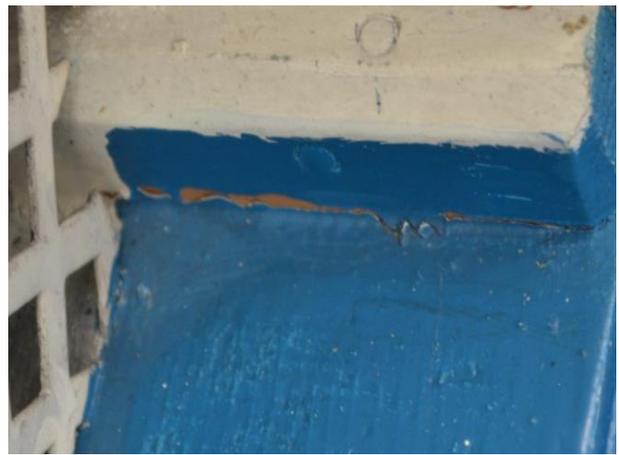
Picture 84 : Paint lifting before restoration ©HE Arc CR, A.L

Picture 85 : Paint after restoration ©HE Arc CR, A.L

The paint liftings have been consolidated with 1% jun-funori in deionised water. A sheet of Mylar paper and a weight were installed on the surface to ease the bonding (*Picture 84, Picture 85*).

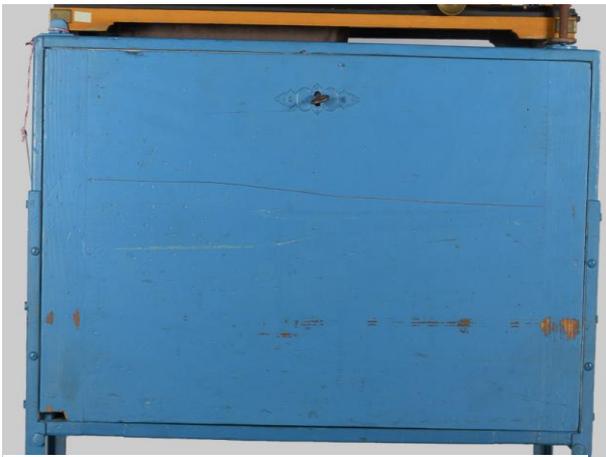
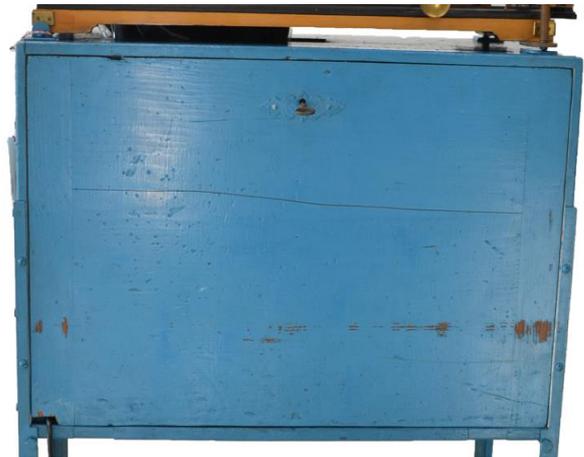
Some areas on the door of the wooden box show losses of the original paint and wood : these are quite pronounced in comparison with the rest of the surface. In order to mitigate this difference, Gamblin colours® in Laropal A81 have been used. The colours have been reactivated with Shellsoll A and a first layer of white painting has been applied on the losses as a preparation layer. A colour with a tone lighter to those of the wooden door has then been applied.

Picture 86 : Door of the wooden box before cleaning and retouching ©HE Arc CR, A.L

Picture 87 : Door of the wooden box after cleaning and retouching ©HE Arc CR, A.L

This retouching is retreatable as a hydrocarbon solvent as Shellsol A can be used to remove the layer without damaging the original painting, which is sensitive to alcohols (*Picture 86, Picture 87.*

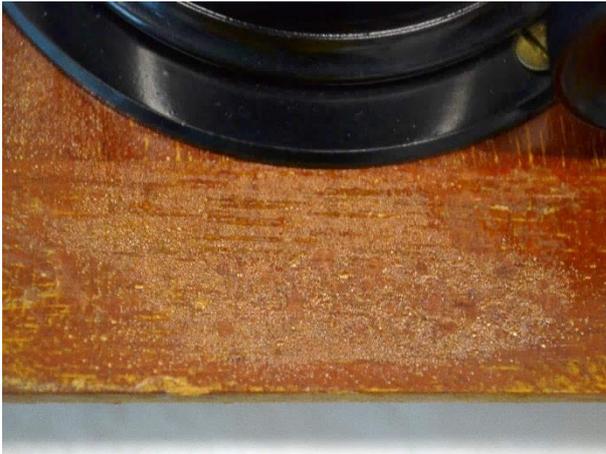
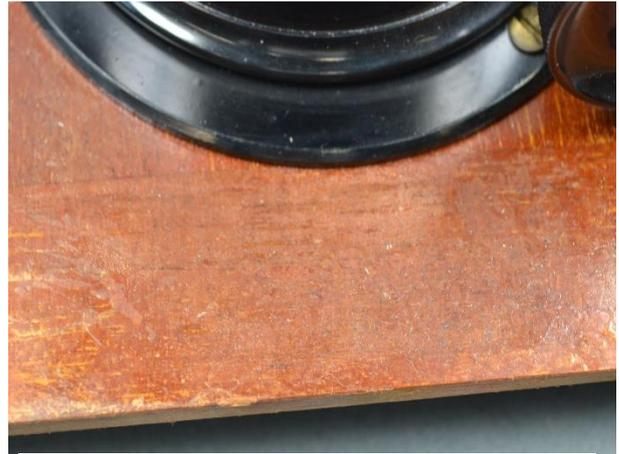
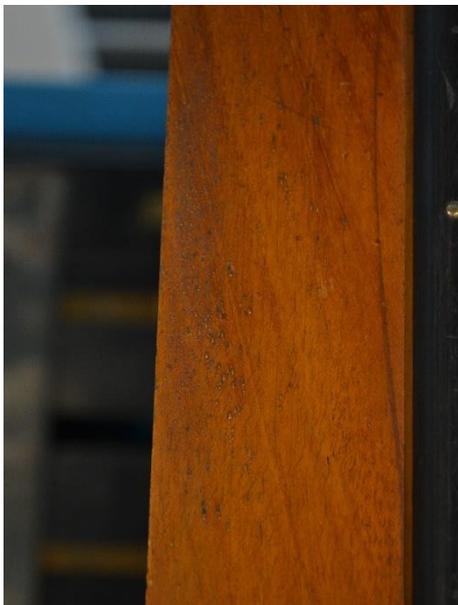
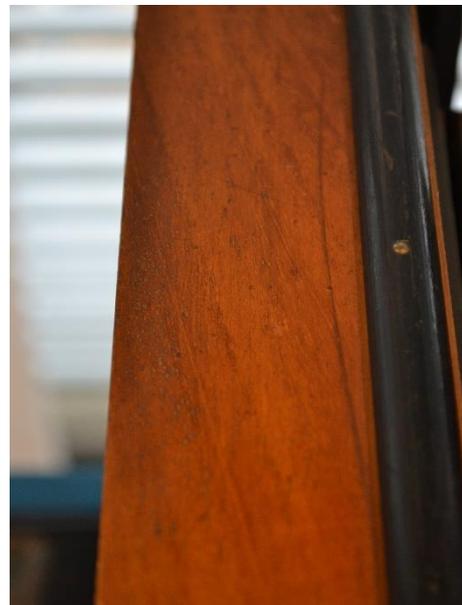
Picture 88 : Surface of the lens carrier before restoration ©HE Arc CR, A.L

Picture 89 : Surface of the lens carrier after restoration ©HE Arc CR, A.L

Picture 90 : Surface of the wooden base of the lantern before restoration ©HE Arc CR, A.L

Picture 91 : Surface of the wooden base of the lantern after restoration ©HE Arc CR, A.L

In order to resettle the lifted and reticulated varnish on the surface of the wood, a Mylar® film has been placed between the surface and a heat spatula at a temperature of 130°C. The heat spatula was leaved a few seconds on the Mylar® to localize the heating and allow the varnish to reactivate. Then, the spatula was gently rubbed from left to right on the surface to allow the varnish to resettle (*Picture 88, Picture 89, Picture 90, Picture 91*).

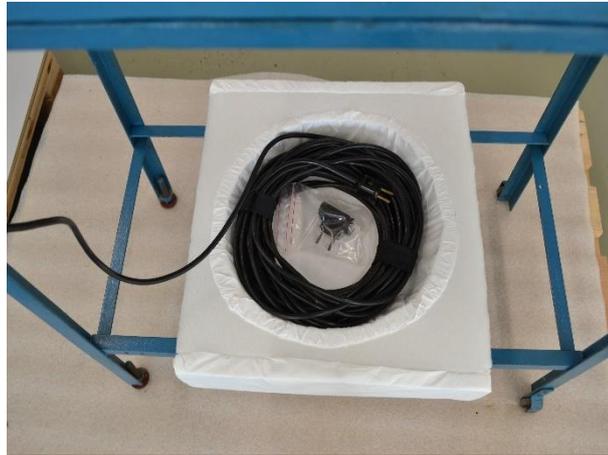
Also, as the cable disseminates a strong smell due to the degradation of PVC, it has been decided to conserve the cable outside of the wooden box, to avoid its accumulation inside, while a collaborator

would open the door of the box. Stearic acid, which is a fatty acid used as a lubricant from the PVC, is a non-toxic material. Its only issue is that it is combustible⁷¹, which is not an issue for its conservation in a museum storage. A packaging covered with Tyvek has been created to be placed on the metallic structure of the object, in order to be able to shift the object easily (*Picture 92*).

Picture 92 : Packaging of the PVC cable ©HE Arc CR, A.L

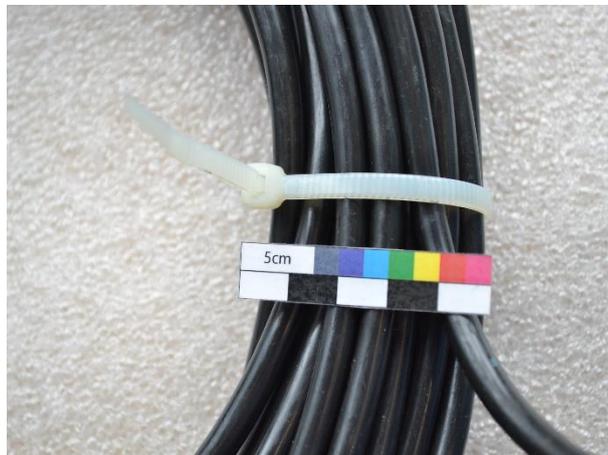
Picture 93 : Plastic tie damaging the plastic cable ©HE Arc CR, A.L

The plastic tie gathering the cable together (*Picture 93*) has been cut and replaced by 2 made to measure cotton and Velcro removable ties (*Picture 94, Picture 95*). An Oddy tested black cotton has been used for this purpose. This set up will allow an easy displacement of the cable.

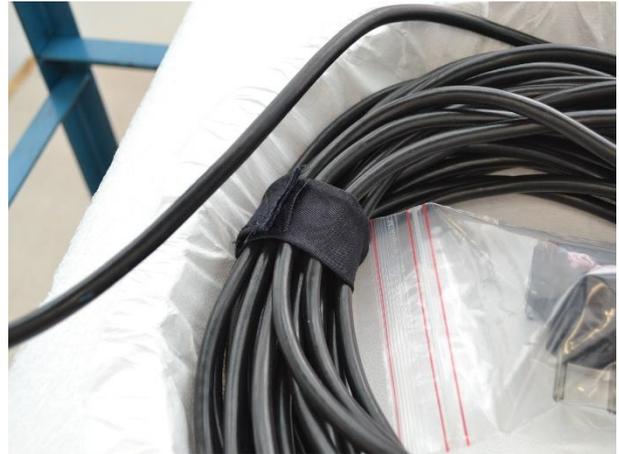
Picture 95 : Cotton and Velcro tie on the object
©HE Arc CR, A.L

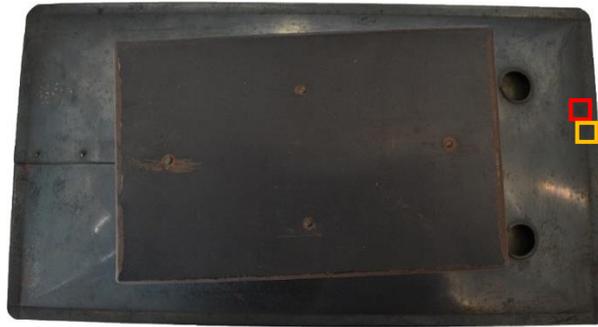
Two samples have been collected on the object : one from the red corrosion products, and another from the black corrosion products (*Picture 106*).

Picture 106 : Localization of the samples of the red corrosion products (red square) and the black corrosion products (orange square) ©HE Arc CR, A.L

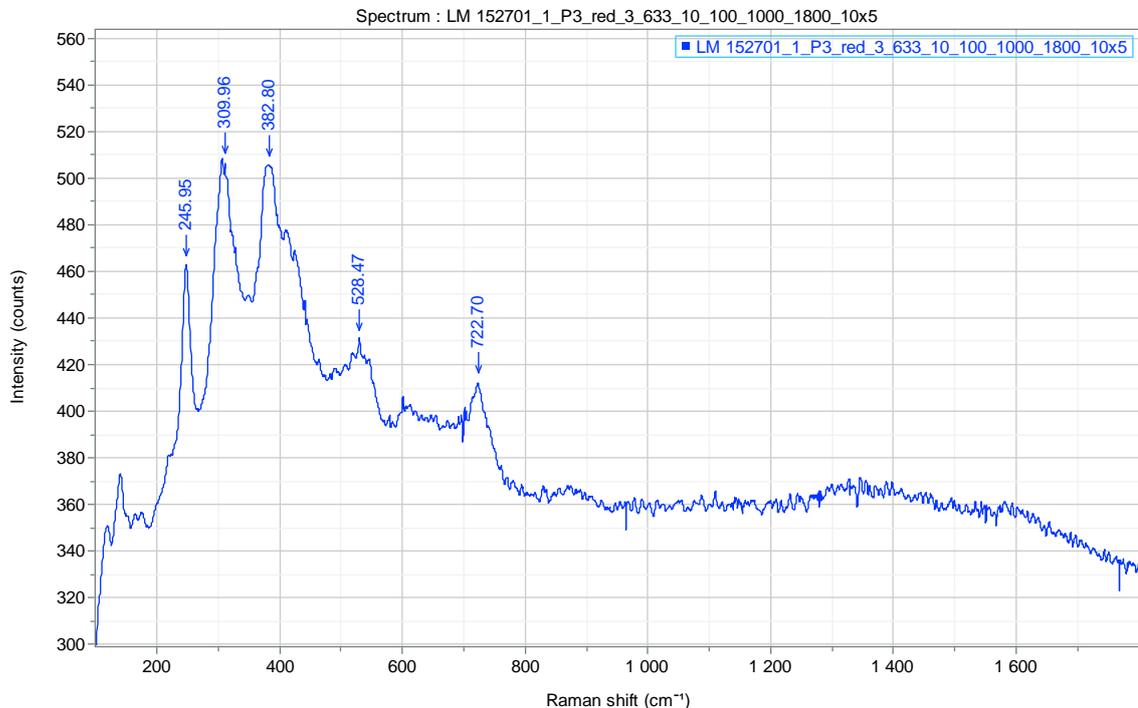
Literature evokes two main peaks around 310 and 386 cm^{-1} for akaganeite. A peak at 725 cm^{-1} is also documented⁸⁰. The spectrum on *Picture 107* is distinctly characterized by three peaks 309, 382 and 722 cm^{-1} corresponding to akaganeite.

Picture 107 : Raman spectrum of the P3 sample, third measurement, confirming the presence of akaganeite ©HE Arc CR, A.L

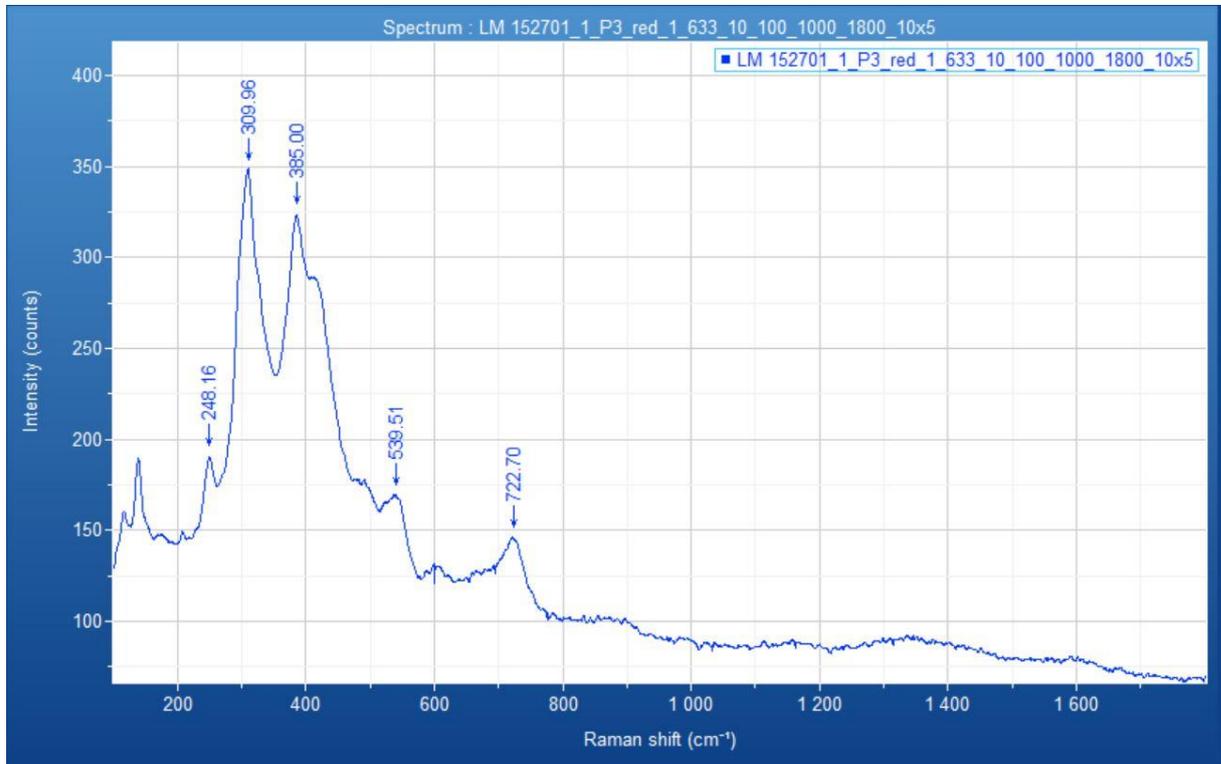
Also, lepidocrocite has also been identified with Raman spectroscopy on this sample. The peaks on the spectrum of the *Picture 108* reach 248 and 385 cm^{-1} and literature evokes peaks at 252 and 380 cm^{-1} for this corrosion product⁸¹.

Picture 108 : Raman spectrum of the P3 sample, first measurement, announcing the presence of lepidocrocite
©HE Arc CR, A.L

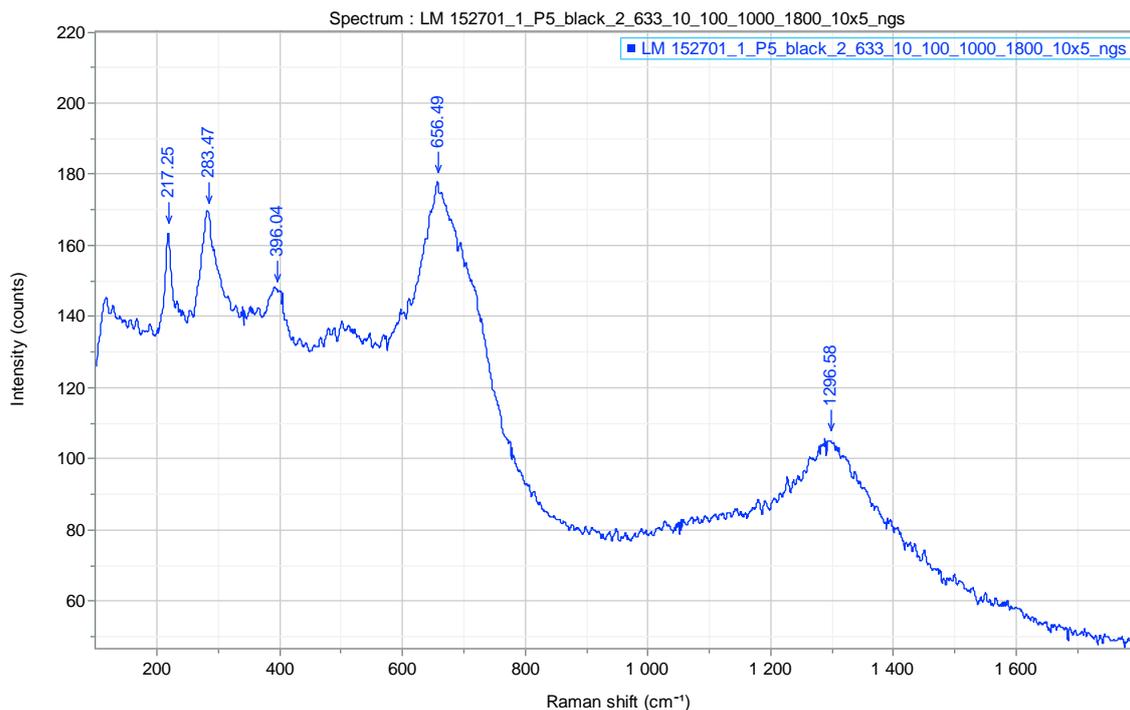
The spectrum on *Picture 109* shows two distinctive peaks at 217 and 283 cm^{-1} . In the literature, the peaks of hematite are defined around 225 and 295 cm^{-1} . A third peak is also characteristic at 413 cm^{-1} ⁸²but it is not that clear on the spectrum of the sample, where a peak at 396 cm^{-1} is visible.

Picture 109 : Raman spectrum of the P5 sample, second measurement, raising the presence of hematite and magnetite ©HE Arc CR, A.L

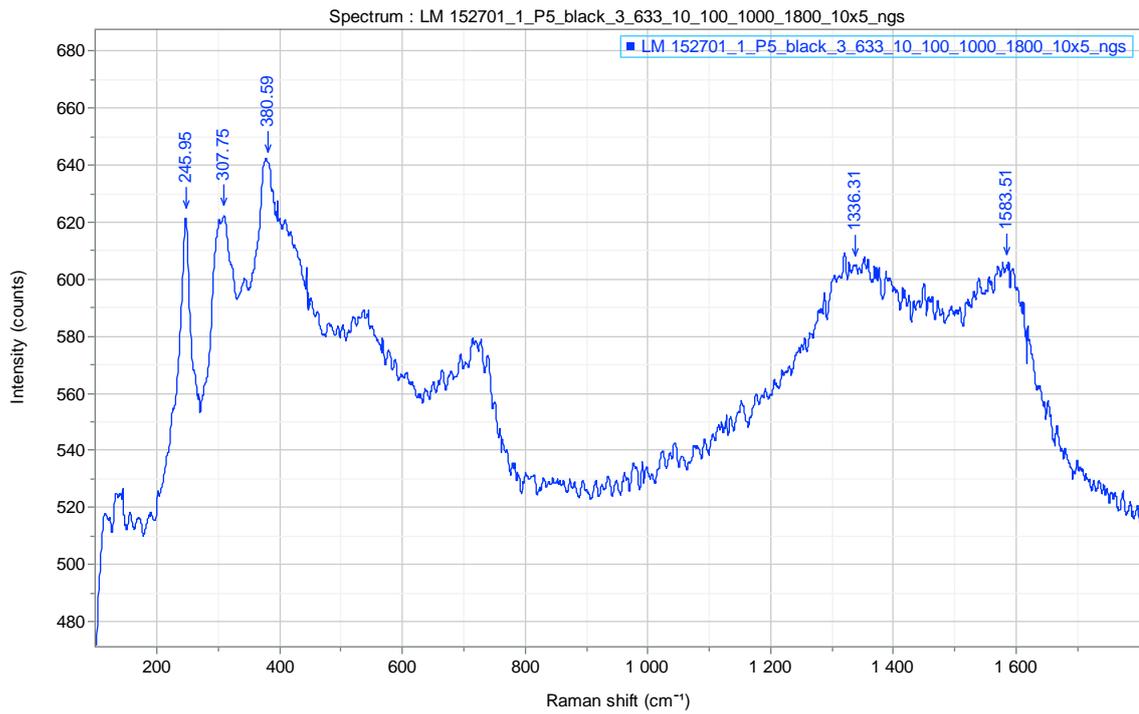
Besides, the spectrum on *Picture 110* raises the presence of goethite, with a peak at 380 cm^{-1} . In literature, the main peak of goethite is located around 385 and 397 cm^{-1} ⁸⁴.

Also, two significant peaks attaining 1336 and 1583 cm^{-1} correspond to furnace black (1346 - 1399 cm^{-1} and 1587 - 1592 cm^{-1} in literature⁸⁵). Furnace black, which is also known as "carbon black" is a material obtained by the incomplete combustion of organic materials as oils, resins, natural gas, wood or bone as well as petroleum products⁸⁶. Several hypotheses can be formulated about this result. The light source of the object may have been an oil (*Picture 112*) or petroleum lamp (*Picture 111*) in the past : light sources of this type were commercialised by Ganz & Co in 1920 to equip the lanterns. But the Rigi model which resembles the object of this study was only commercialised with an arc lamp (*Picture 113*) or an electric incandescent lamp⁸⁷. The most likely hypothesis is that charcoal, which is made of carbonized wood, has been used as a combustible on the previous arc lamp, diffusing furnace black on the object.

Picture 110 : Raman spectrum of the P5 sample, third measurement, raising the presence of goethite and furnace black

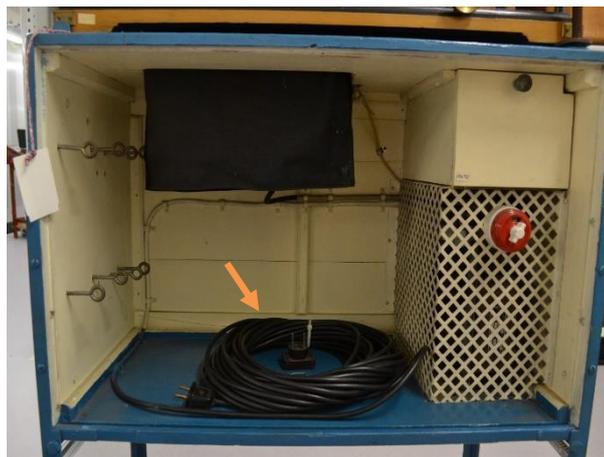
A strong smell coming from the power cable of the object has been detected (*Picture 114*). As the modifications brought to the object have been estimated between the 1940s and the 1960s, the presence of bitumen and polychlorinated biphenyls is questioned as they were often use in cables for their insulating properties.

Picture 114 : Localisation of the cable ©HE Arc CR, A.L

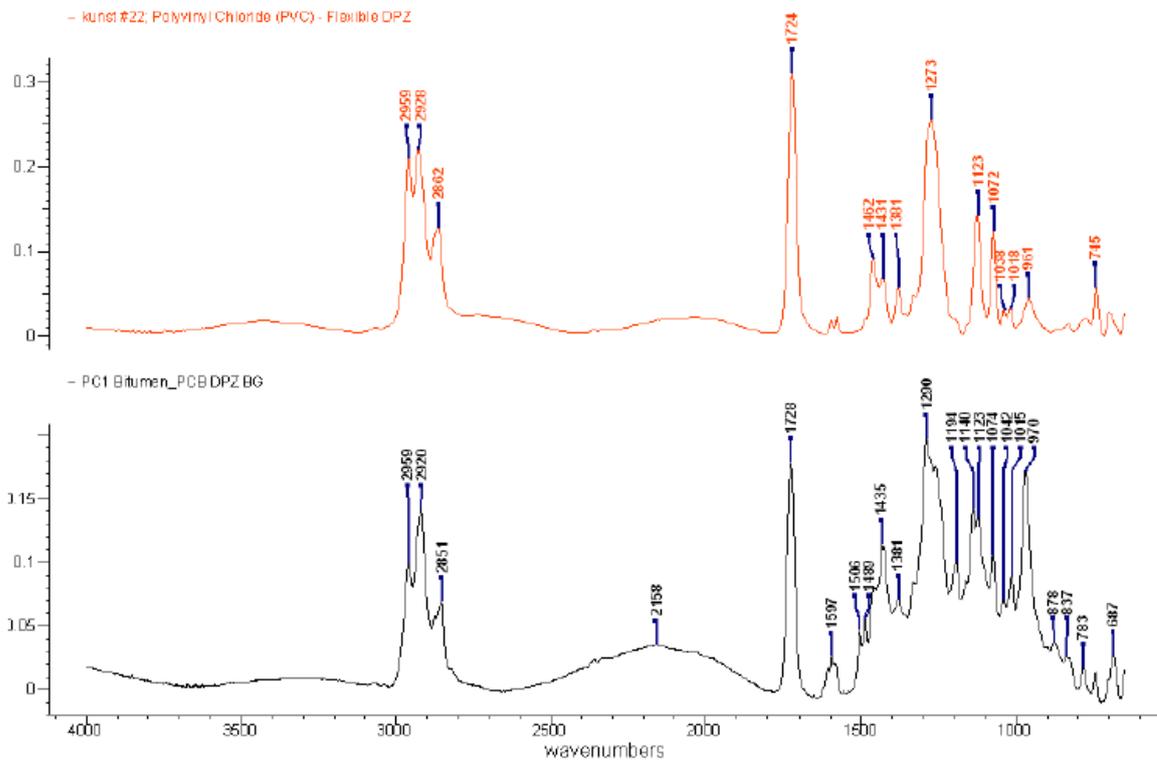
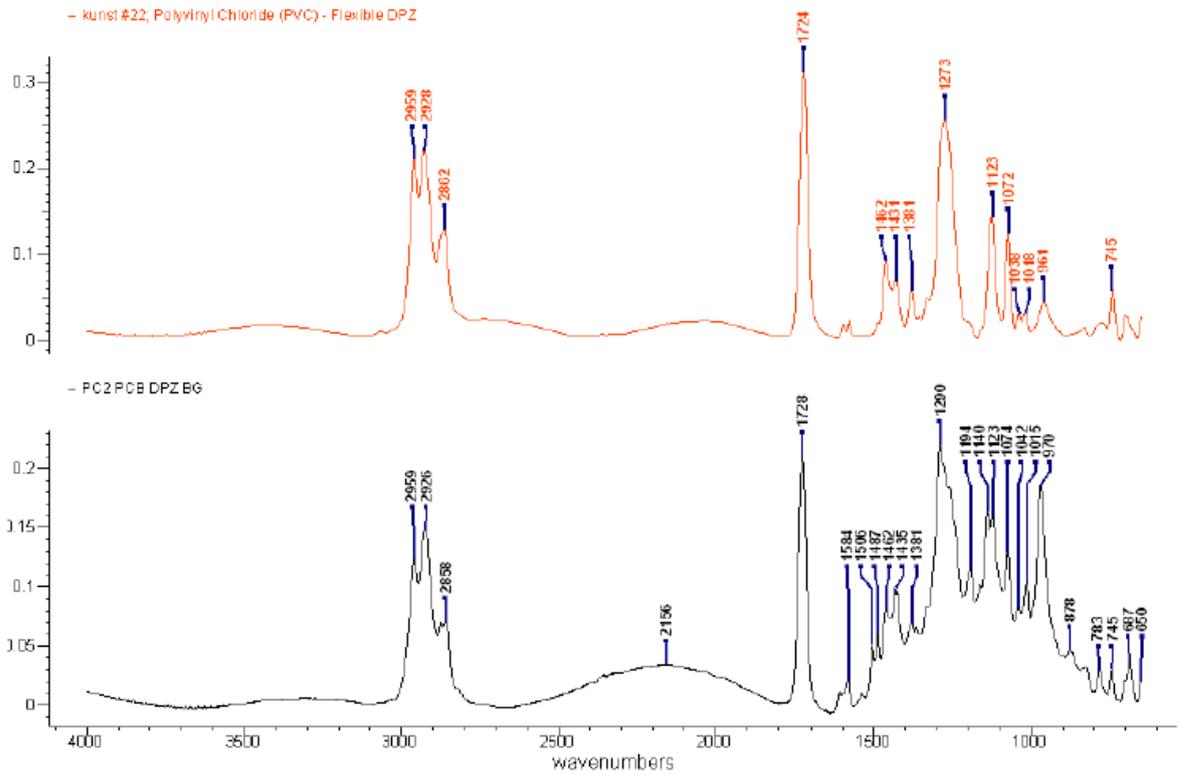
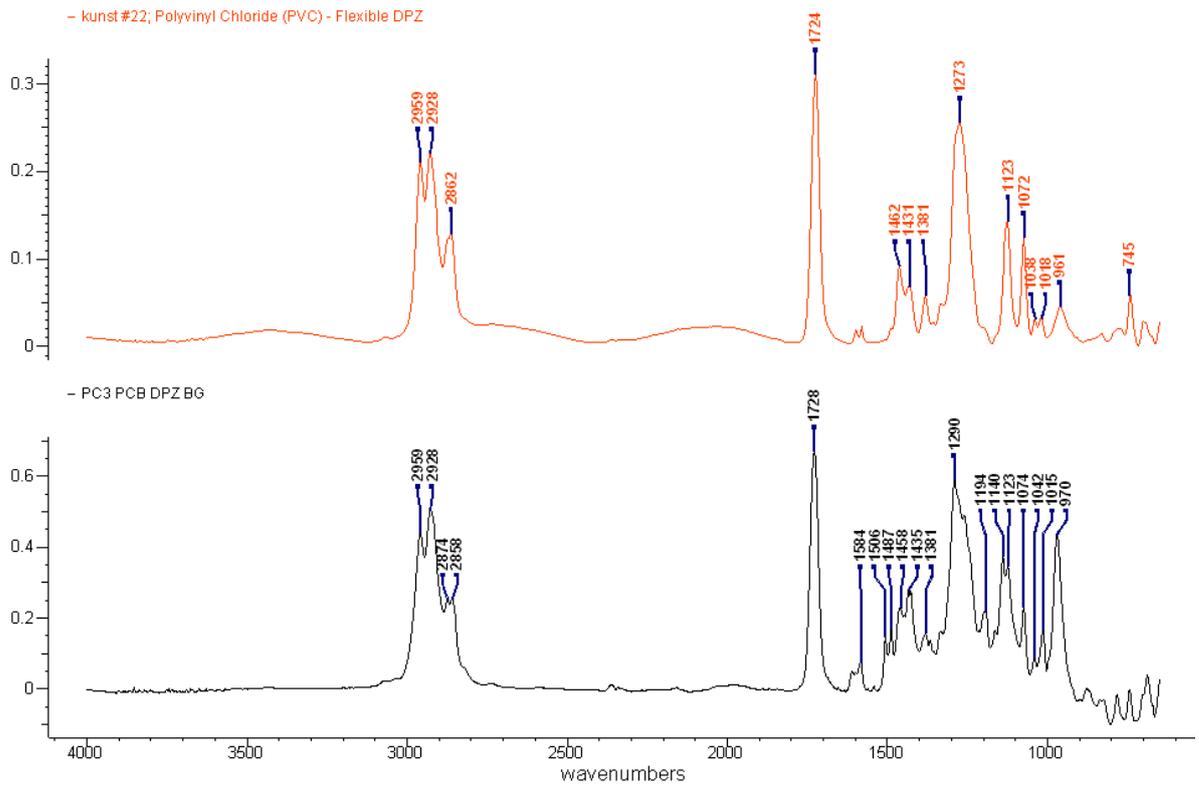
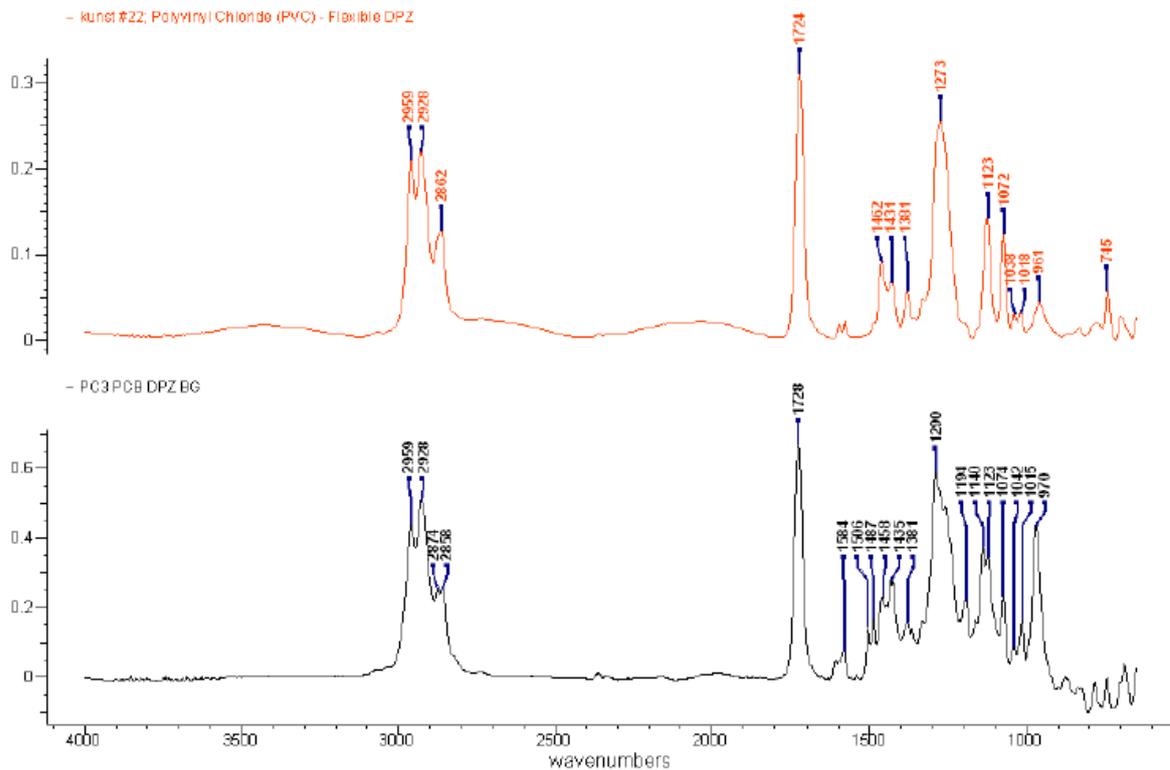
The 3 samples are principally composed of PVC containing phthalates. Other peaks are visible, but they don't refer to PVC, PVC products of degradation or polychlorinated biphenyls (Picture 115). It would be recommended to achieve GC-MS analysis to detect PCB and other products of degradation of PVC.

Picture 115 : The 3 first FTIR spectra show the presence of PVC and phthalates for samples PC1, PC2 and PC3.
The last spectrum show the hexane extraction residue of a piece of PC1 electrical cable (black spectrum)
compared to phthalates (red spectrum) ©HE Arc CR, A.L

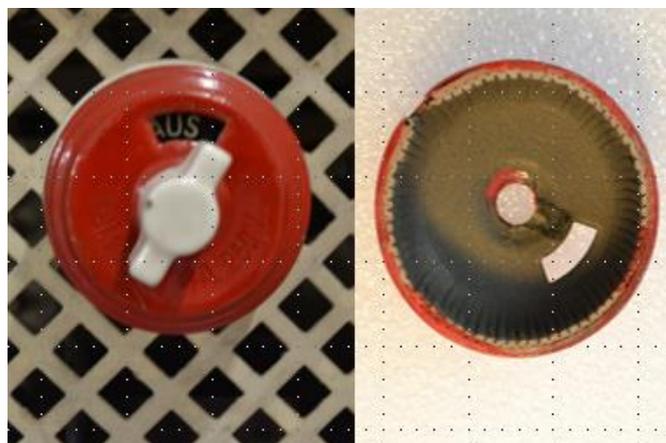
An insulating cardboard located in the cover of the switch of the transformer is suspected to contain asbestos because of its colour and its fibrous aspect (*Picture 116*). Asbestos was often use in the form of cardboard as insulating pieces, close to light sources or electrical devices. FTIR analysis has been carried on in order to identify the composition of the carboard and if necessary, take safety measures.

Picture 116 : Localisation of the insulating cardboard ©HE Arc CR, A.L

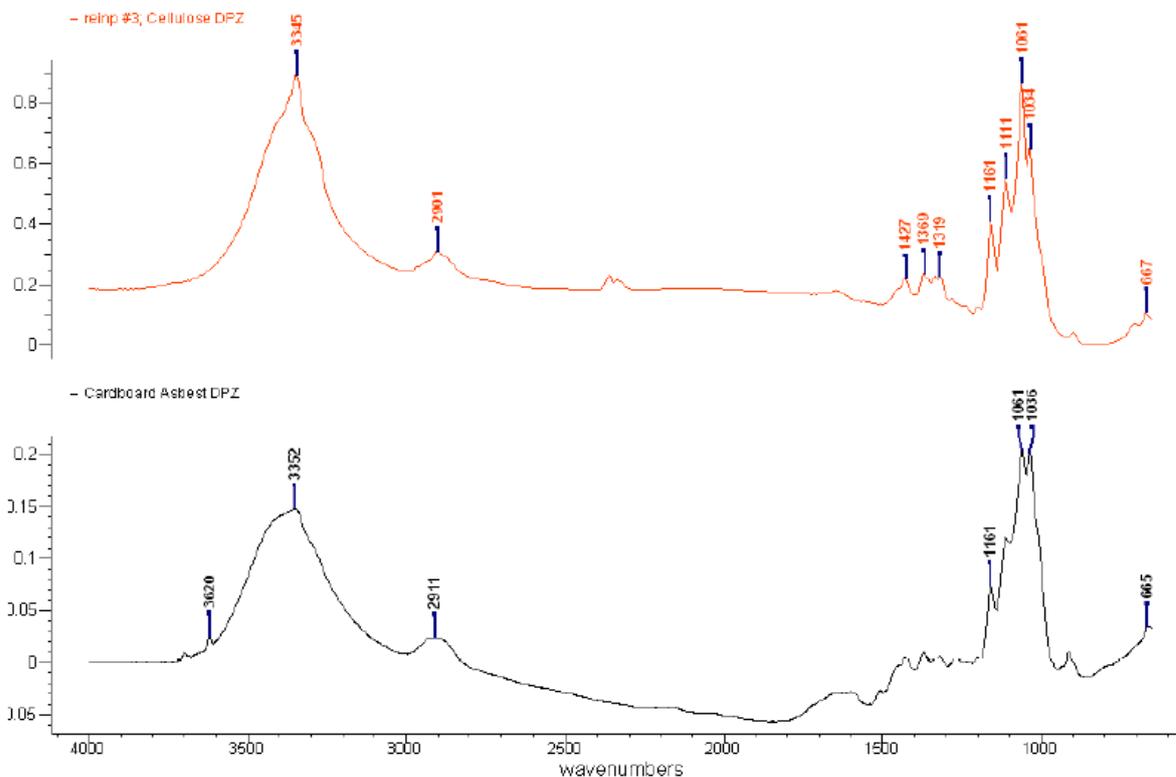
The insulating cardboard is principally constituted of a cellulosic material. It also contains a silicate which could be an ochre for the brown colouration of the cardboard (Picture 117).

Picture 117 : FTIR spectrum of the insulating cardboard (black) compared to cellulose (red) ©HE Arc CR, A.L
