Blued steel sheets : history, manufacturing and conservation.

The case of a Ganz & Co projection and enlargement lantern
conserved at the Collection Centre of the Swiss National Museum.

Master of Arts HES-SO in Conservation-restoration
Specialized in scientific, technical and horological objects

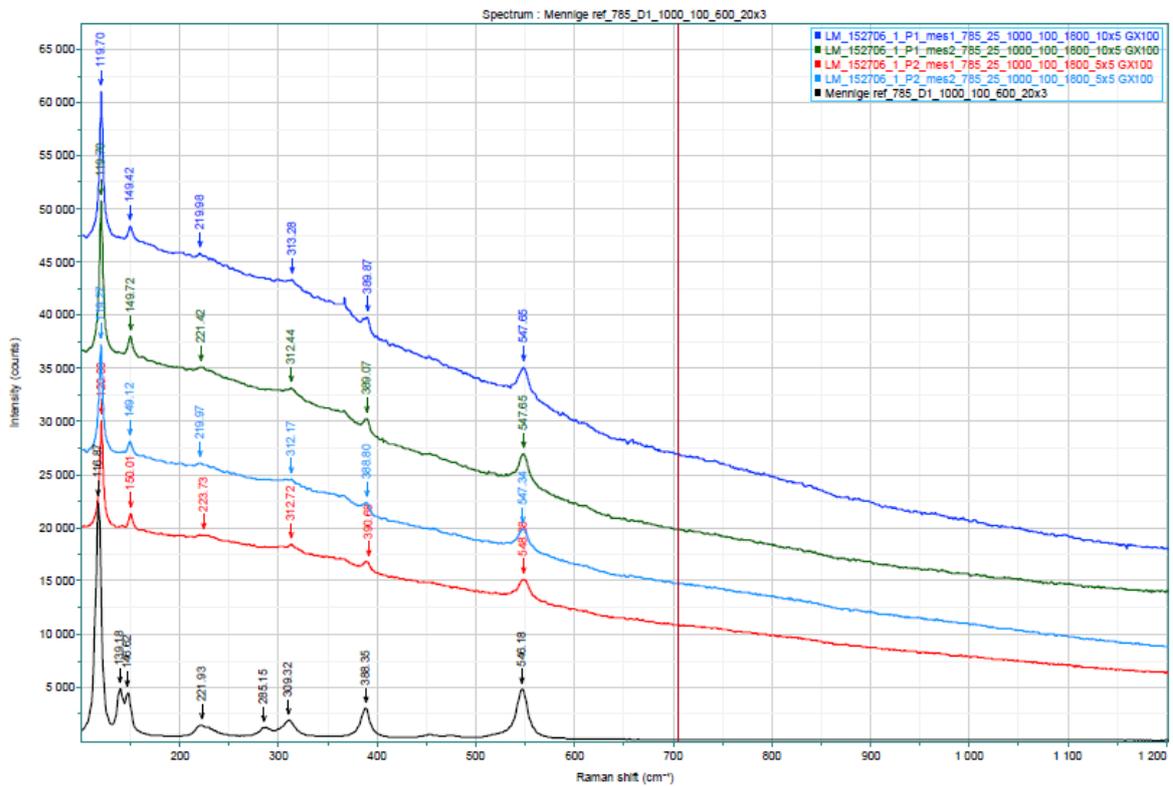
A sample of each paint layer has been collected for Raman spectroscopy analysis. The sample P1 corresponds to the paint of the backdoor of the lantern. The sample P2 corresponds to the sample of the inside of the chimney. Both are composed of red lead (Picture 119) and their binding is a drying oil which is partially or completely degraded. The black areas of the painting of the chimney are constituted of PVC containing phthalates (Picture 120, Picture 121).

Picture 119 : Raman spectra of the paint samples compared with the spectrum of minimum ©HE Arc Cr, A.L
